PFR SPTS No. 25684

## **Poplars and willows as bioengineering solutions for riverbank flood protection – learnings from Cyclone Gabrielle**

June 2024

River Managers' Special Interest Group  
Te Uru Kahika – Regional and Unitary Councils Aotearoa

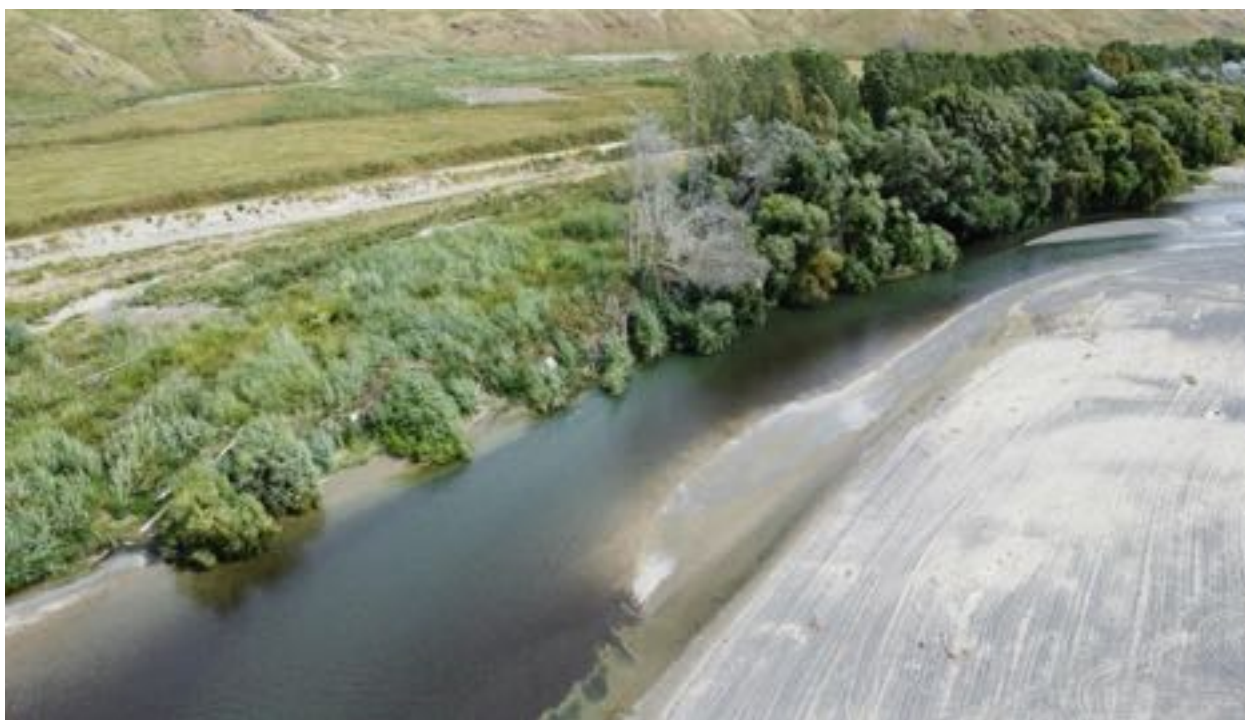
**Figure 11.** Regrowth of mature willows and poplars, flattened by overland flood flow return, contrasted with unaffected standing trees upstream.

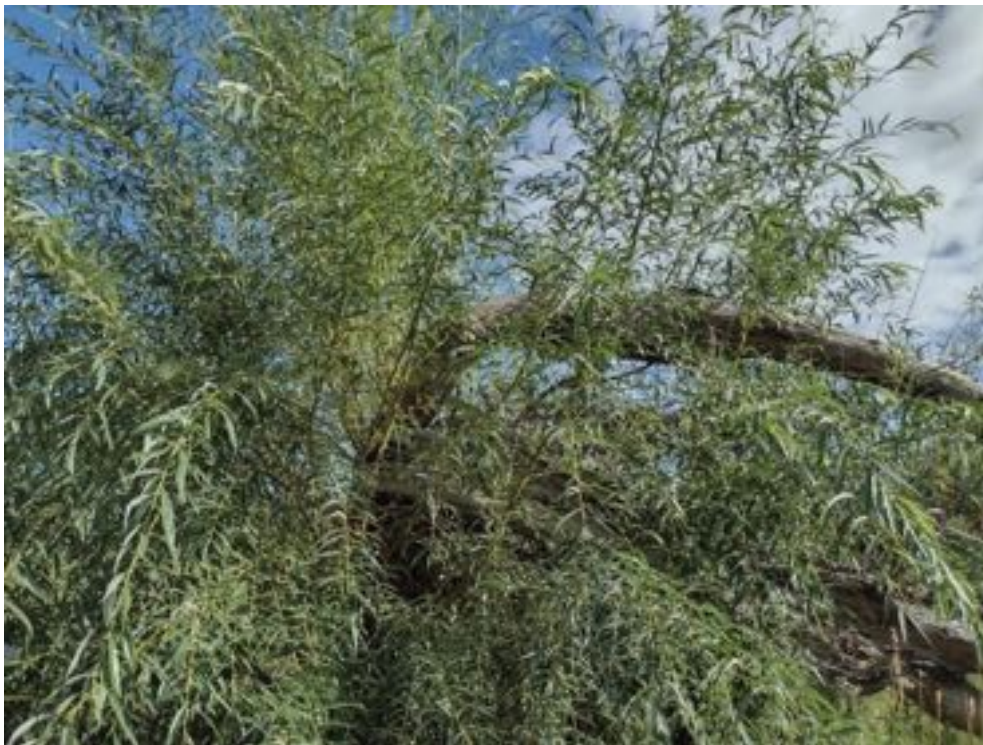
Flattened willows were not uprooted, they were still anchored in the soil/sediment by live roots (Figures 12 & 13). Any reorientation should consider whether the live roots may be broken off, with resulting slowing of regrowth of shoots, particularly from the stump area.

**Figure 12.** Shoot regrowth, after one year, from a tree willow flattened from behind by floodwaters. The trunk-soil connection remained intact.

**Recommendation – cut through the fallen trunk somewhere above the stump to create two trees from one. Realign or relocate the cut off trunk as anchored or layered tree protection. This is suggested as a sensible approach to dealing with trees that have fallen on a poor alignment, either on the berm or into the channel. If left they could create a weakness in bank or berm protection.**

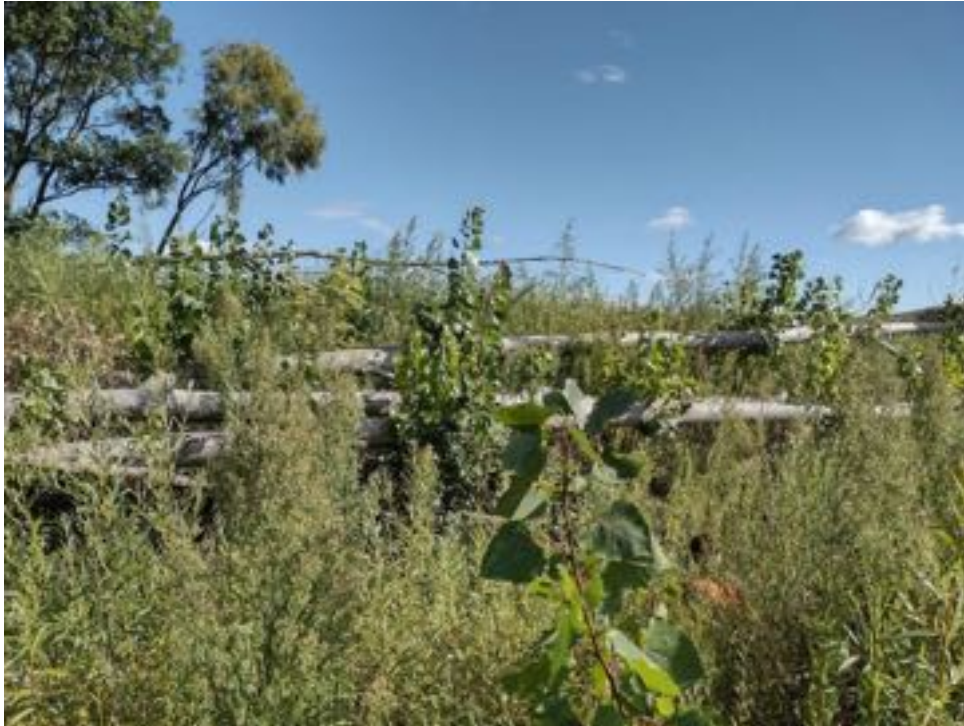
Flattened poplars (Figure 13) were more damaged. The trunk-soil connection was largely intact, but the prostrate trees will create management problems. Our recommendation is to remove them and replant replacement poles.

**Figure 13.** Shoots resprouting from flattened poplars. Almost all the bark was stripped by the abrasive floodwaters, leaving little opportunity for recovery from the trunk.

**Recommendation – that any debarked trunk be cut off and removed. They will always be a weak protection asset.**

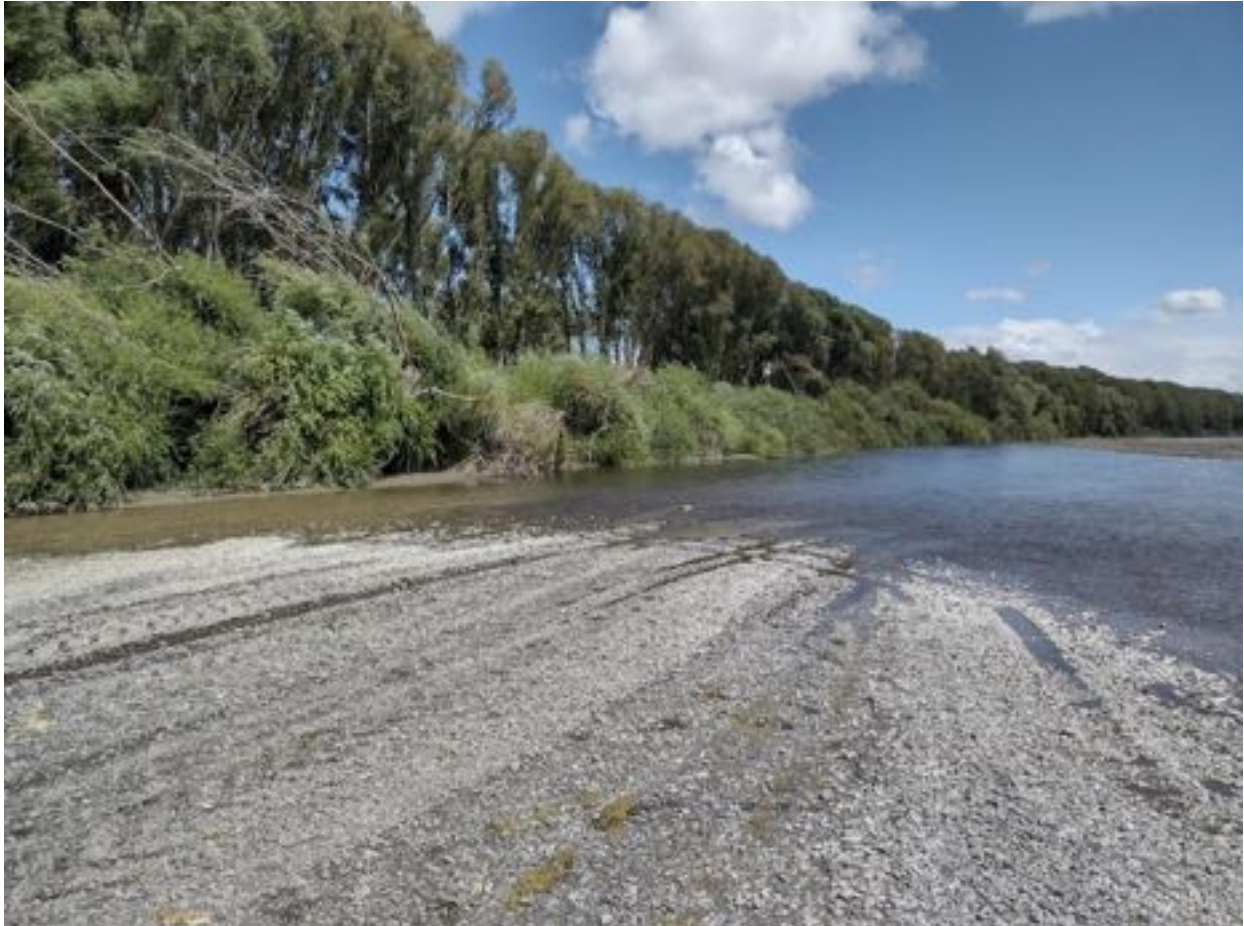
**Figure 14.** Recovery of front row of tree willows layered by floodwaters in the main channel, one year on from Cyclone Gabrielle.

**Recommendation – that bank and berm protection plantings are maintained by appropriate planting, layering, and mulching as required.**

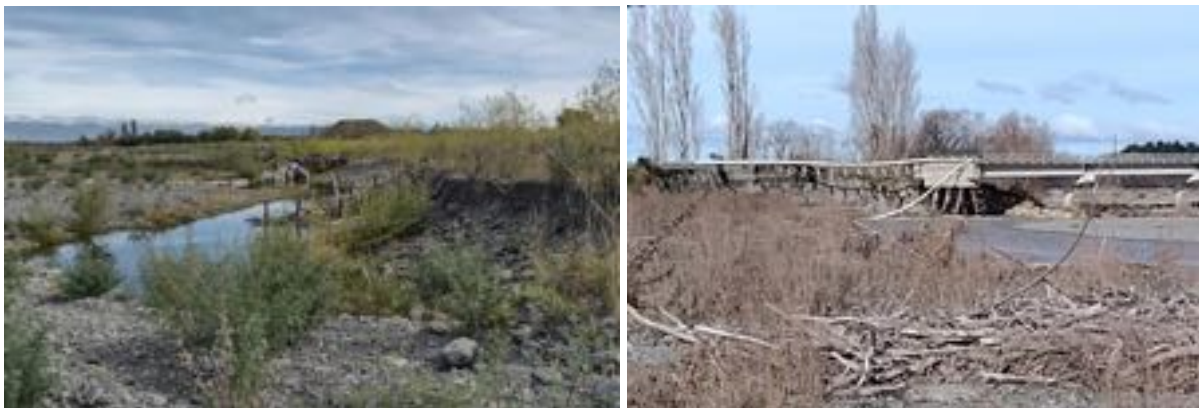
A comprehensive project was undertaken upstream of SH50, and just prior to Cyclone Gabrielle, to secure the channel alignment and prevent damage to the SH50 Bridge. Works consisted of channel realignment, erosion bay infill, Akmon groynes, rope/rail groynes & training lines, and extensive tree planting (Figure 15). Infilled gravel areas closer to the river were planted with willow poles (*Salix matsudana x alba* hybrids), and poplar poles (*Populus x euramericana* 'Veronese') were planted higher up on the banks. Cyclone Gabrielle partially undermined the Akmon and rope/rail groynes causing bank erosion and channel realignment (Figure 16). A further flood in June 2023 further damaged these works upstream of SH50, resulting in bridge abutment wash-out and road closure.

**Figure 16.** Bank erosion with damaged Akmon & rope/rail groynes (left). SH50 Bridge wash out (right).

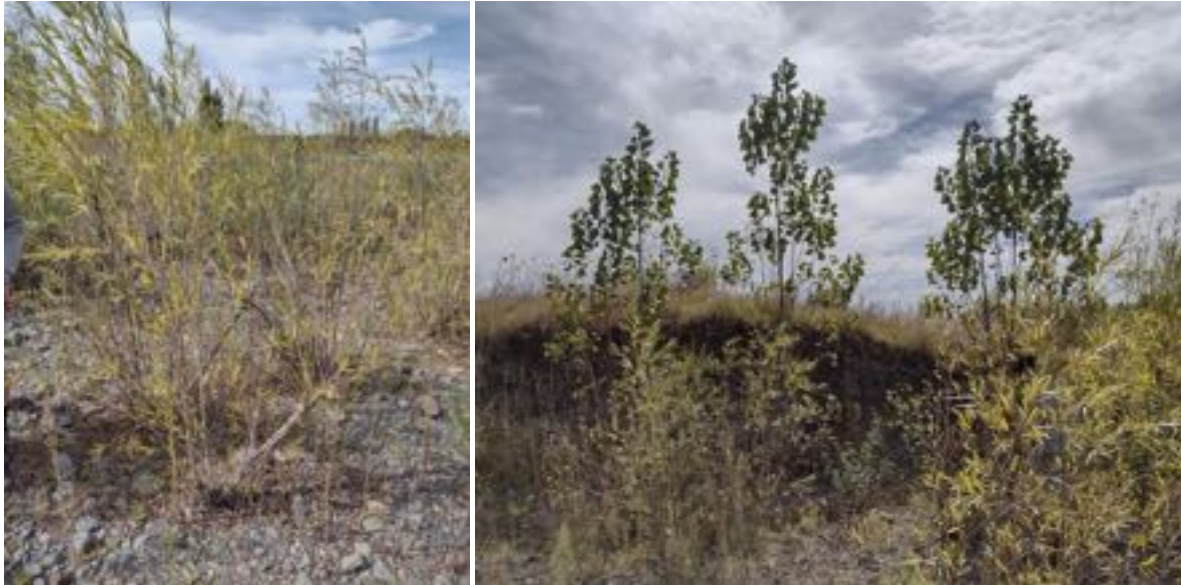
**Figure 17.** Willow and poplar growth in spite of flood damage.

Key points taken from this inspection were the surprisingly good condition of the newly planted willow poles, in spite of abrasion and breakage damage caused by floodwaters and debris. The poplar poles were in even better condition mainly because they were less exposed to flood damage. The root systems had established sufficiently to hold and prevent erosion of loose gravels. The normal approach of planting the willows closer to the water's edge, and the poplars on drier ground away from the river, proved to be successful (Figure 17). Another useful finding was how successful rope/rail groynes were in trapping woody debris, preventing local tree damage as well as downstream debris movement and related problems (Figure 18).

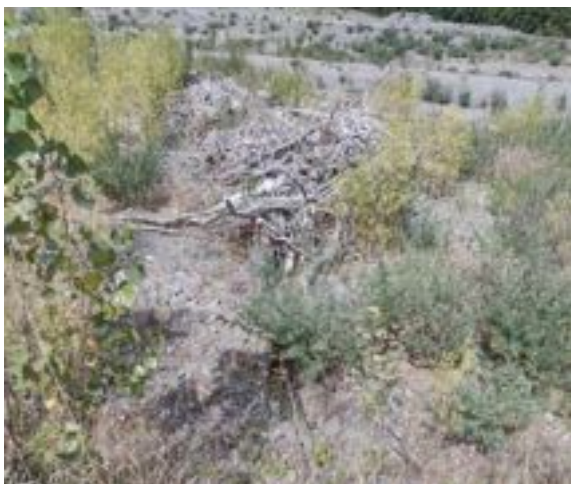
**Figure 18.** Debris capture by rope/rail groyne.

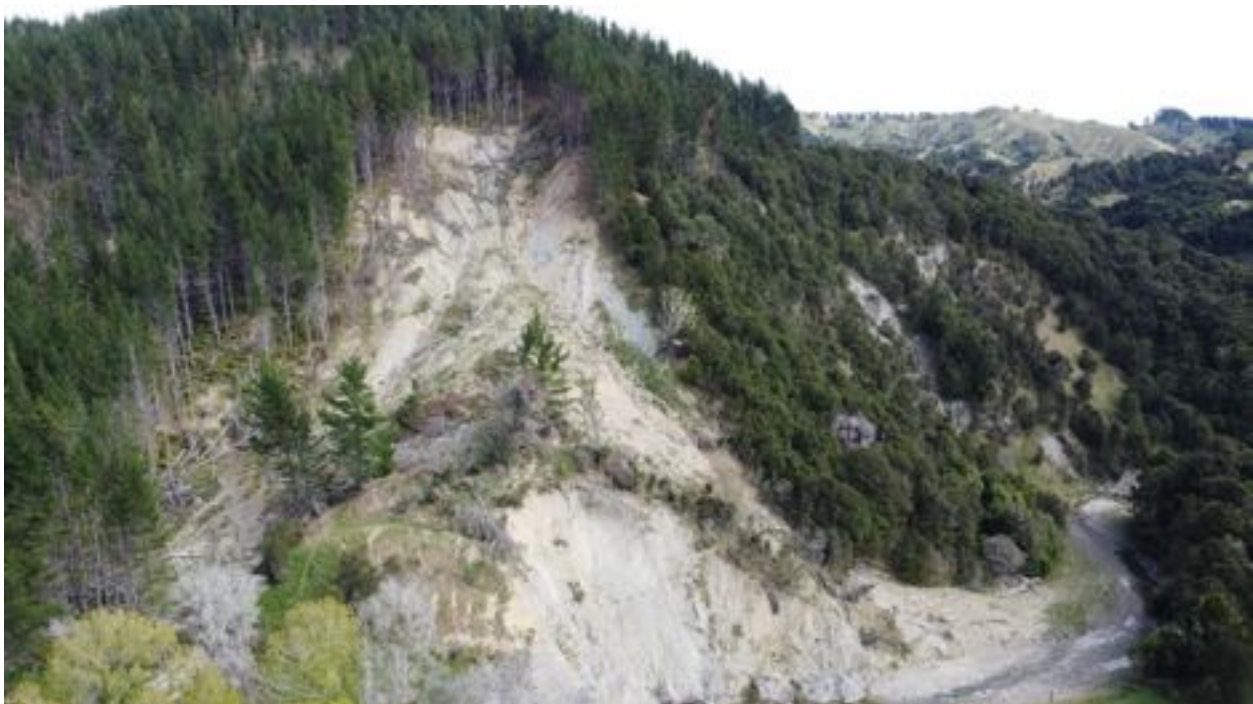
In the upper reaches, fallen plantation pine trees (falling off steep shallow soil slopes) were observed at two locations (see Figure 20). We considered that other fallen pines had been caught up in floodwaters and carried downstream to break pipe bridges along the Waingake water supply pipeline and to create blockages at bridges and bends. Mānuka-clad steep slopes did not show tree toppling (Figure 20). There was some bank erosion, mostly at sites where the bank was unprotected and had experienced erosion previously. Comparing Google images pre- and post-Gabrielle, some woody vegetation had disappeared from sloping banks in a few locations, but numbers of trees were small, and likely a mix of osier and tree willows. In the upper reaches, before the river has left the hills, floodwaters tracked over farmland, and woody debris settled on pasture, among edge trees and within the channel.

**Figure 20.** Plantation pine covered steep slope, contrasted with mānuka covered steep slopes, upper Te Ārai River.

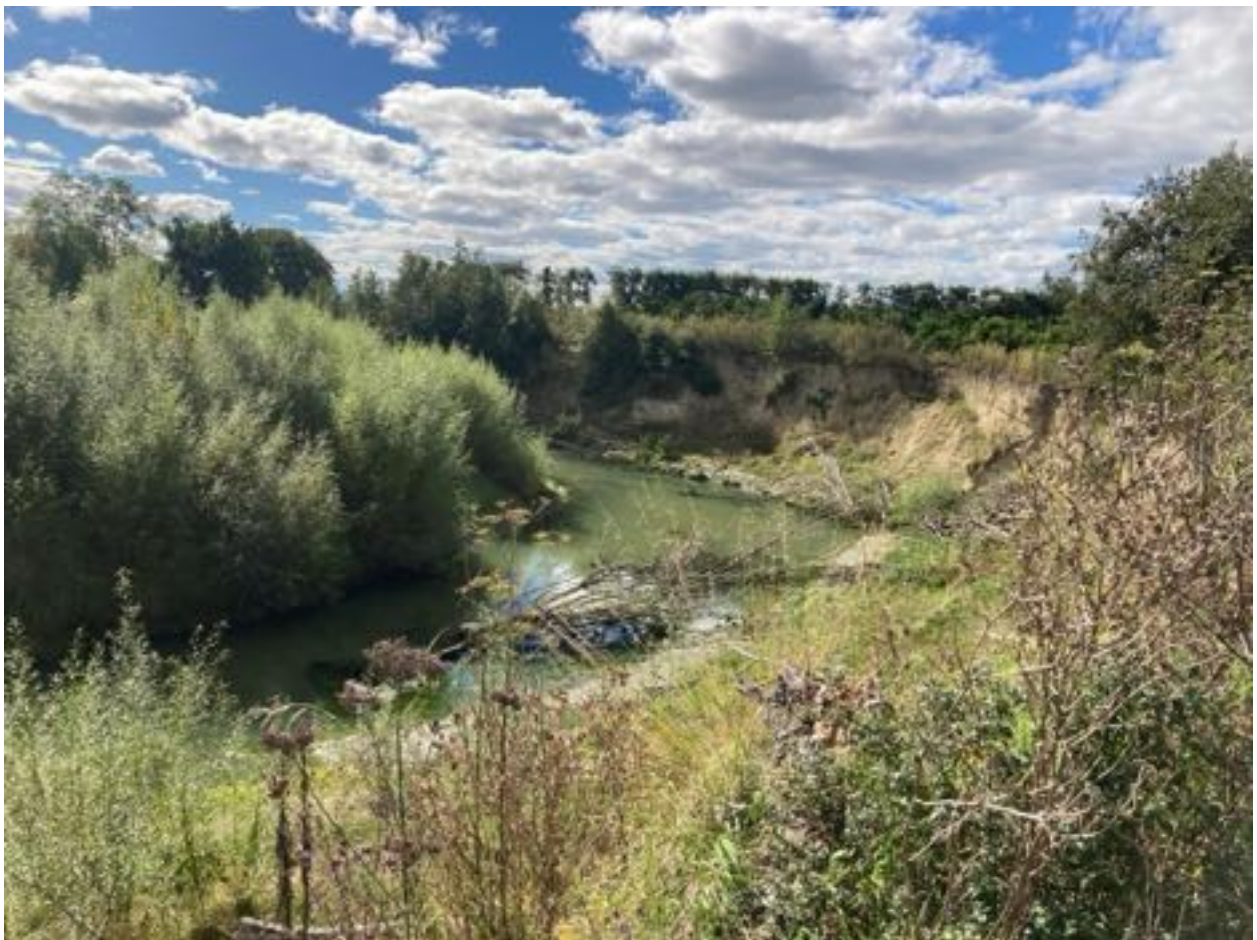
**Figure 23.** Erosion of the bank on an outside bend, Te Ārai River. Heavily wooded inside bend traps sediment and narrows the channel.

**Recommendation – establish osier willows on the outside of bends, with a combination of tree and osier willows (or other bioengineering methods) on outside bends where erosion or slumping is threatening roads, high value farmland, or other valuable assets.**

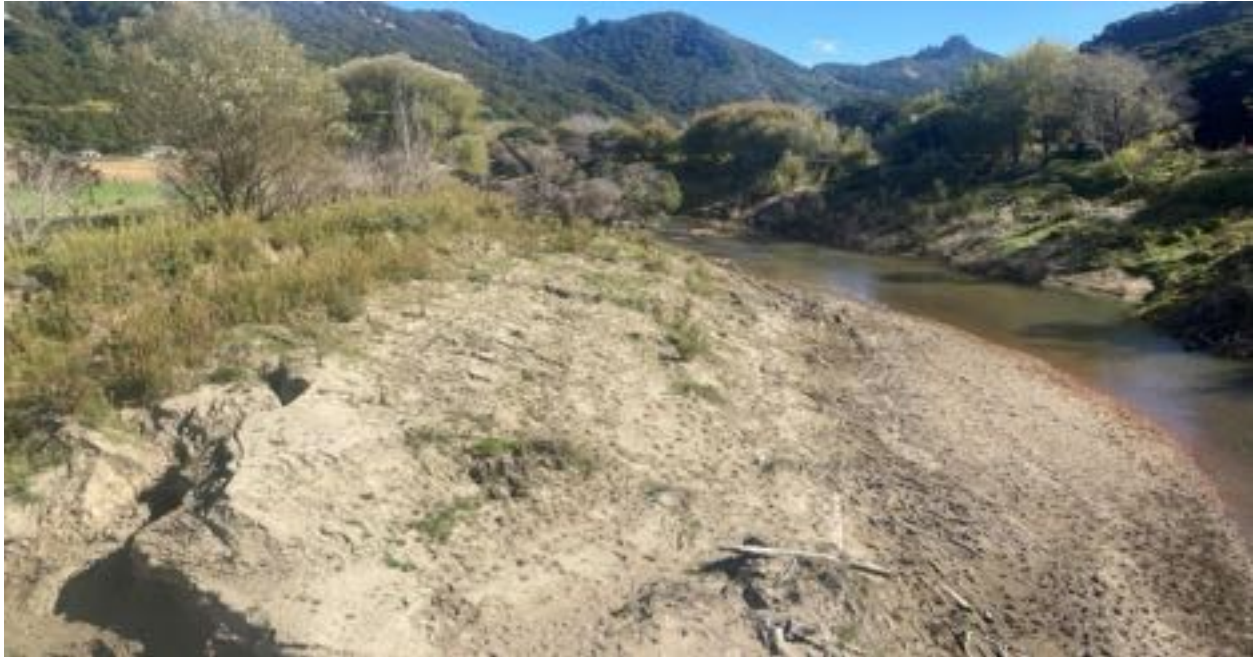
**Figure 25.** View of Hikuwai River showing stable sloping banks. Overland flow returning to the channel caused the erosion in the foreground.

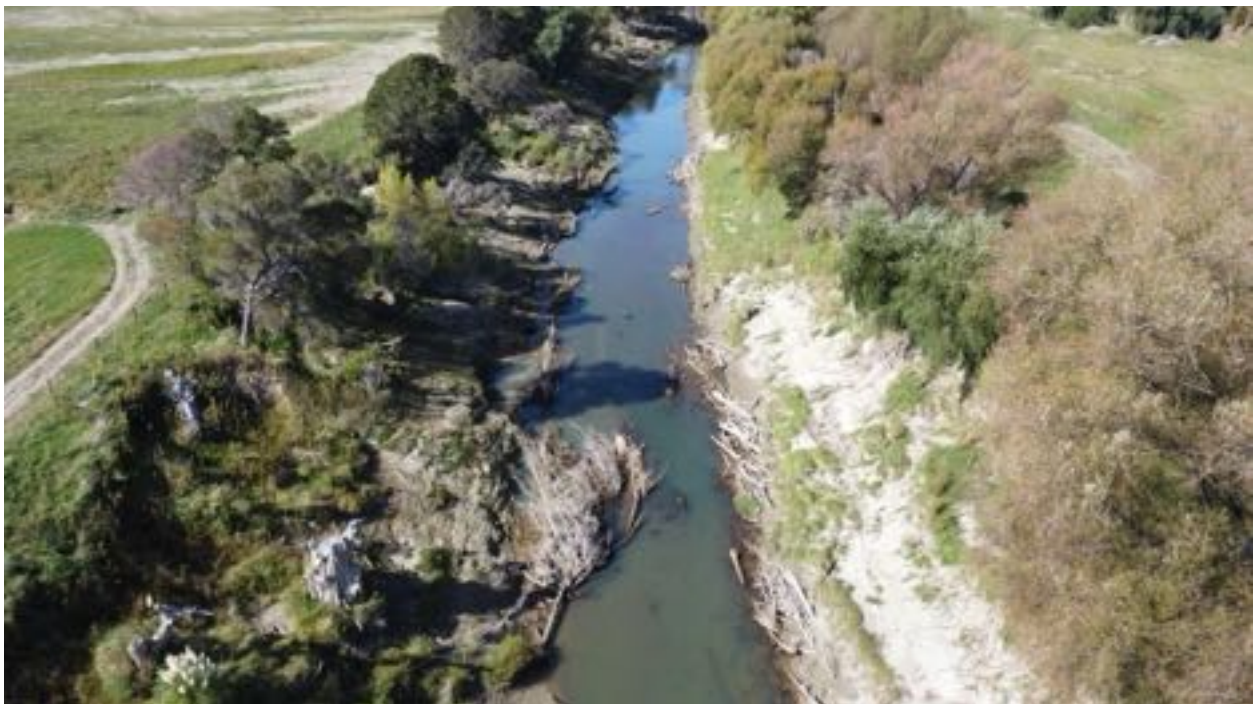
**Figure 26.** Bank stabilisation by tree willows (right bank) contrasted with slumping into the channel on left bank (despite the presence of mature mānuka and other tree species).

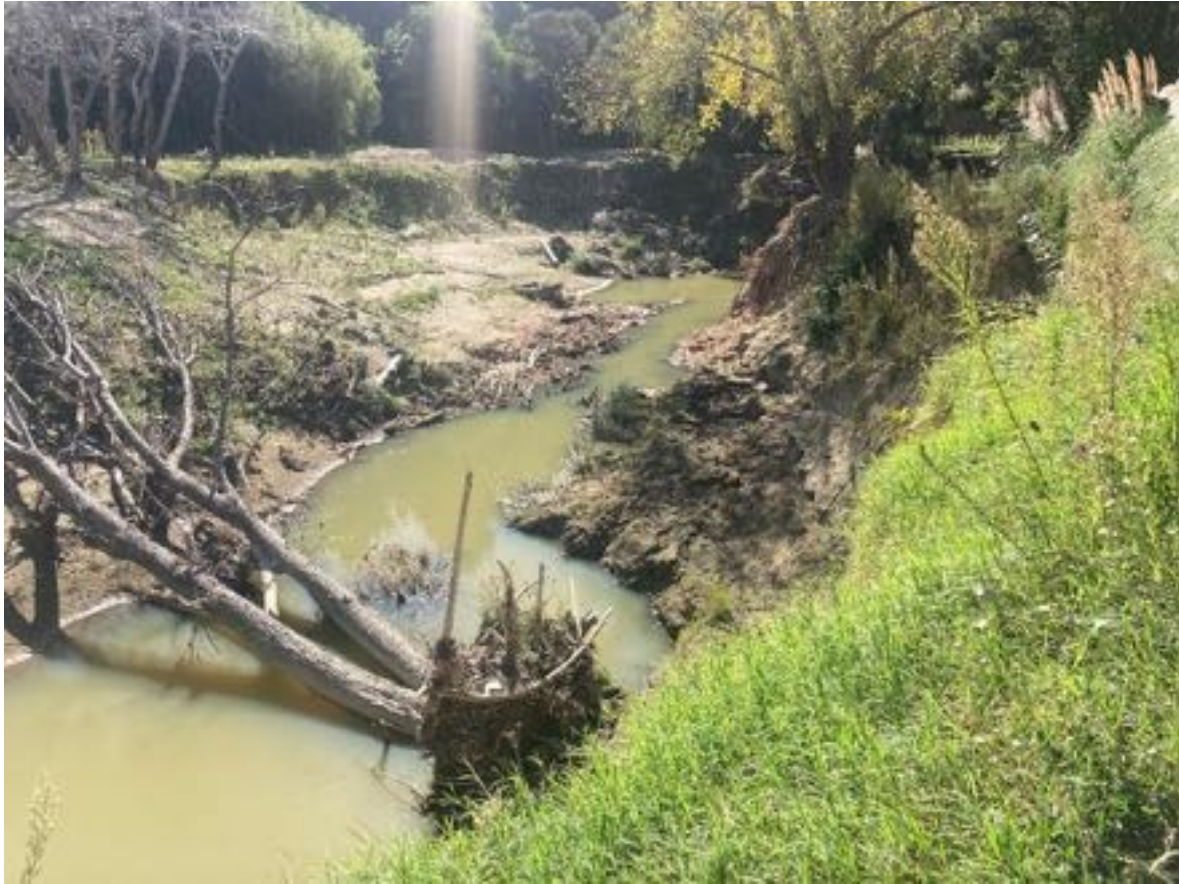
Banks on the Hikuwai River showed a high degree of stability. Where tree willows were planted at the top of the bank there was little if any slumping (Figure 24). Fibrous willow roots occupied the bank profile down to the channel. We observed large roots in the banks, partially exposed by the floodwaters, which were running laterally at different depths, and with fibrous roots extending from them (Figure 24). This was clear evidence of how willow root systems hold steep banks intact. Erosion from the top of the banks was evident where drains entered the river, and where overland flow from a low point on the paddock flowed back into the river (Figure 25). Toe erosion and slumping of the bank occurred along stretches of the river, either with no trees planted at the top of the bank, or where unsuitable trees (mānuka, poplar, tōtara) were undermined (Figure 26). At several locations, we observed that poplars planted on the top of the bank, and close to edge, were undermined and toppled by floodwaters. One example was at Hikuwai No. 1 Bridge (Figure 27).

**Figure 27.** *Populus x euramericana* poplar undermined by floodwater above No. 1 Bridge, Hikuwai River.

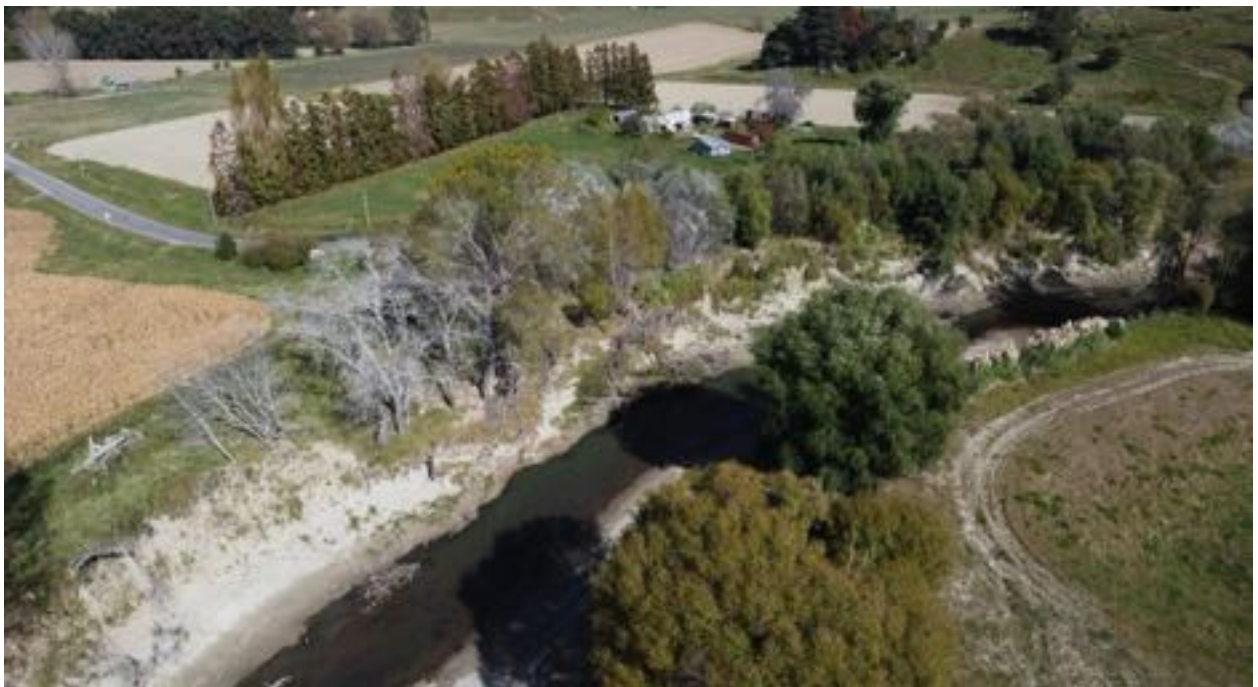
Outer bends which were well planted with trees showed little erosion, whereas outer bends devoid of trees lost sediment at the top and sides of the banks (Figures 28 & 29).

**Figure 28.** Densely treed outer bends suffered little bank erosion, but silver poplars (foreground, left bank) were undermined by toe erosion.

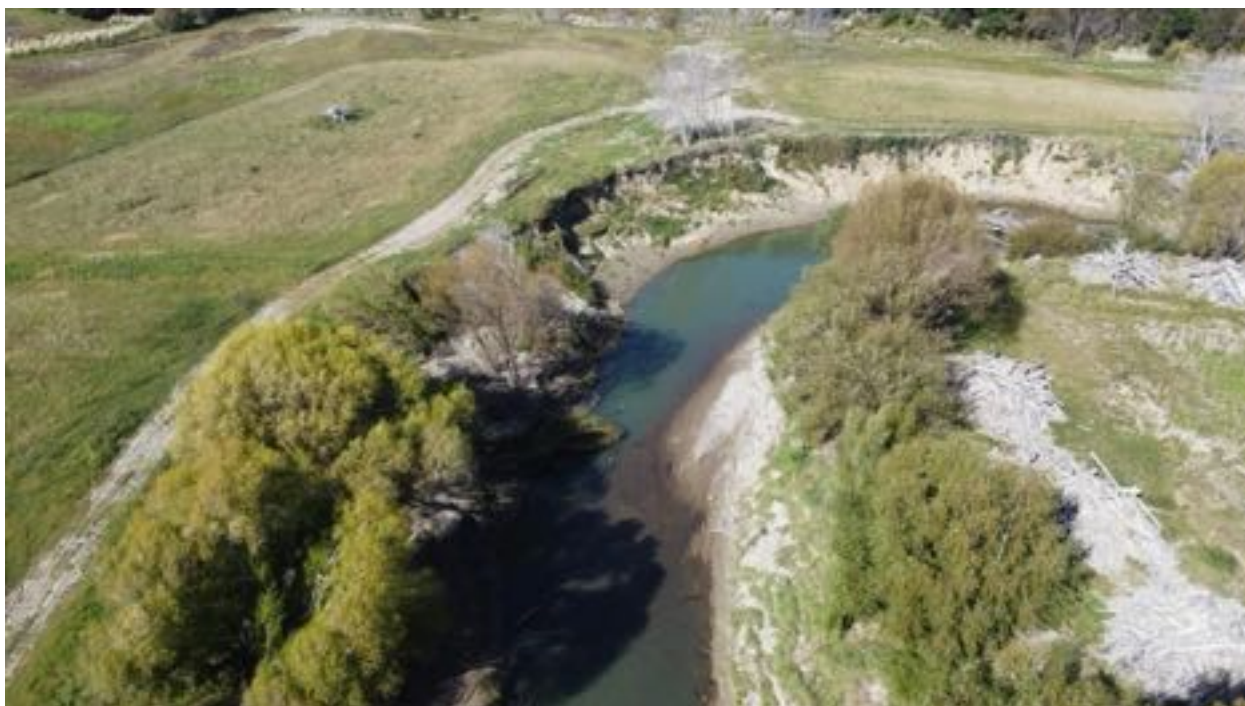
**Figure 29.** Sparsely treed outer bends showed more toe erosion and slumping.

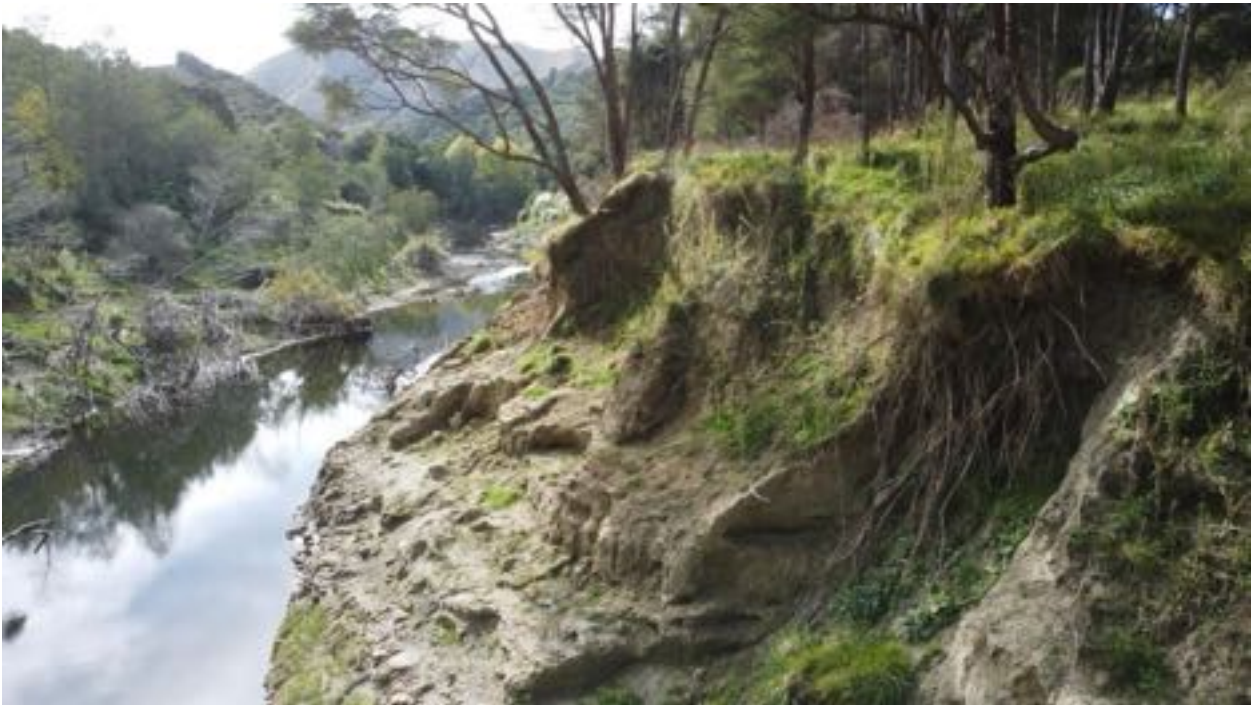
**Figure 31.** Mānuka roots exposed by bank erosion, Waimatā River. Poplars on opposite side partially destabilised by floodwaters.

**Recommendation – woody plantings intended for bank stabilisation along rivers must have adequate root systems to bind sediment.**

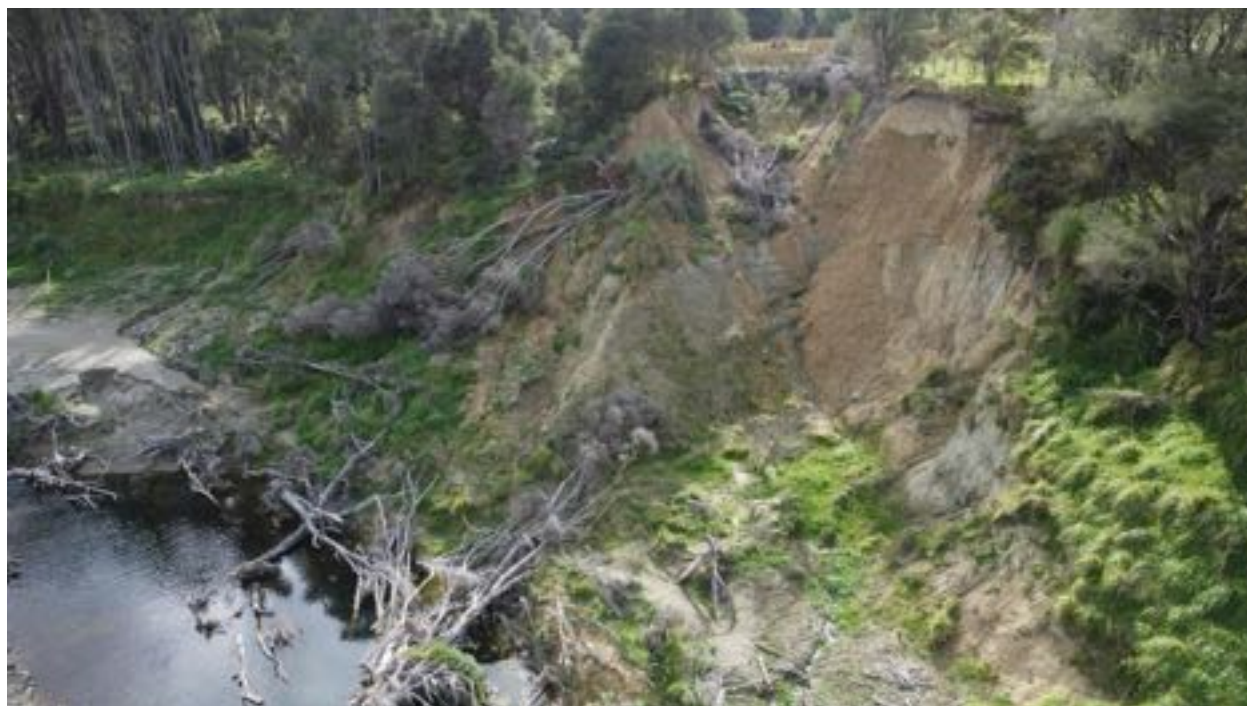
**Figure 32.** Mānuka trees toppled by gullyng of a stream running into Waimatā River.

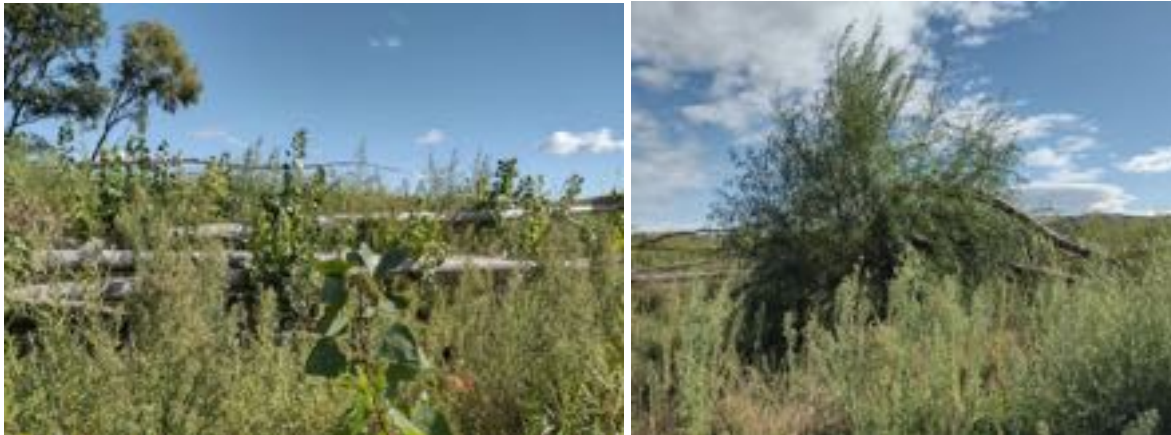
**Figure A10.** Regrowth under debarked poplar (left). Layered & partially debarked willow regrowth (right).

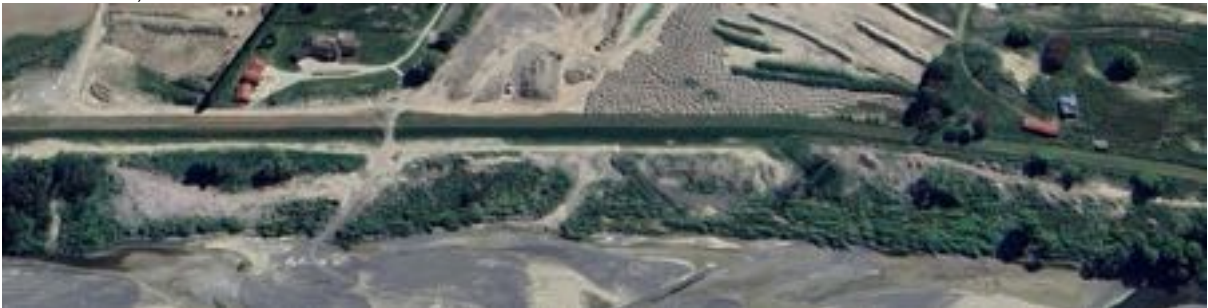
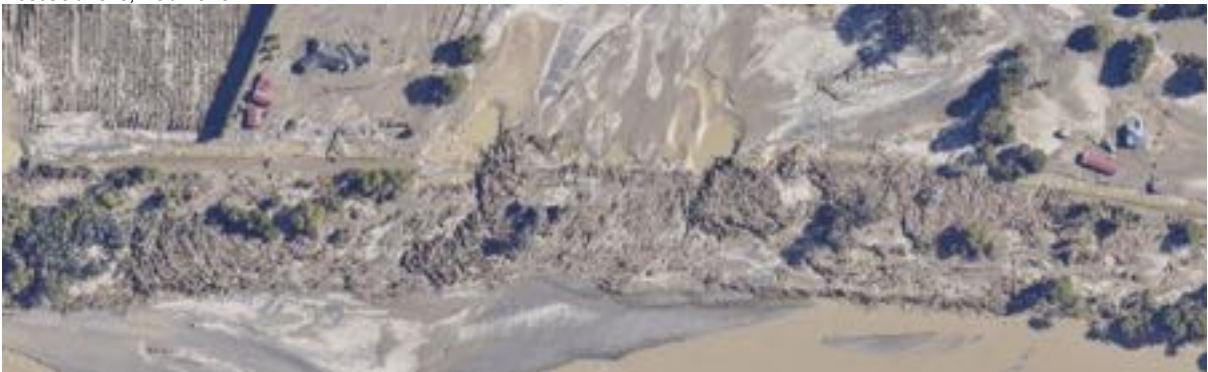
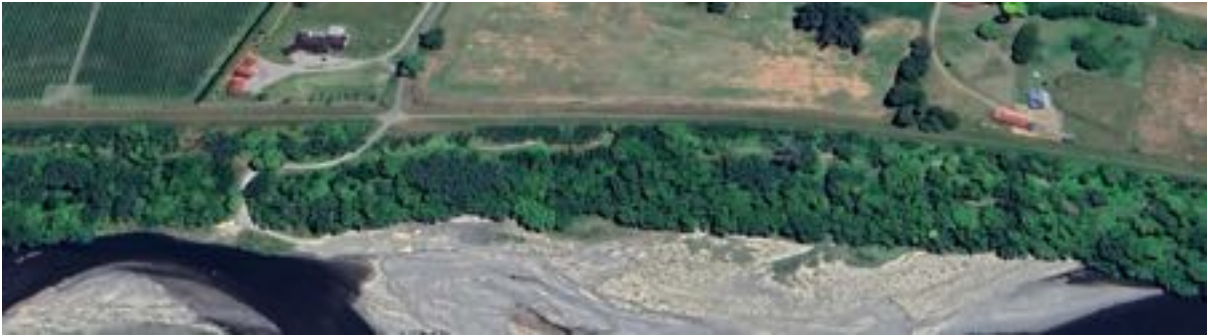
**Figure A11.** Directional effect of Ebbetts floodplain return flows & Dartmoor stopbank breach flows.

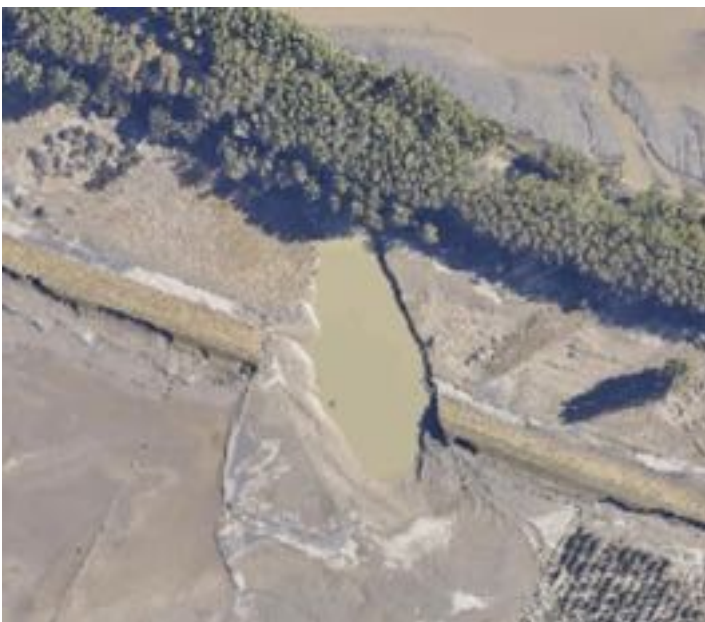
**Figure A15.** Moteo stopbank breach – berm scour arrested by buffer zone.

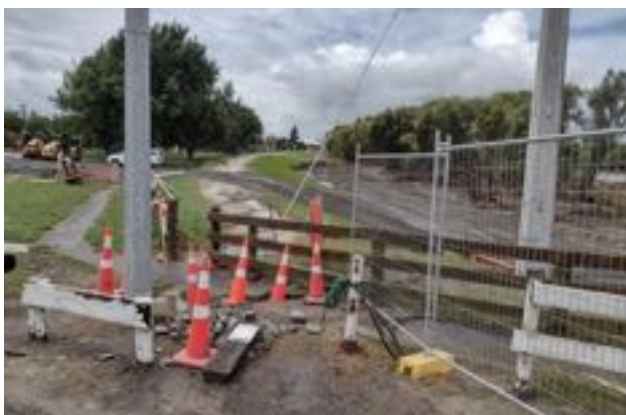
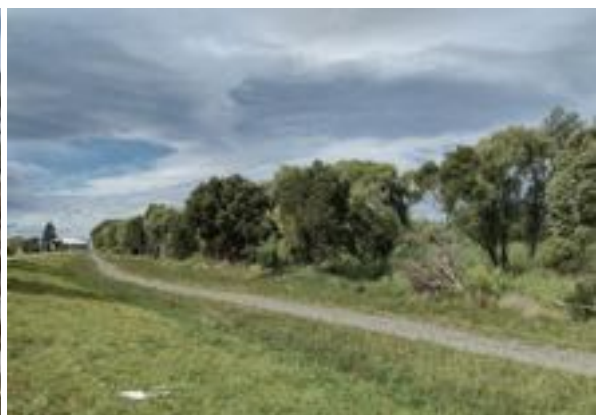
**Figure A21.** Berm erosion alongside Taradale stopbank (left). Taradale stopbank – post-cyclone berm repairs (right).

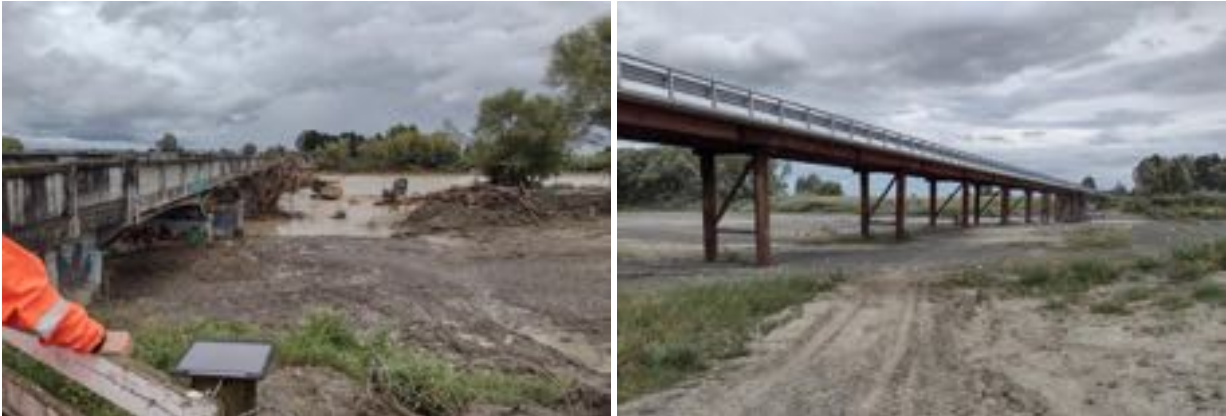
**Figure A22.** Redclyffe Bridge – cyclone debris removal (left). Redclyffe Bridge – interim repairs (right).

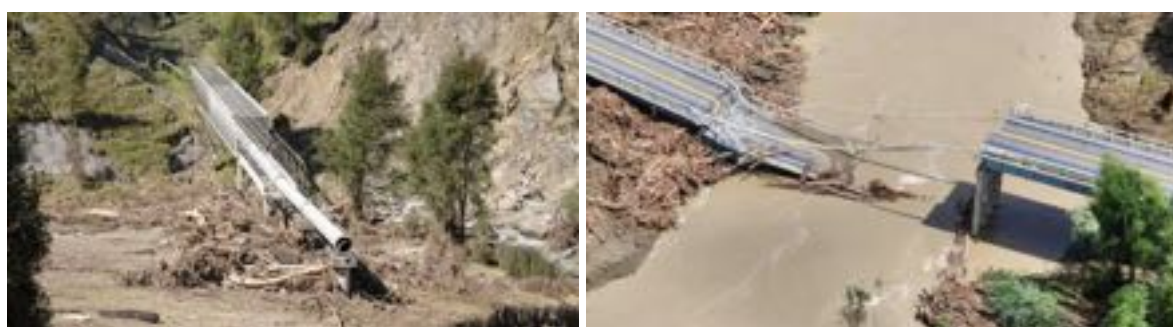
Plantation forestry (*Pinus radiata*) contributed large volumes of woody debris into waterways such as the Ūawa-Hikuwai and Te Ārai Rivers. Although waterways and bridges were largely cleared of Cyclone Gabrielle woody debris at the time of inspection, the team saw evidence of mature pine trees, as well as pruning/thinning waste, being carried downstream and deposited within the river channel, on bridges, and over floodplains. Woody debris contributed to the wash-out of pipe bridges along the Waingake water supply pipeline to Gisborne City (Figure A23 left), as well as collapse of the Hikuwai River No. 1 Bridge (Figure A23 right).

**Figure A23.** Damaged Gisborne water supply pipeline & Hikuwai No.1 Bridge.

Modification of forestry practices to avoid tree planting or the stockpiling of forestry waste on unstable slopes and close to waterways will help reduce woody debris problems. In the upper Te Ārai and Hikuwai catchments there were hill slopes that had failed, carrying whole trees downslope into the river channel (Figures A24 & A25). Locations nearby with comparable slopes, and recently regenerated native vegetation, appeared to be more stable (Figure A26). If these slopes were to fail, the slower growing native vegetation would contribute less woody debris of smaller size than plantation forestry.

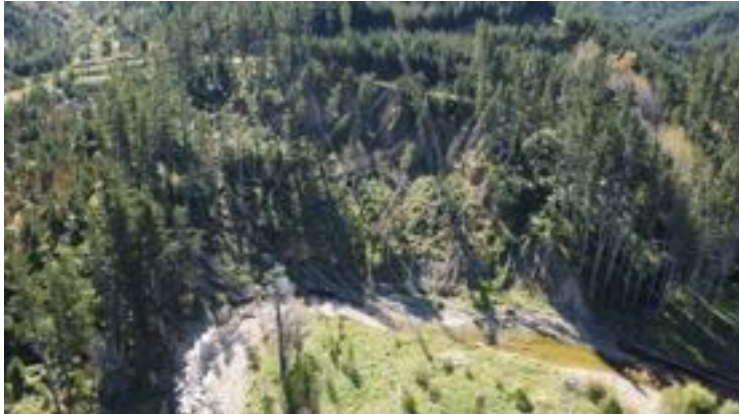
**Figure A24.** Major slip carrying mature pine trees into the river bed – Hikuwai catchment.

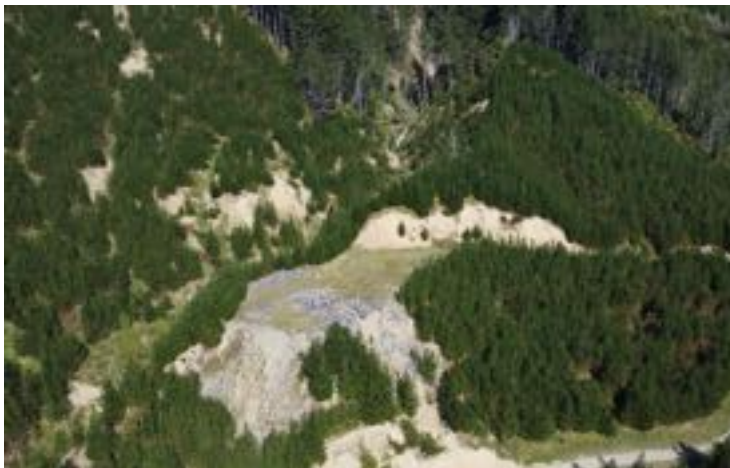
**Figure A25.** Forestry landing and woody waste pile undermining – Hikuwai catchment.

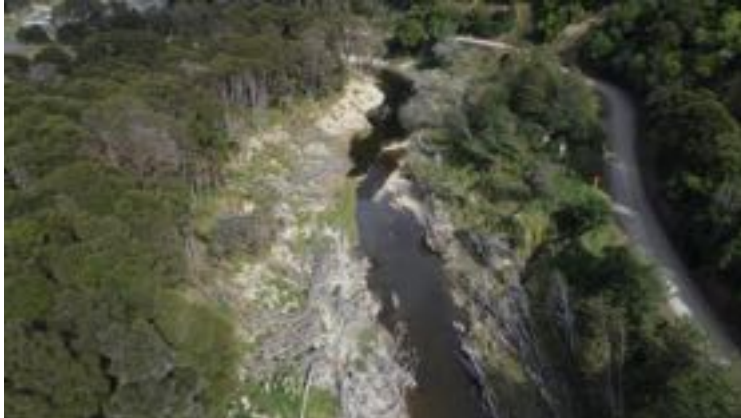
**Figure A27.** Undermined Mānuka/Kānuka trees deposited in riverbed – Waimatā River.

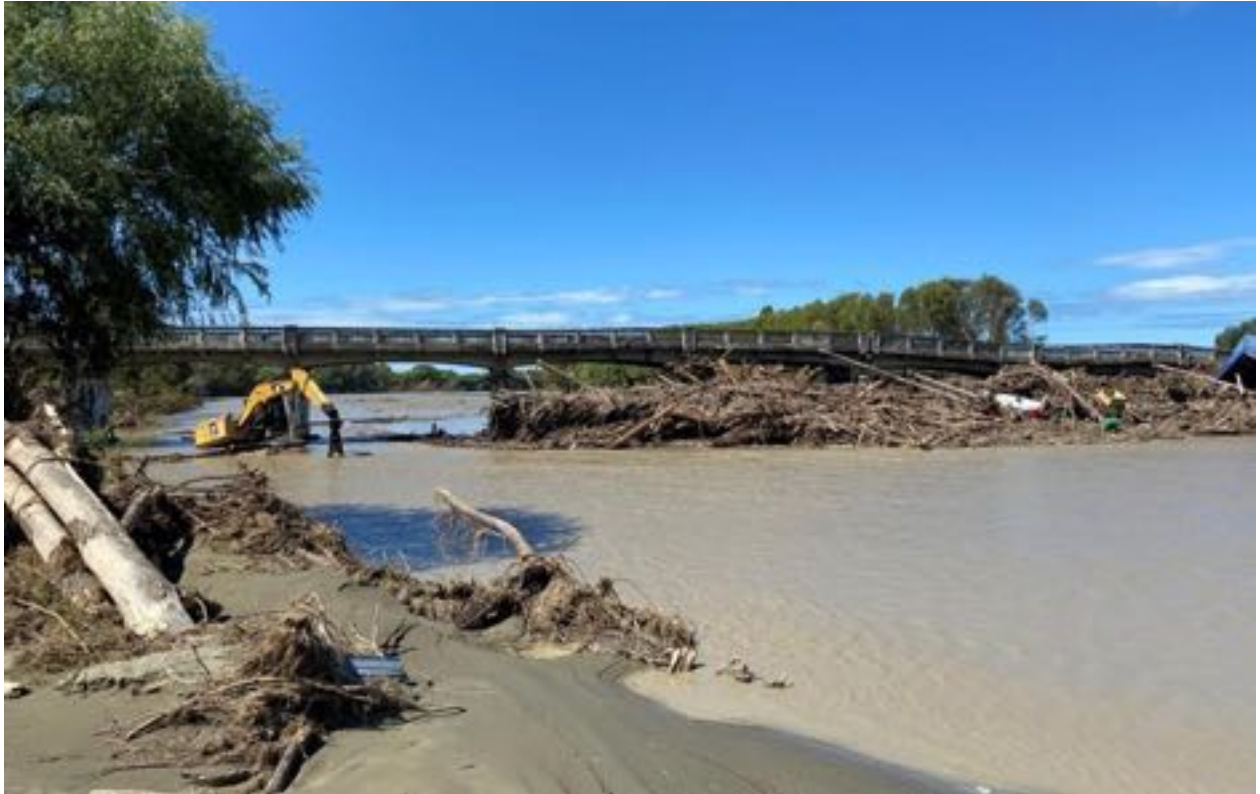
**Figure A36.** Woody debris on collapsed Redclyffe Bridge.
