Root excavation of *Salix matsudana* × *alba* ‘Moutere’ willow on the Hutt River, Wellington, New Zealand and on the Rangitikei River, Ohakea, New Zealand

Ian McIvor (Plant & Food Research) and Mike Jensen (Greater Wellington Regional Council)

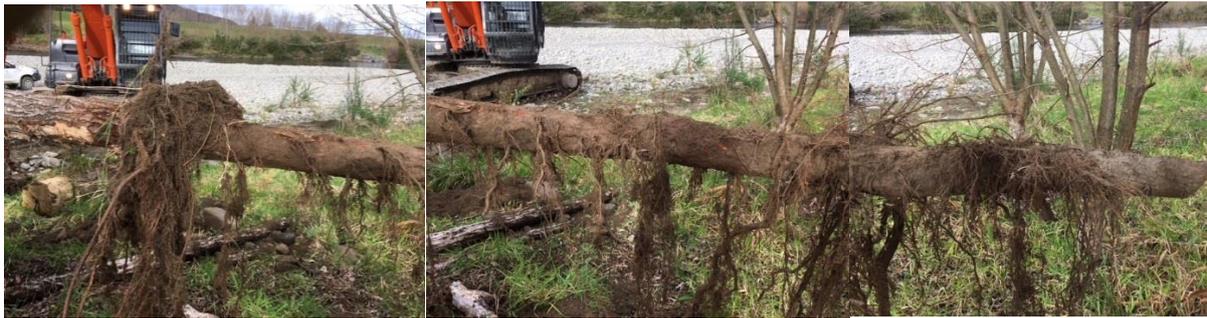
Figure 1. Root presence along the length of the pole for Tree 1

Figures 1 – 6 show how the root development differed along the pole, and also how it varied between trees 1 and 2 in the angle with which the roots grew.

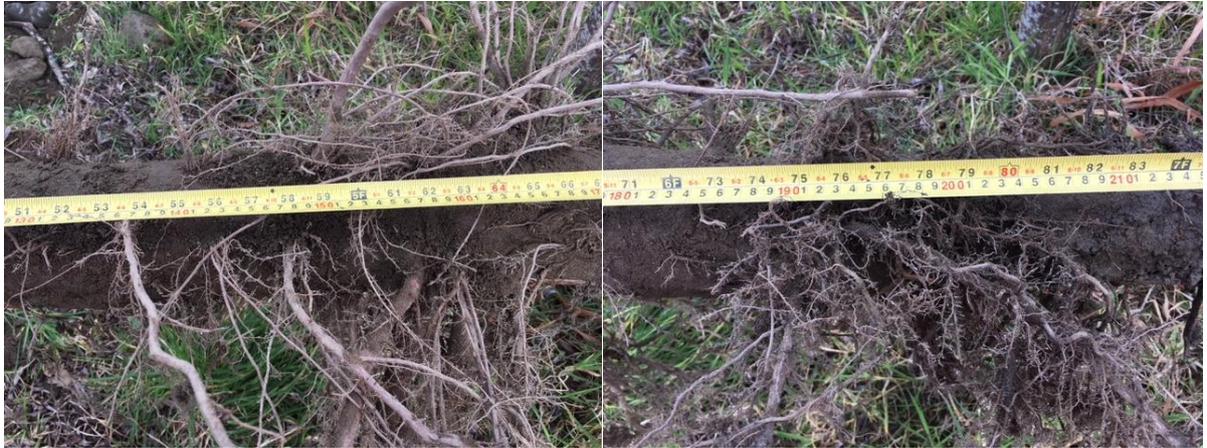
Figure 2. Section of trunk of Tree 1 at 1.6 - 1.8 m (L), and at 1.9 - 2.1 m (R), showing the differences observed in the root development at different parts of the pole.

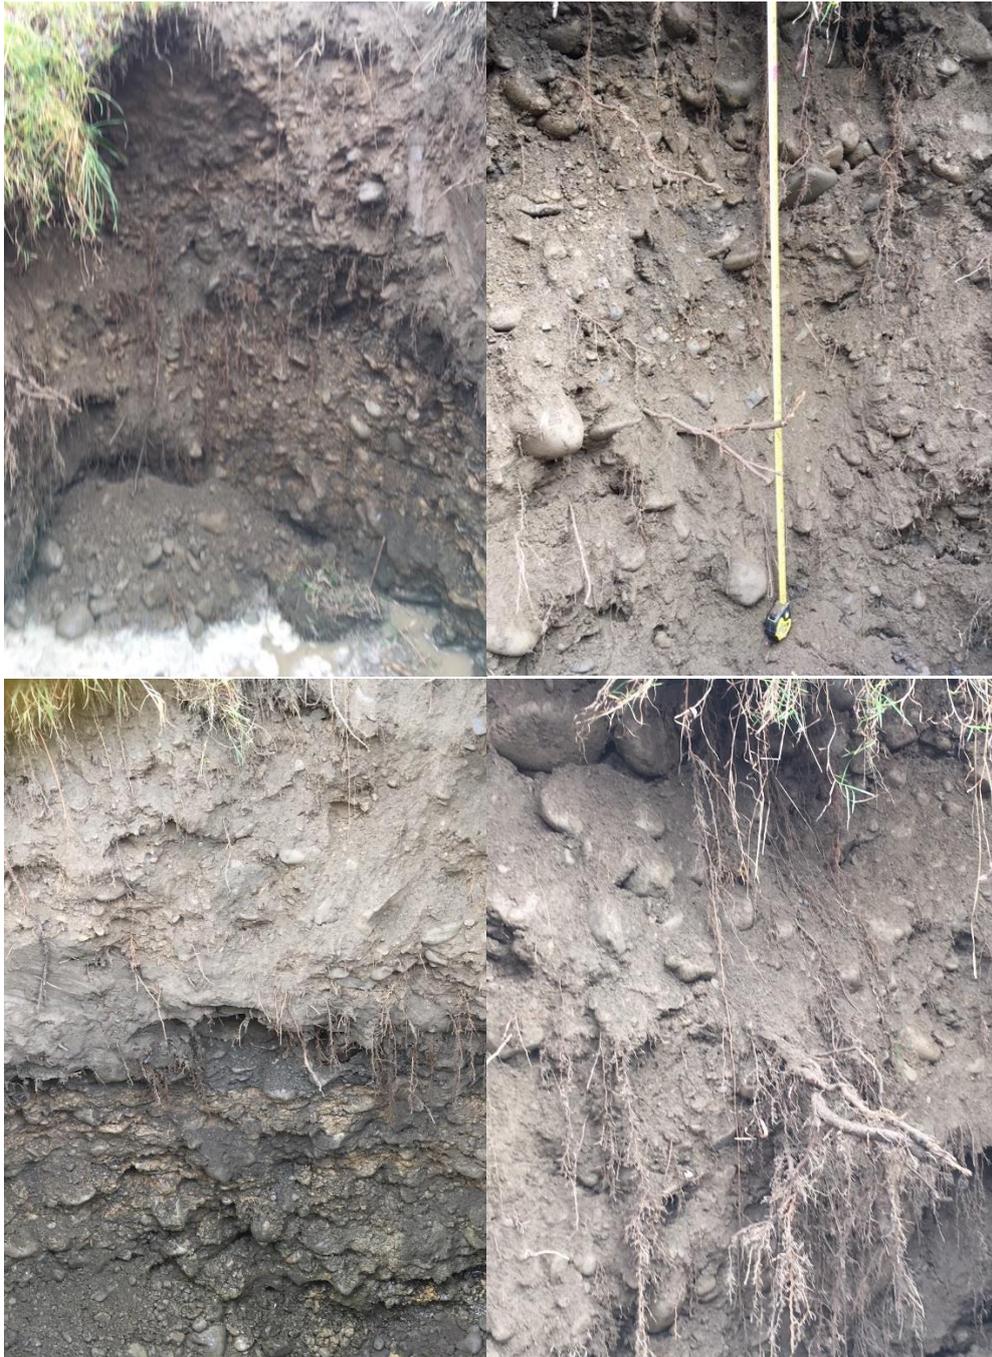
Figure 3. Various views of the soil profile where Tree 1 was excavated, showing water table (top left), presence of root at the different tiers, nature of soil in the top 0.3 m (lower left) and location of thicker roots in the profile (lower right).

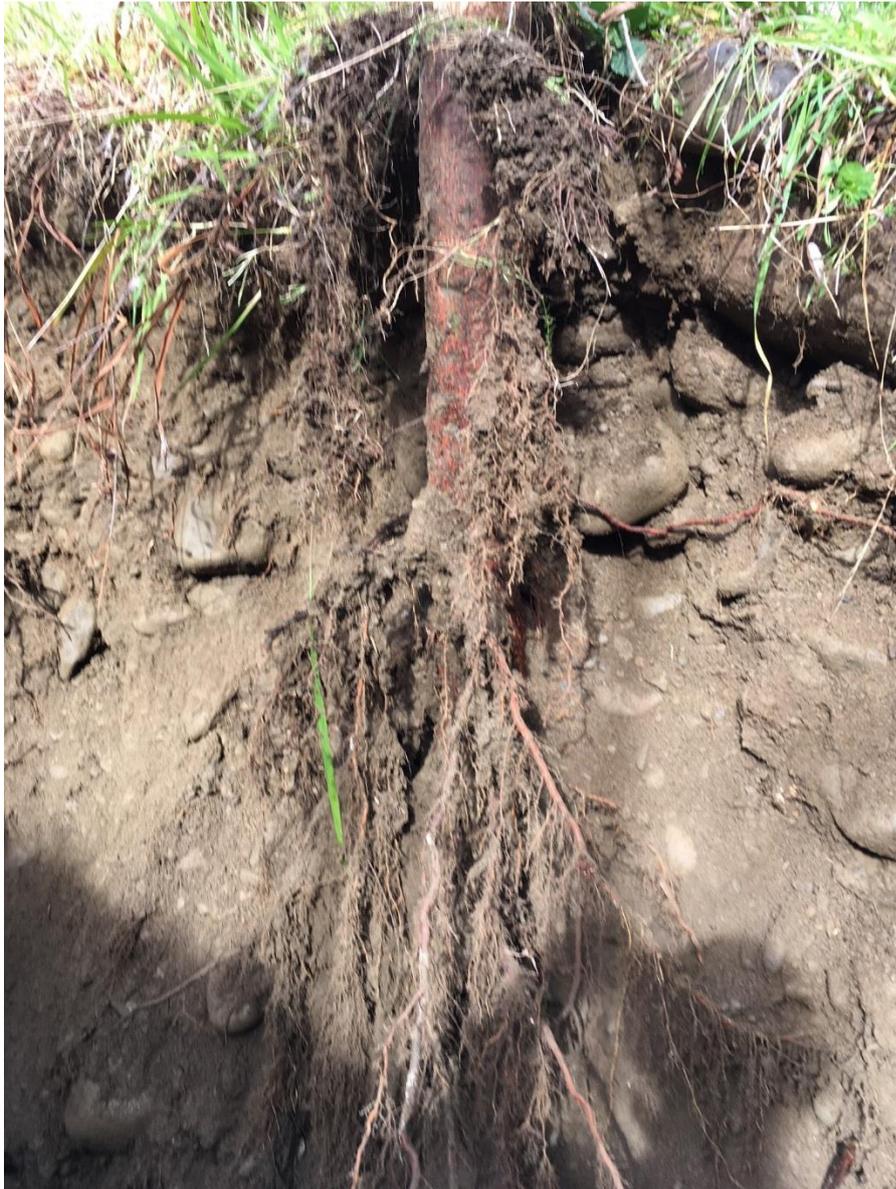
Figure 4. Root growth in Tree 2 was obliquely downwards, in contrast to Tree 1. Soil profile was comparable for the two sites.

The root distribution along the buried length of the pole was similar for both trees 1 and 2. The soil profile was similar with the top 0.3 m being principally silt, and below 0.3 m dominated by stones of various sizes with small amounts of silt and sand. Below the silt layer water storage capacity is extremely low in both summer and winter. Significant root development is seen at depths where water is presumed to be constantly available to the many small roots growing off the main roots.

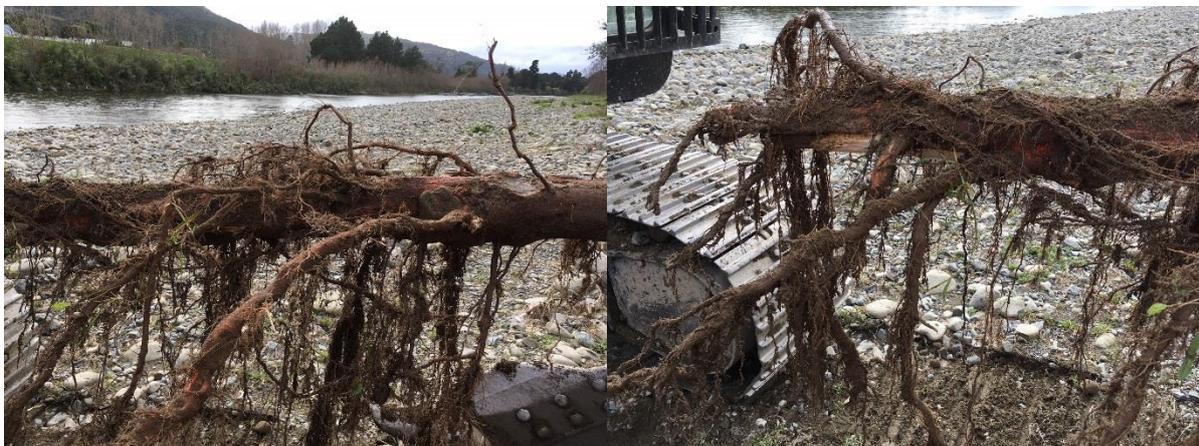
Figure 5. Very little sediment attached to the roots of tree 1.

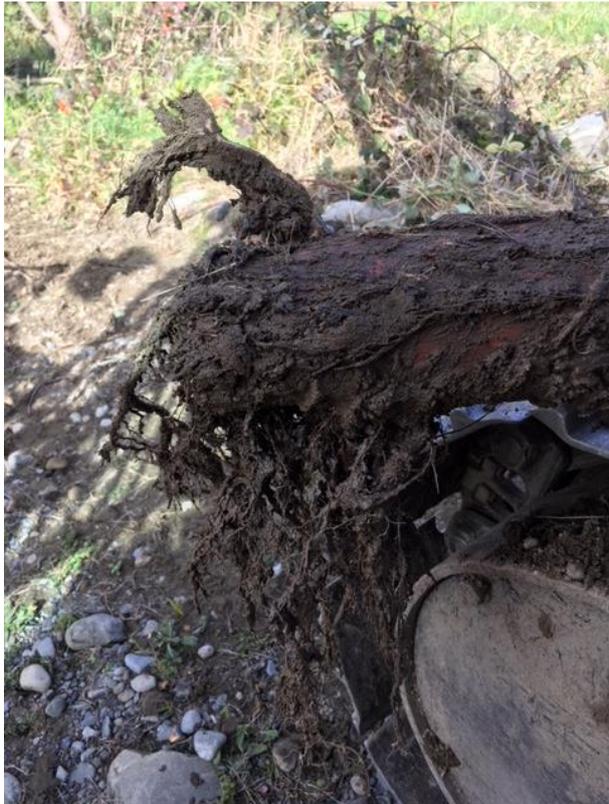
Figure 6. The bottom of the pole was in a saturated soil zone restricting root growth.

The observations of dead and small roots near the bottom of the pole for the deep planted trees indicates that survival of these roots, particularly the finest roots, depends on the height of the water table. During periods of low river flow, when the roots are well aerated, they will be active in water absorption and some mineral uptake, and during periods of high flow the anoxic environment will lead to fine root dieback. There was no evidence that the large roots are affected adversely by periods of normal high flow, or of periodic flood inundations.

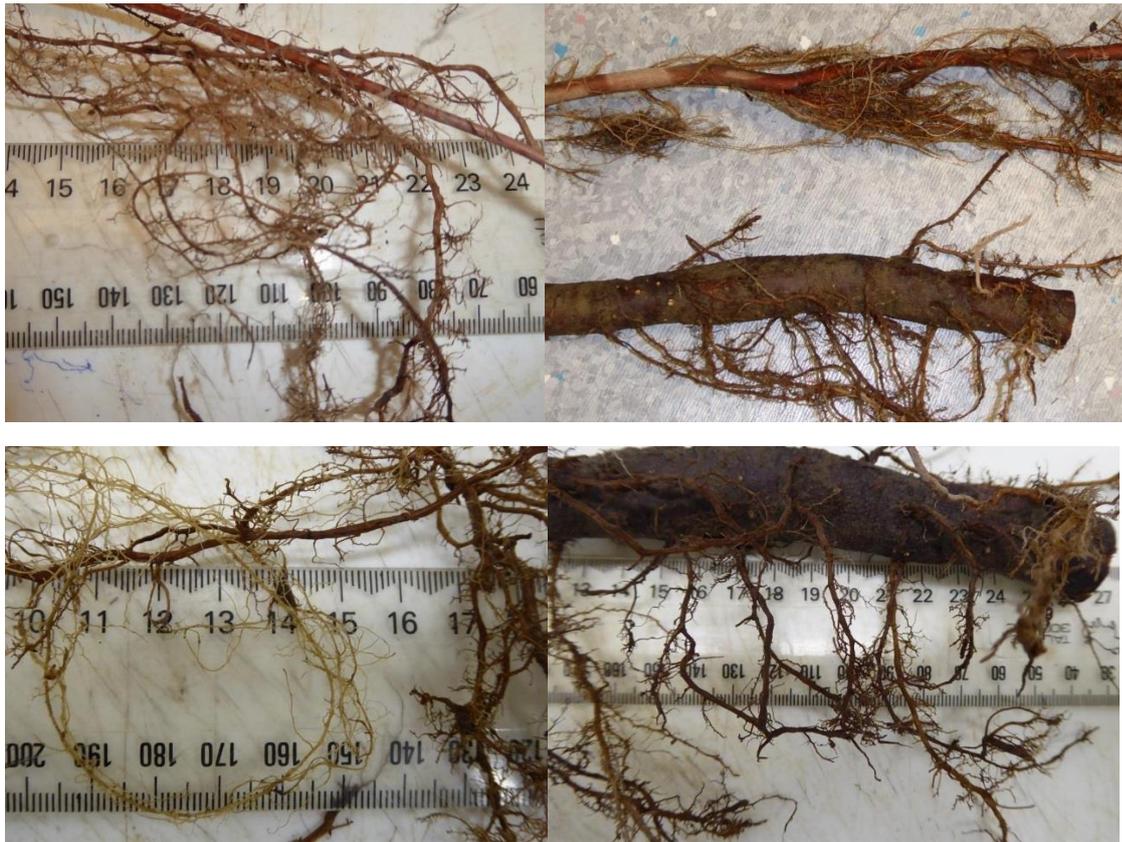
Figure 7. Roots were long with little side-branching of structural roots.

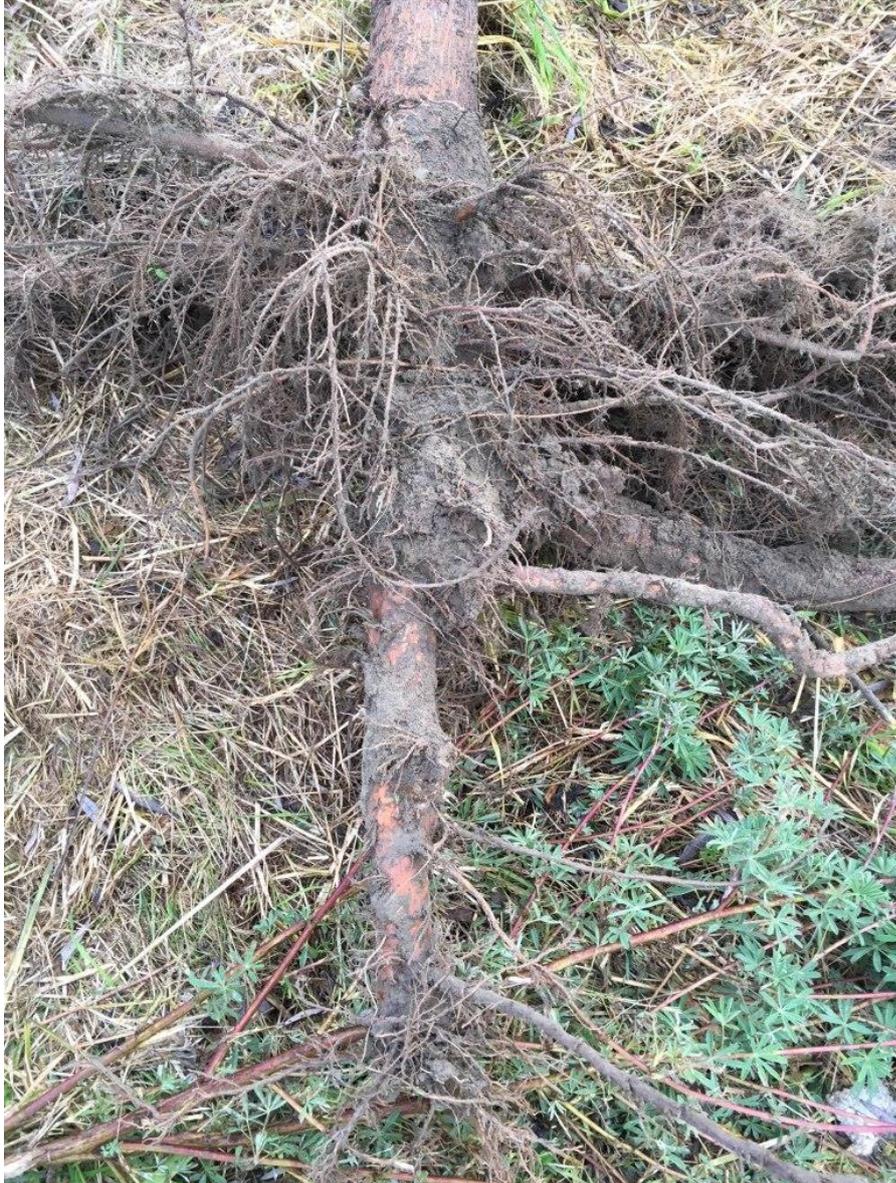
Figure 8. Tree 3 from Rangitikei River showing root development down the stake. The prominent lateral root is at 0.5 m depth. Note changes in diameter of the original stake showing where growth has occurred. Changes in diameter are always associated with root activity. The remains where some large roots broke off can be seen ~20 cm up from the bottom of the stake.

Root development for tree 3 was largely lateral (Figure 8). Root data for tree 3 are given in table 3.

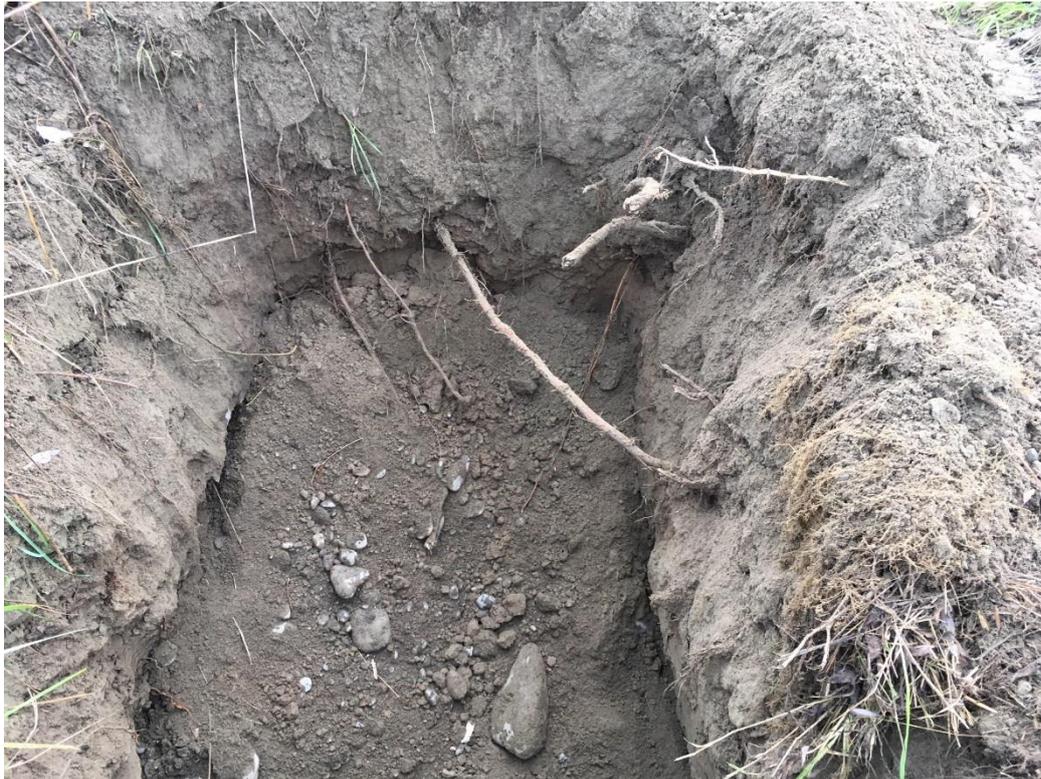
Figure 9. Soil profile at Rangitikei river site

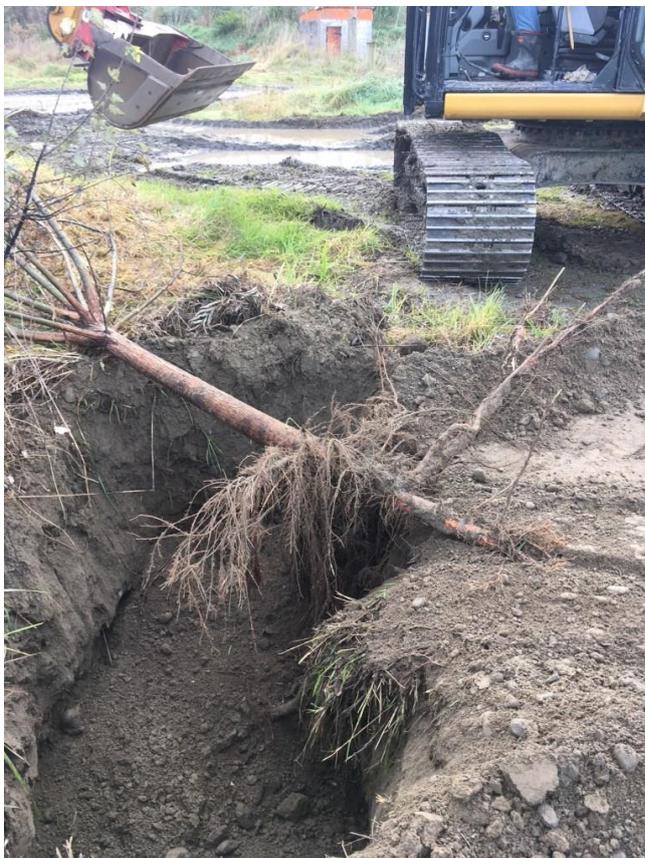
Figure 10. Another view of the root allocation for the 'Moutere' willow at Rangitikei river.
