# The use of willows in the rivers of the Bay of Plenty region, New Zealand

Principal Works Engineer

Bay of Plenty Regional Council

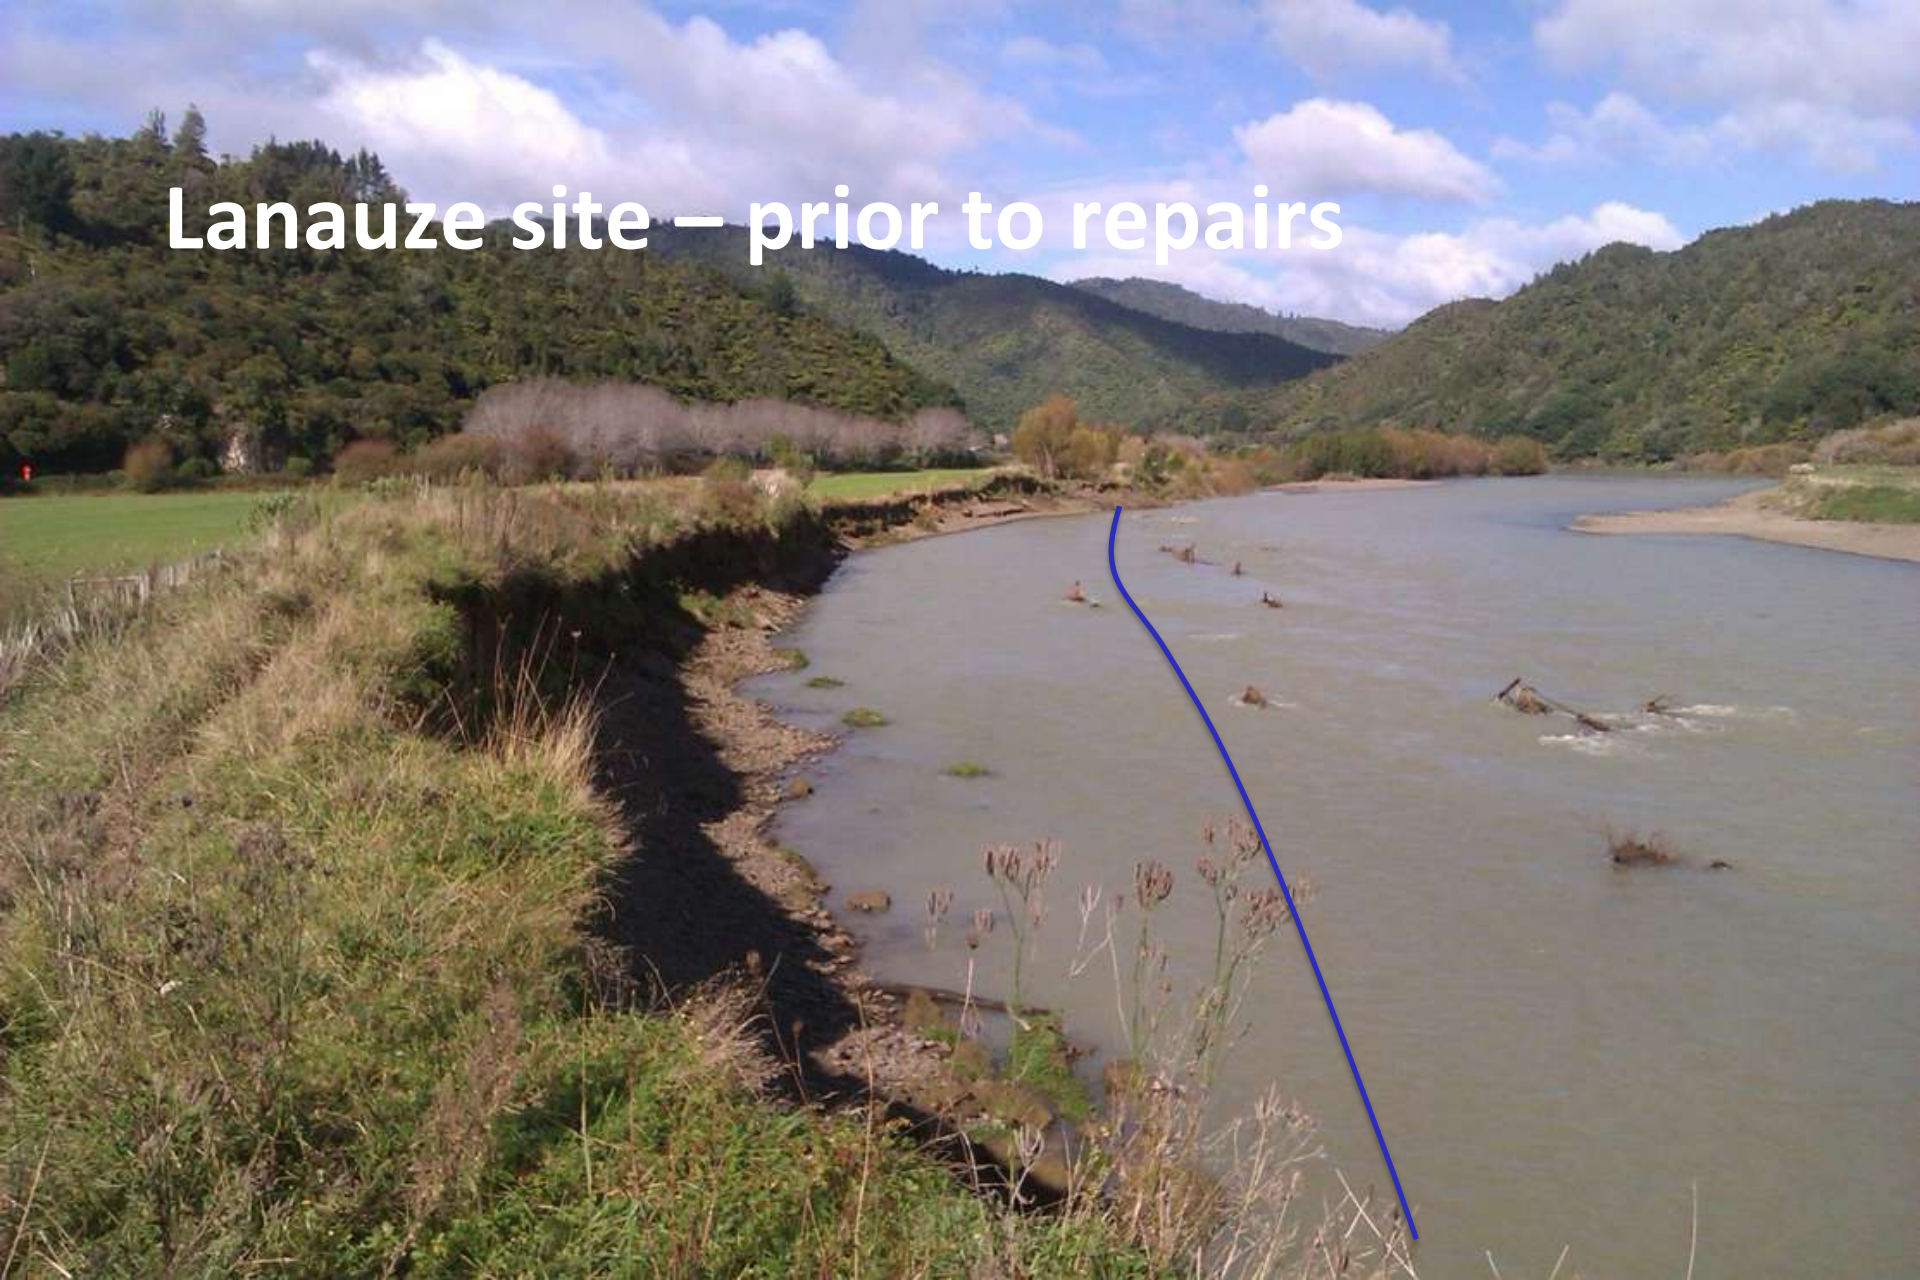
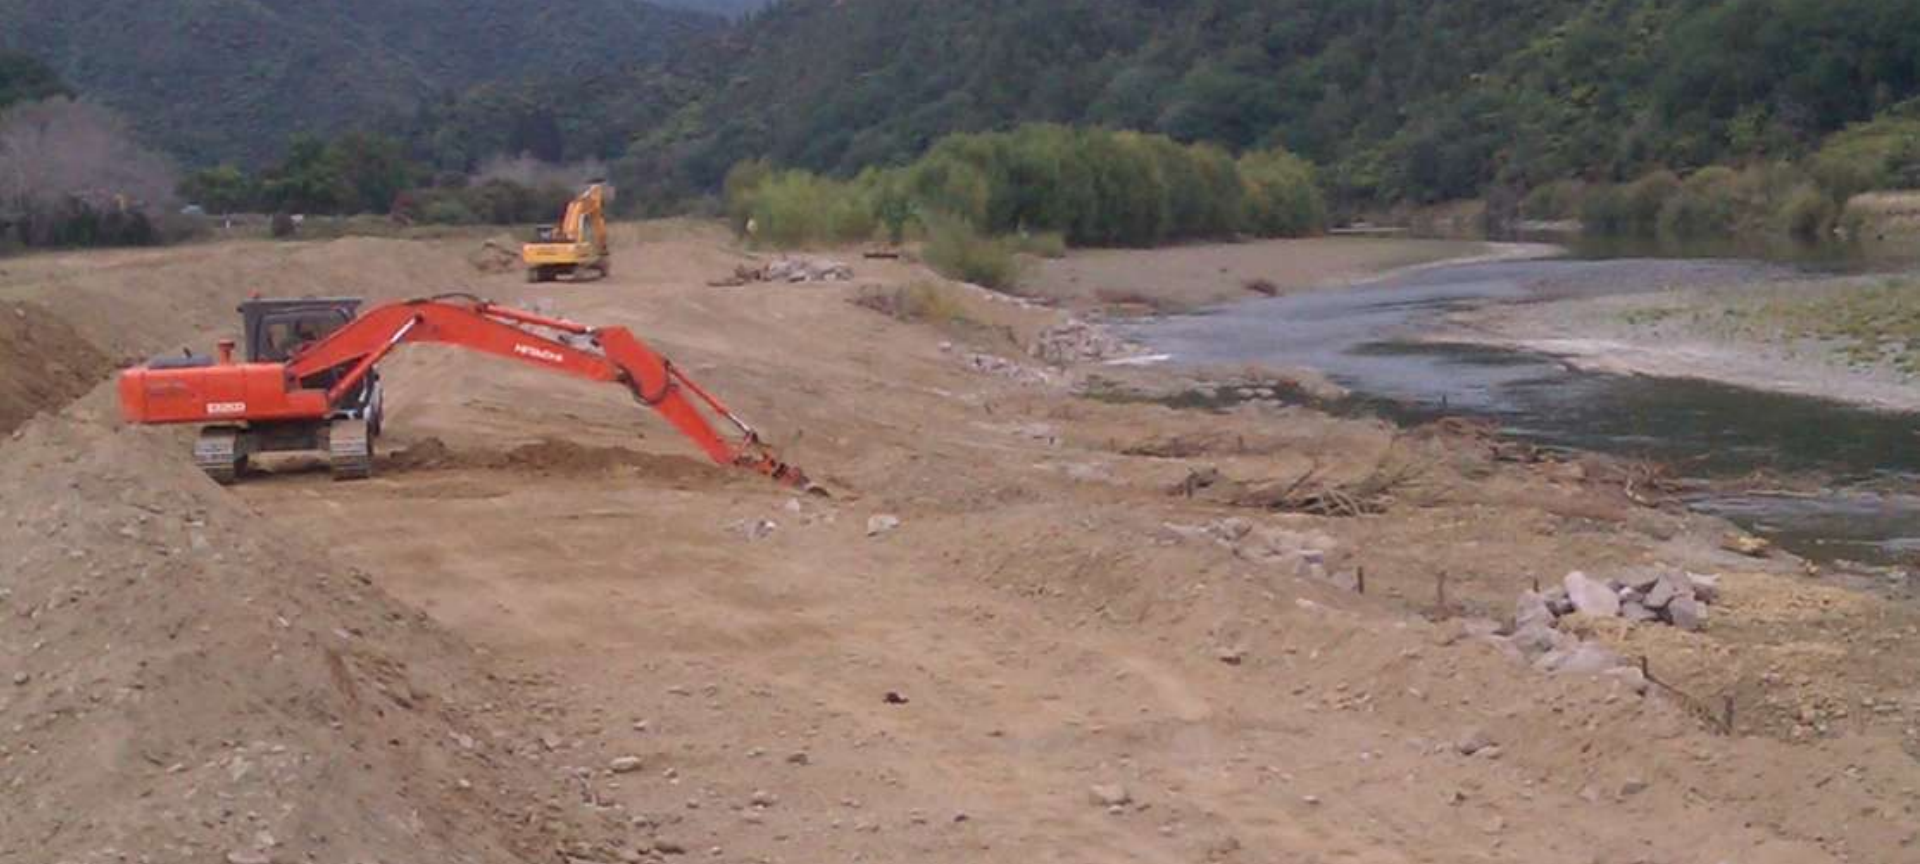
# Lanauze site – prior to repairs

Front line vegetative protection and stop bank severely damaged

## Preparation works at site

Included – stop bank reposition; bank battered to 4:1;  
rock stubb groynes; willow trench groynes; willow planting

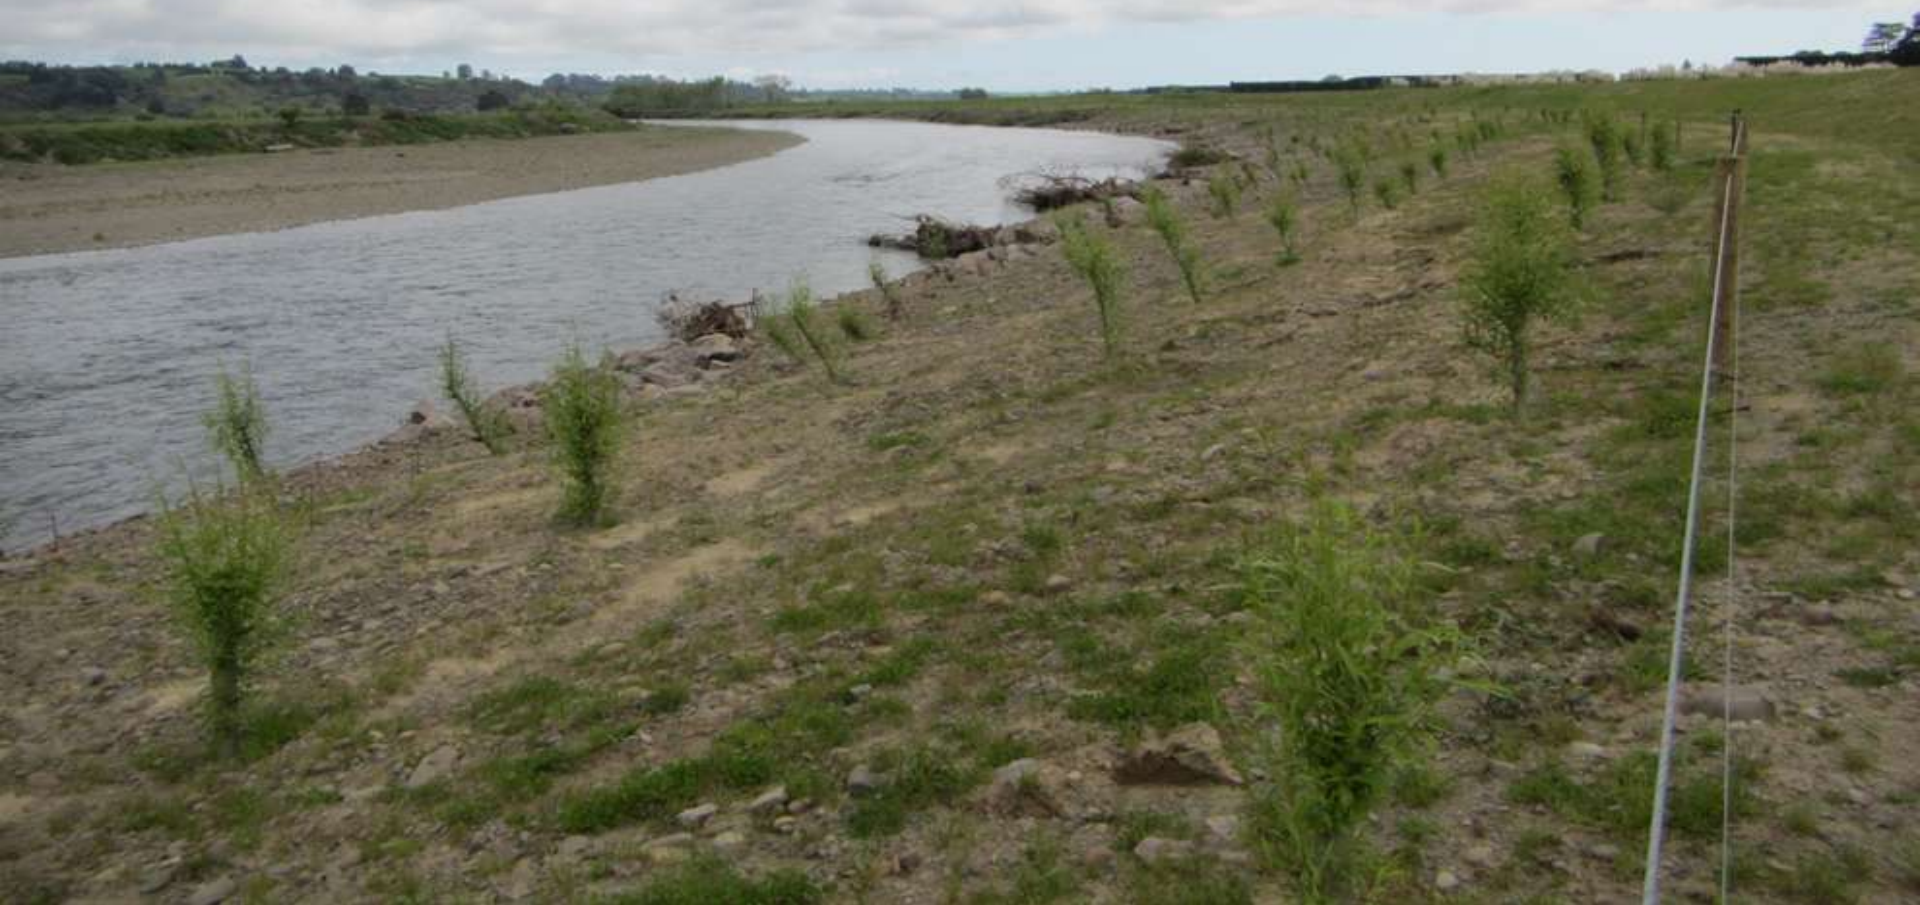
# Lanauze site completed

(October/November 2013)

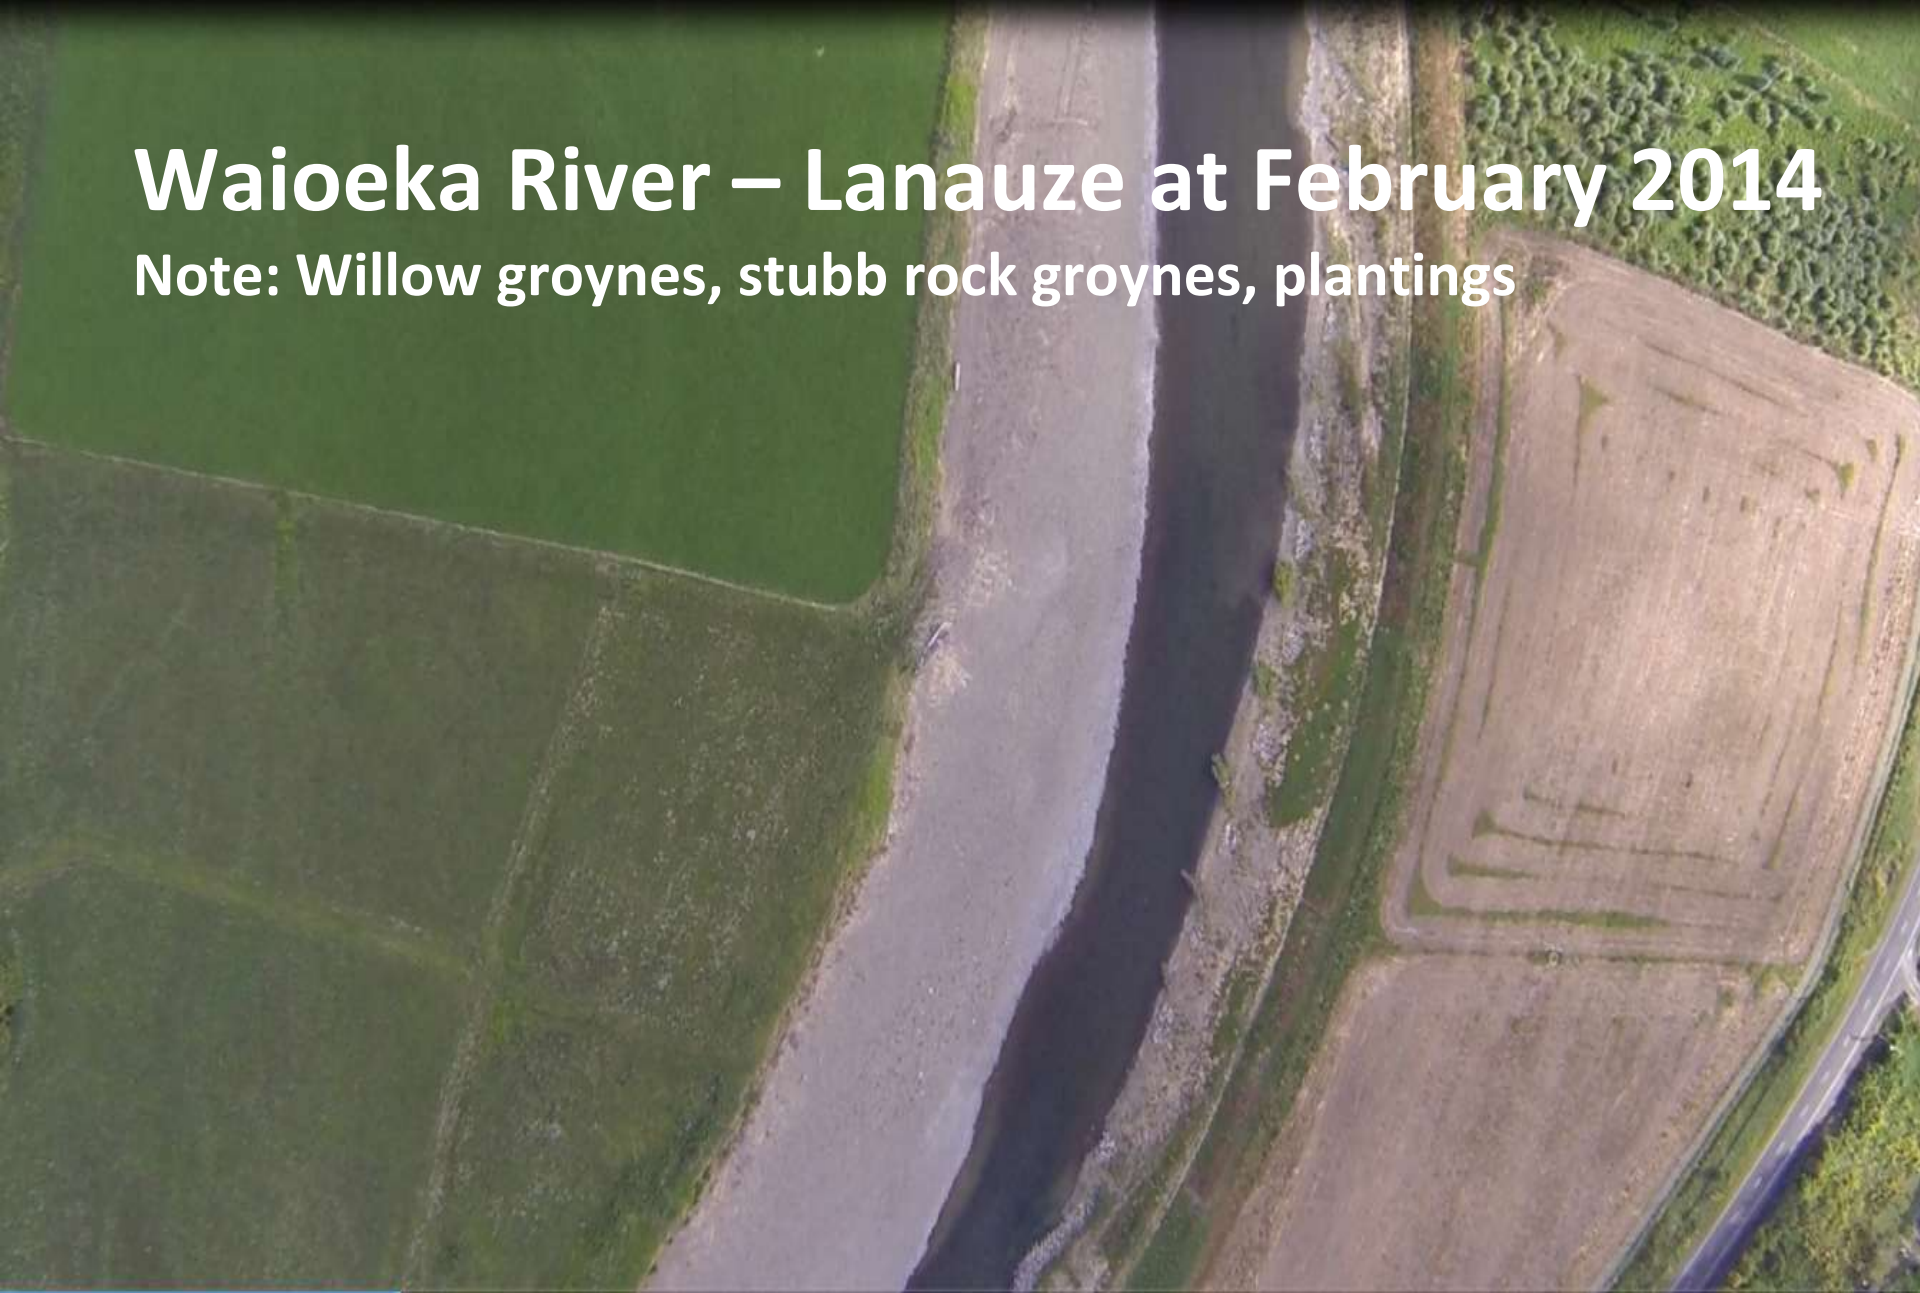
# Waioeka River – Lanauze at February 2014

Note: Willow groynes, stubb rock groynes, plantings

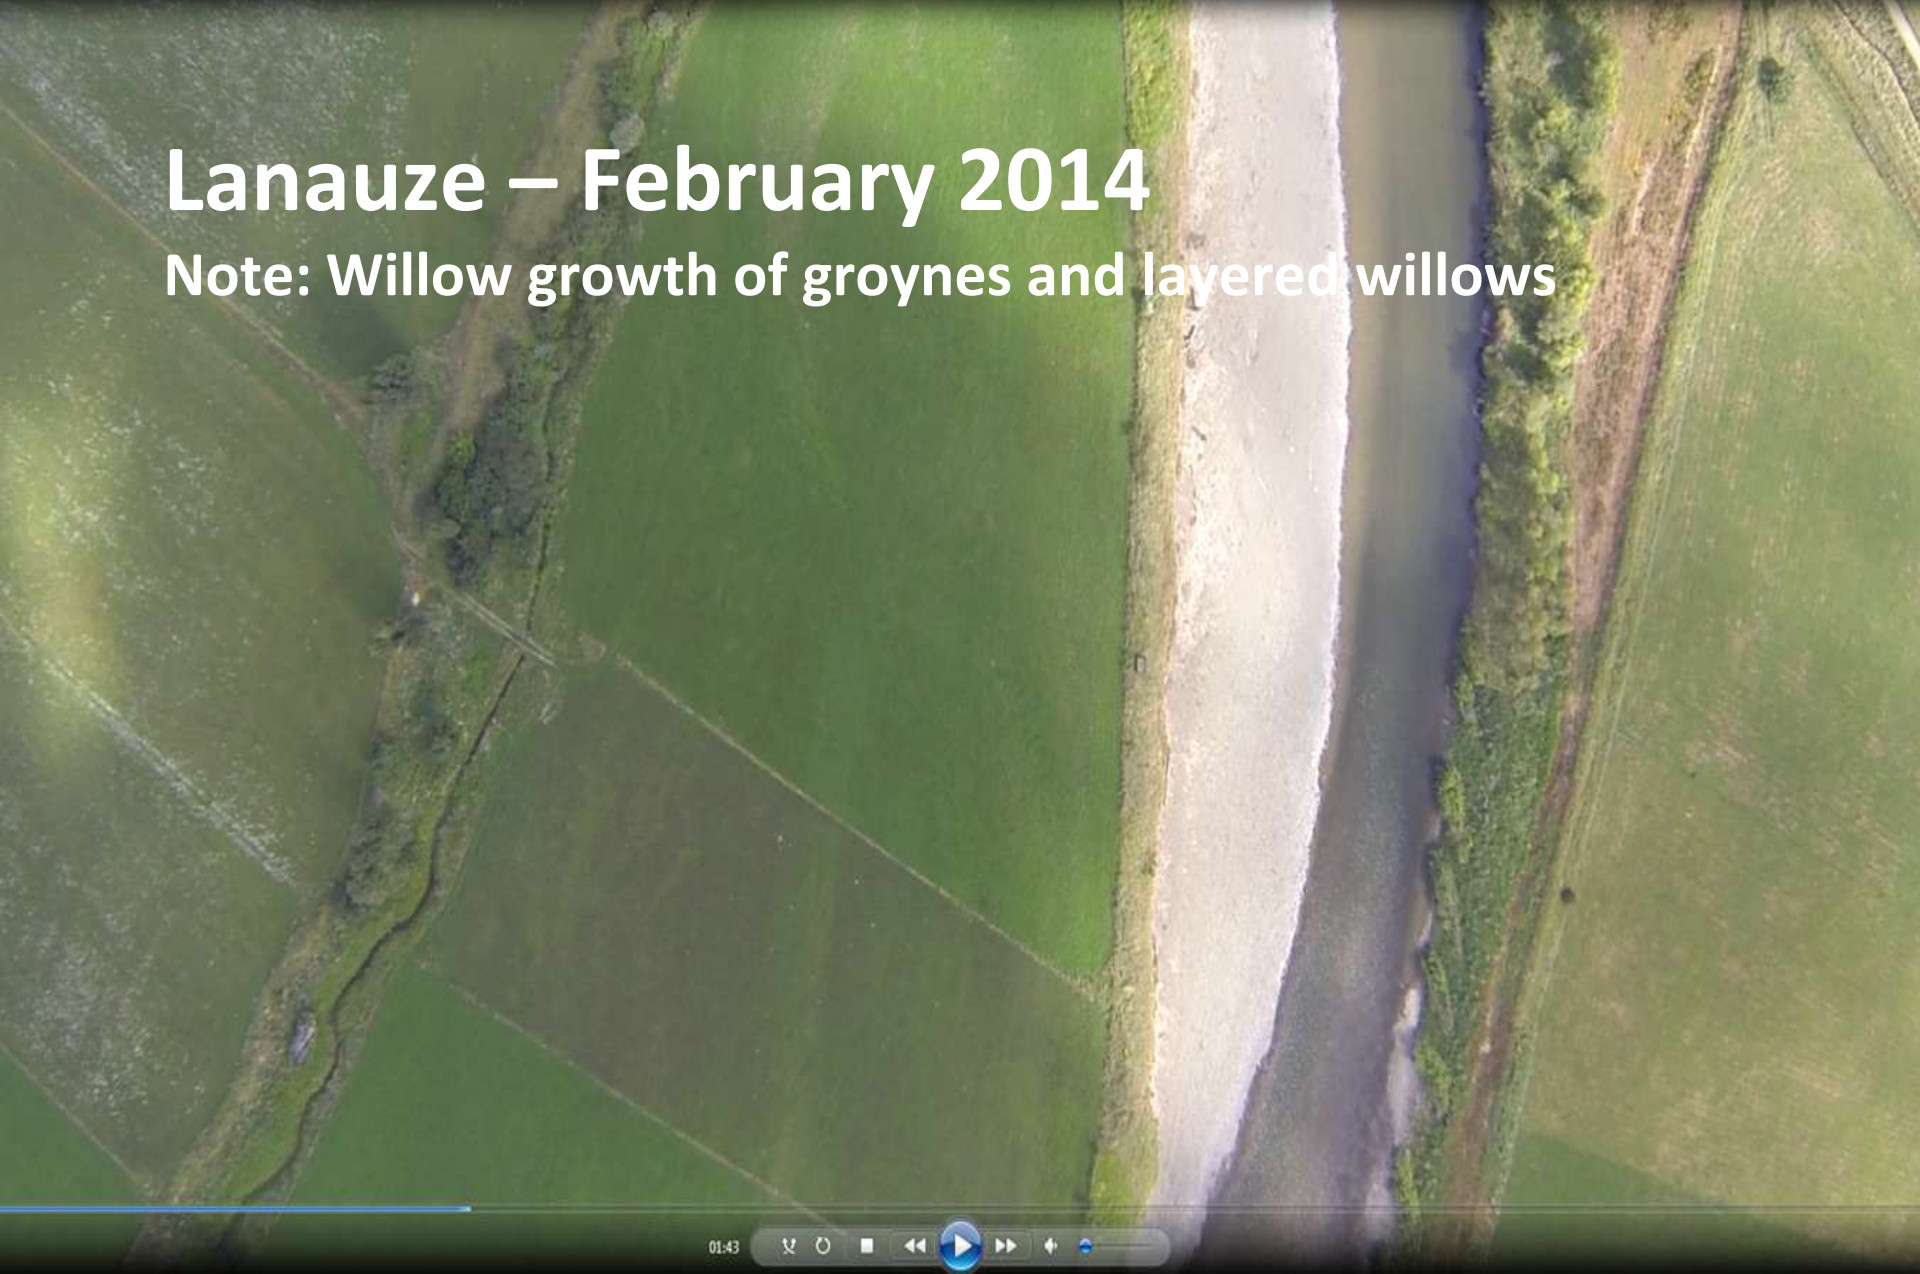
# Lanauze – February 2014

Note: Willow growth of groynes and layered willows

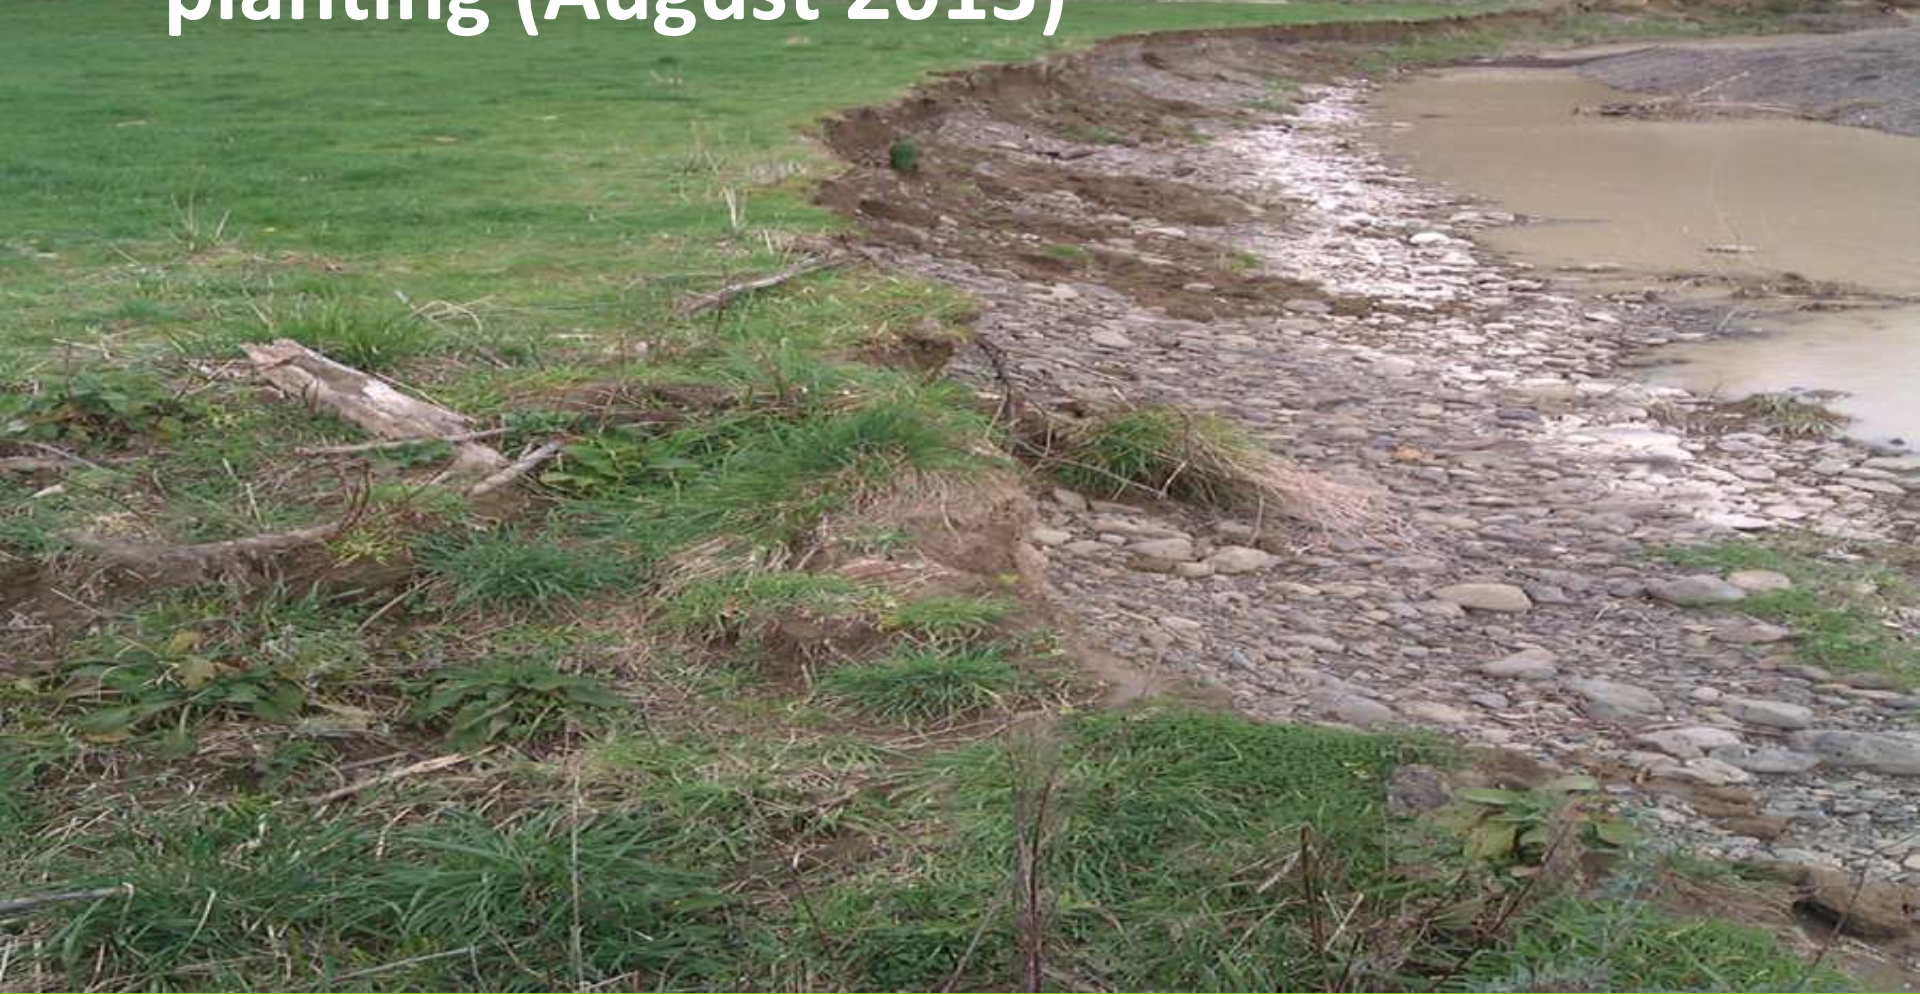
# Typical bank erosion — prior to pole planting (August 2013)

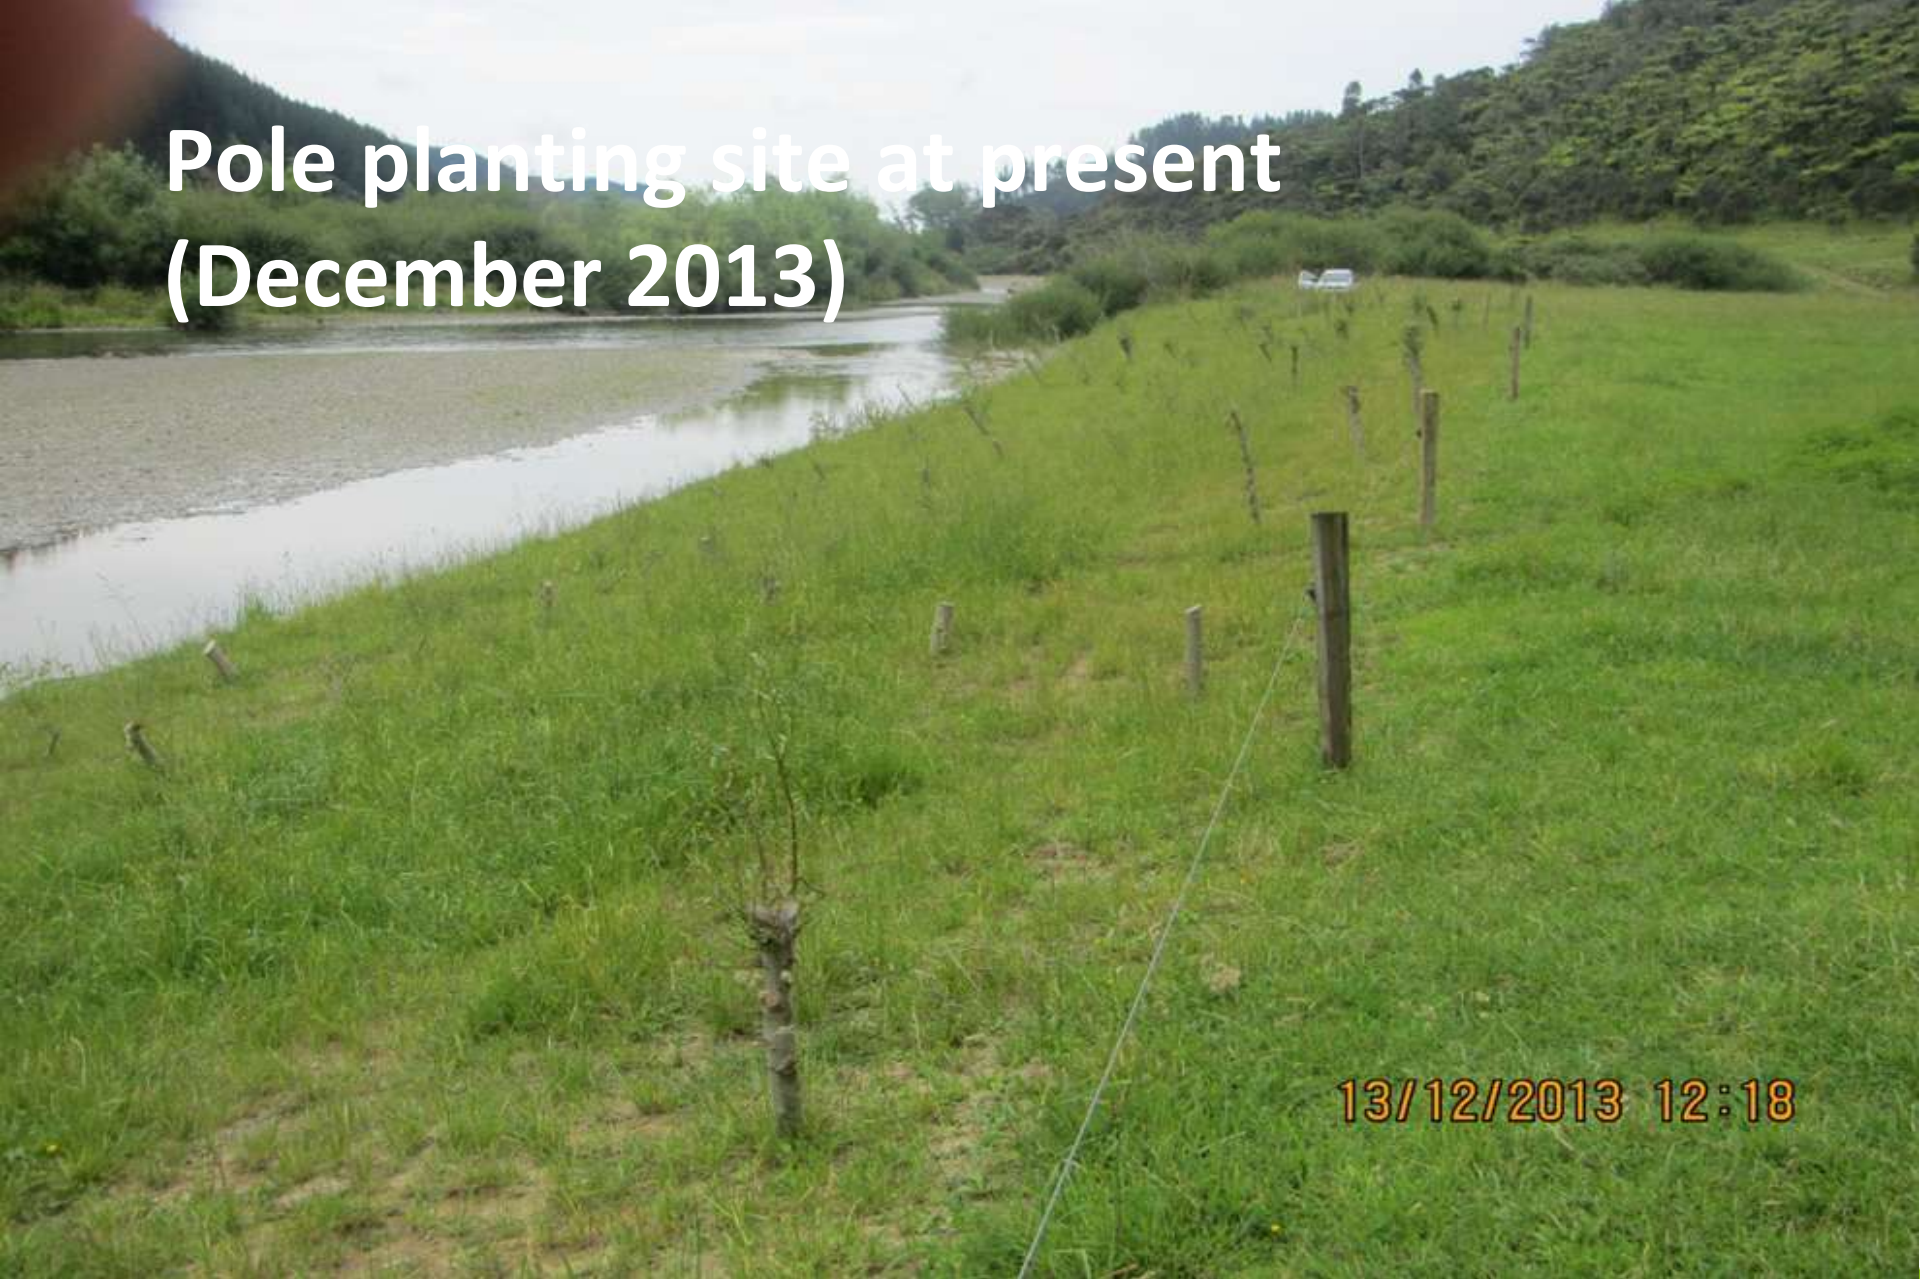
# Pole planting site at present (December 2013)

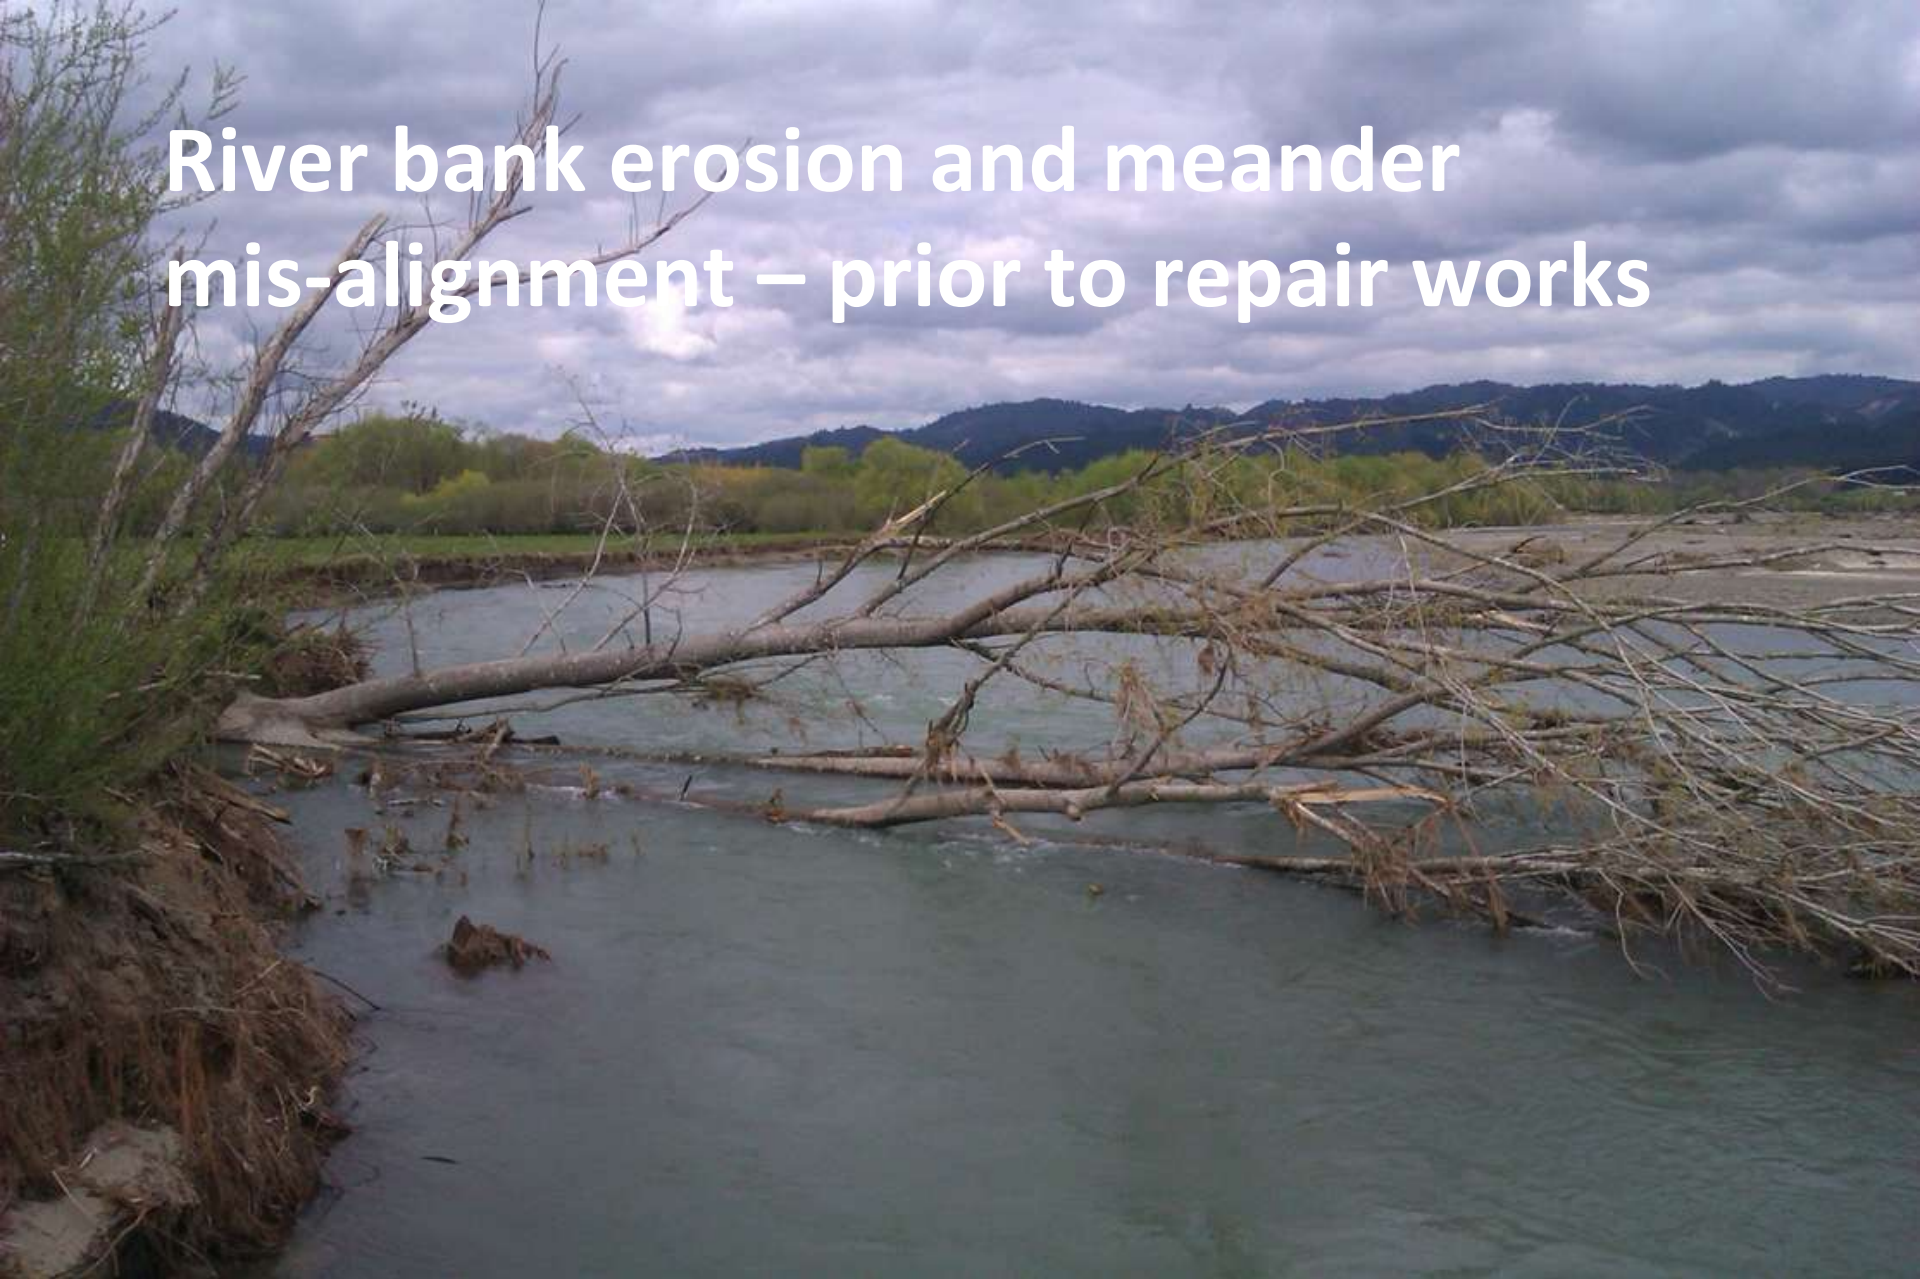
# River bank erosion and meander mis-alignment – prior to repair works

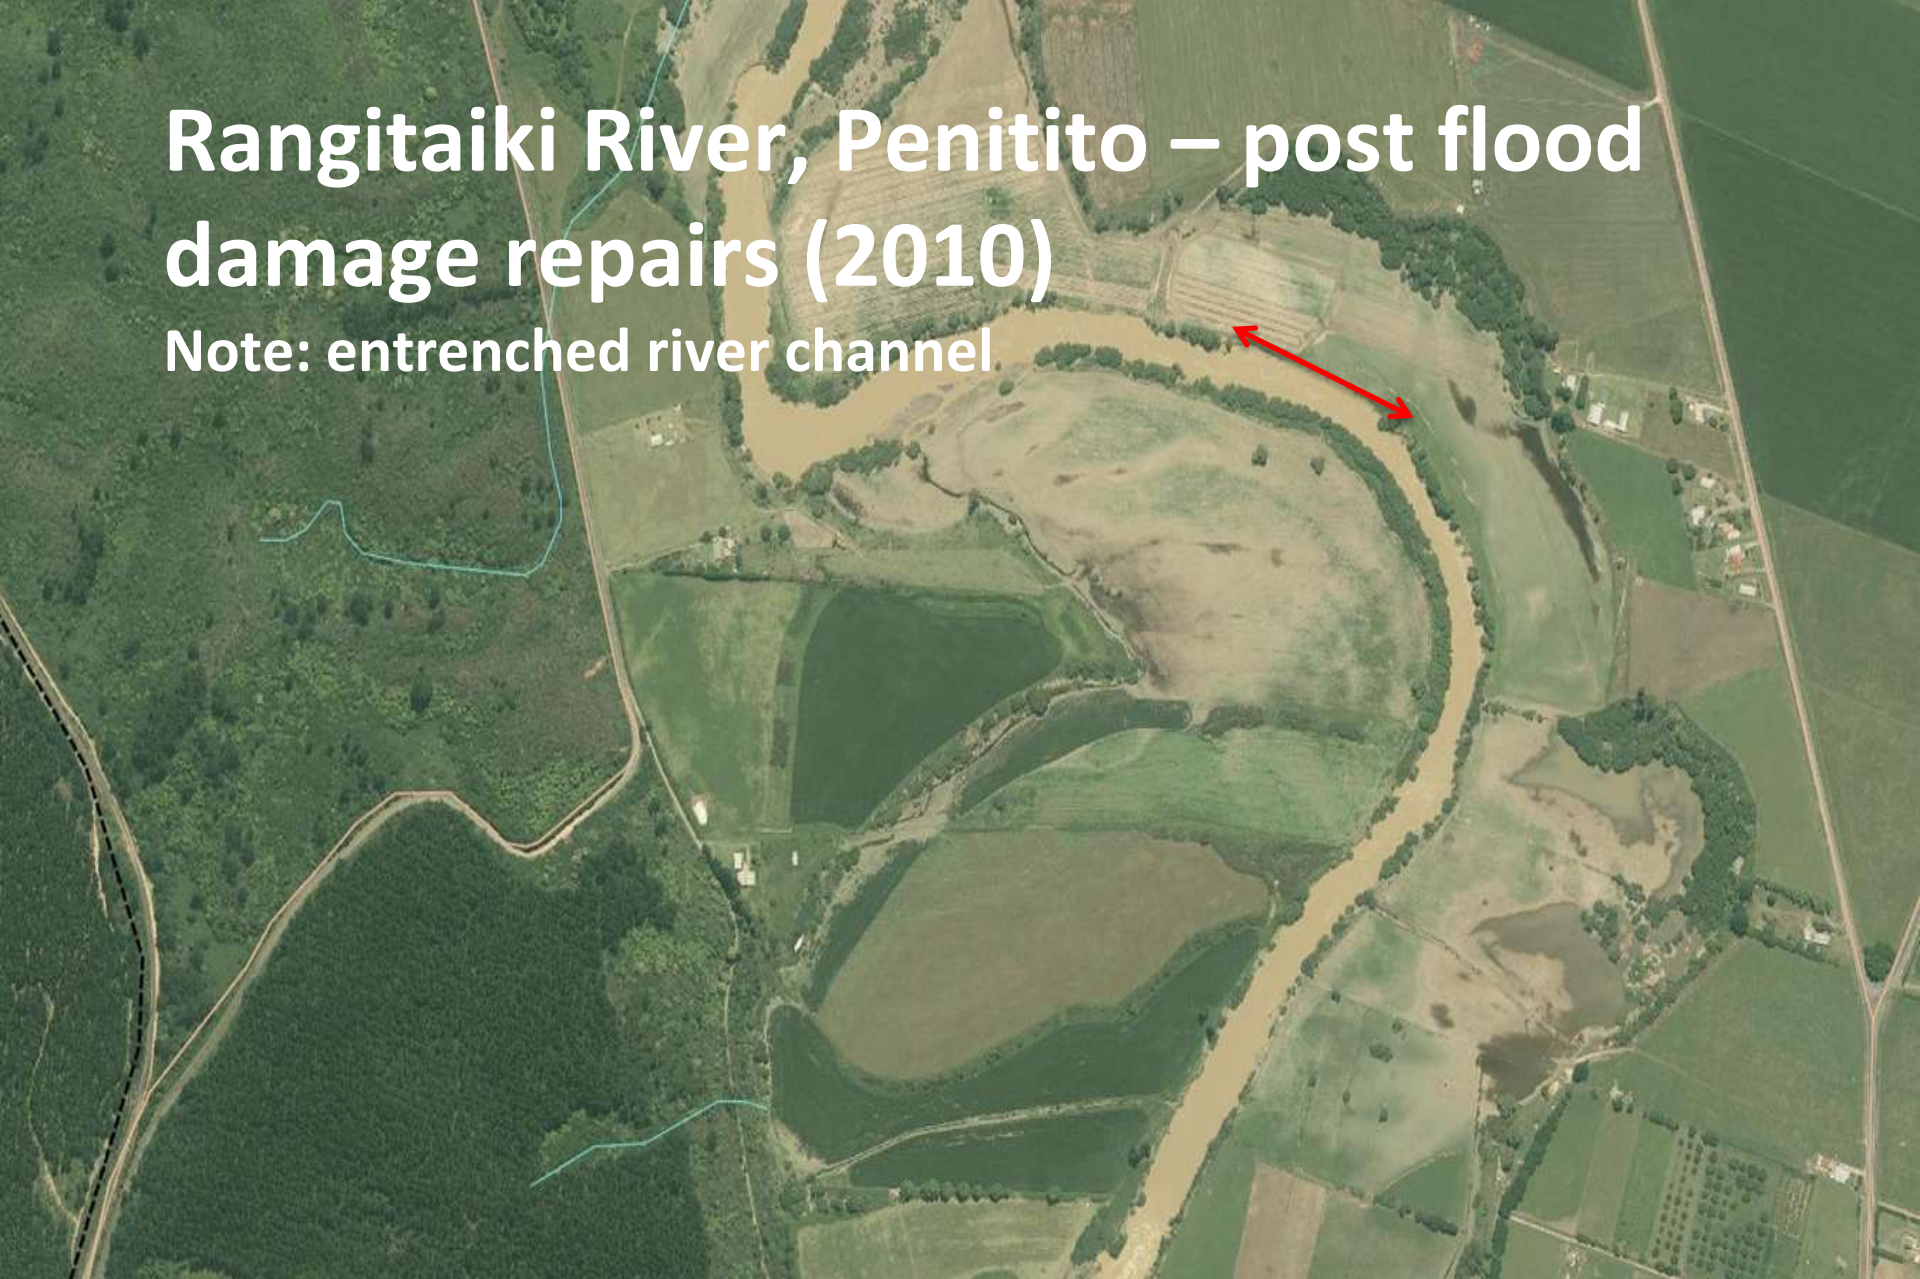
# Rangitaiki River, Penitito – post flood damage repairs (2010)

Note: entrenched river channel.

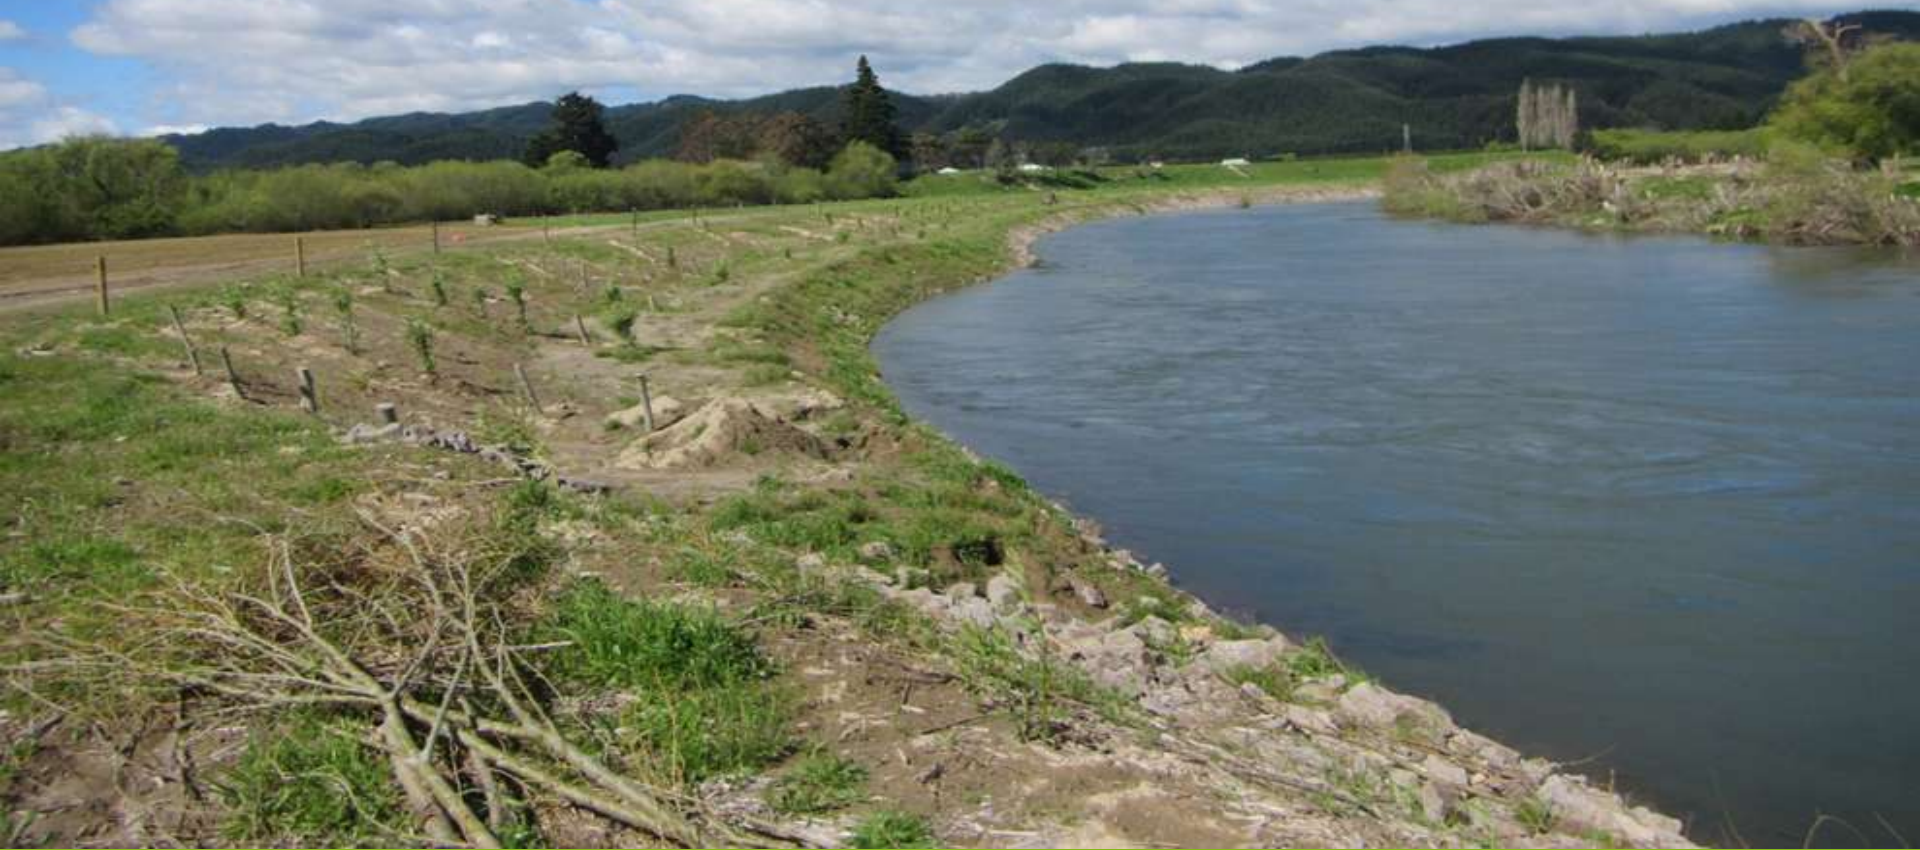
Note: Willows have been mulched on opposite bank

# Completed works – rock toe strengthening benching and willows - December (2013)
