# The use of willows in the rivers of the Bay of Plenty region, New Zealand

Principal Works Engineer

Bay of Plenty Regional Council

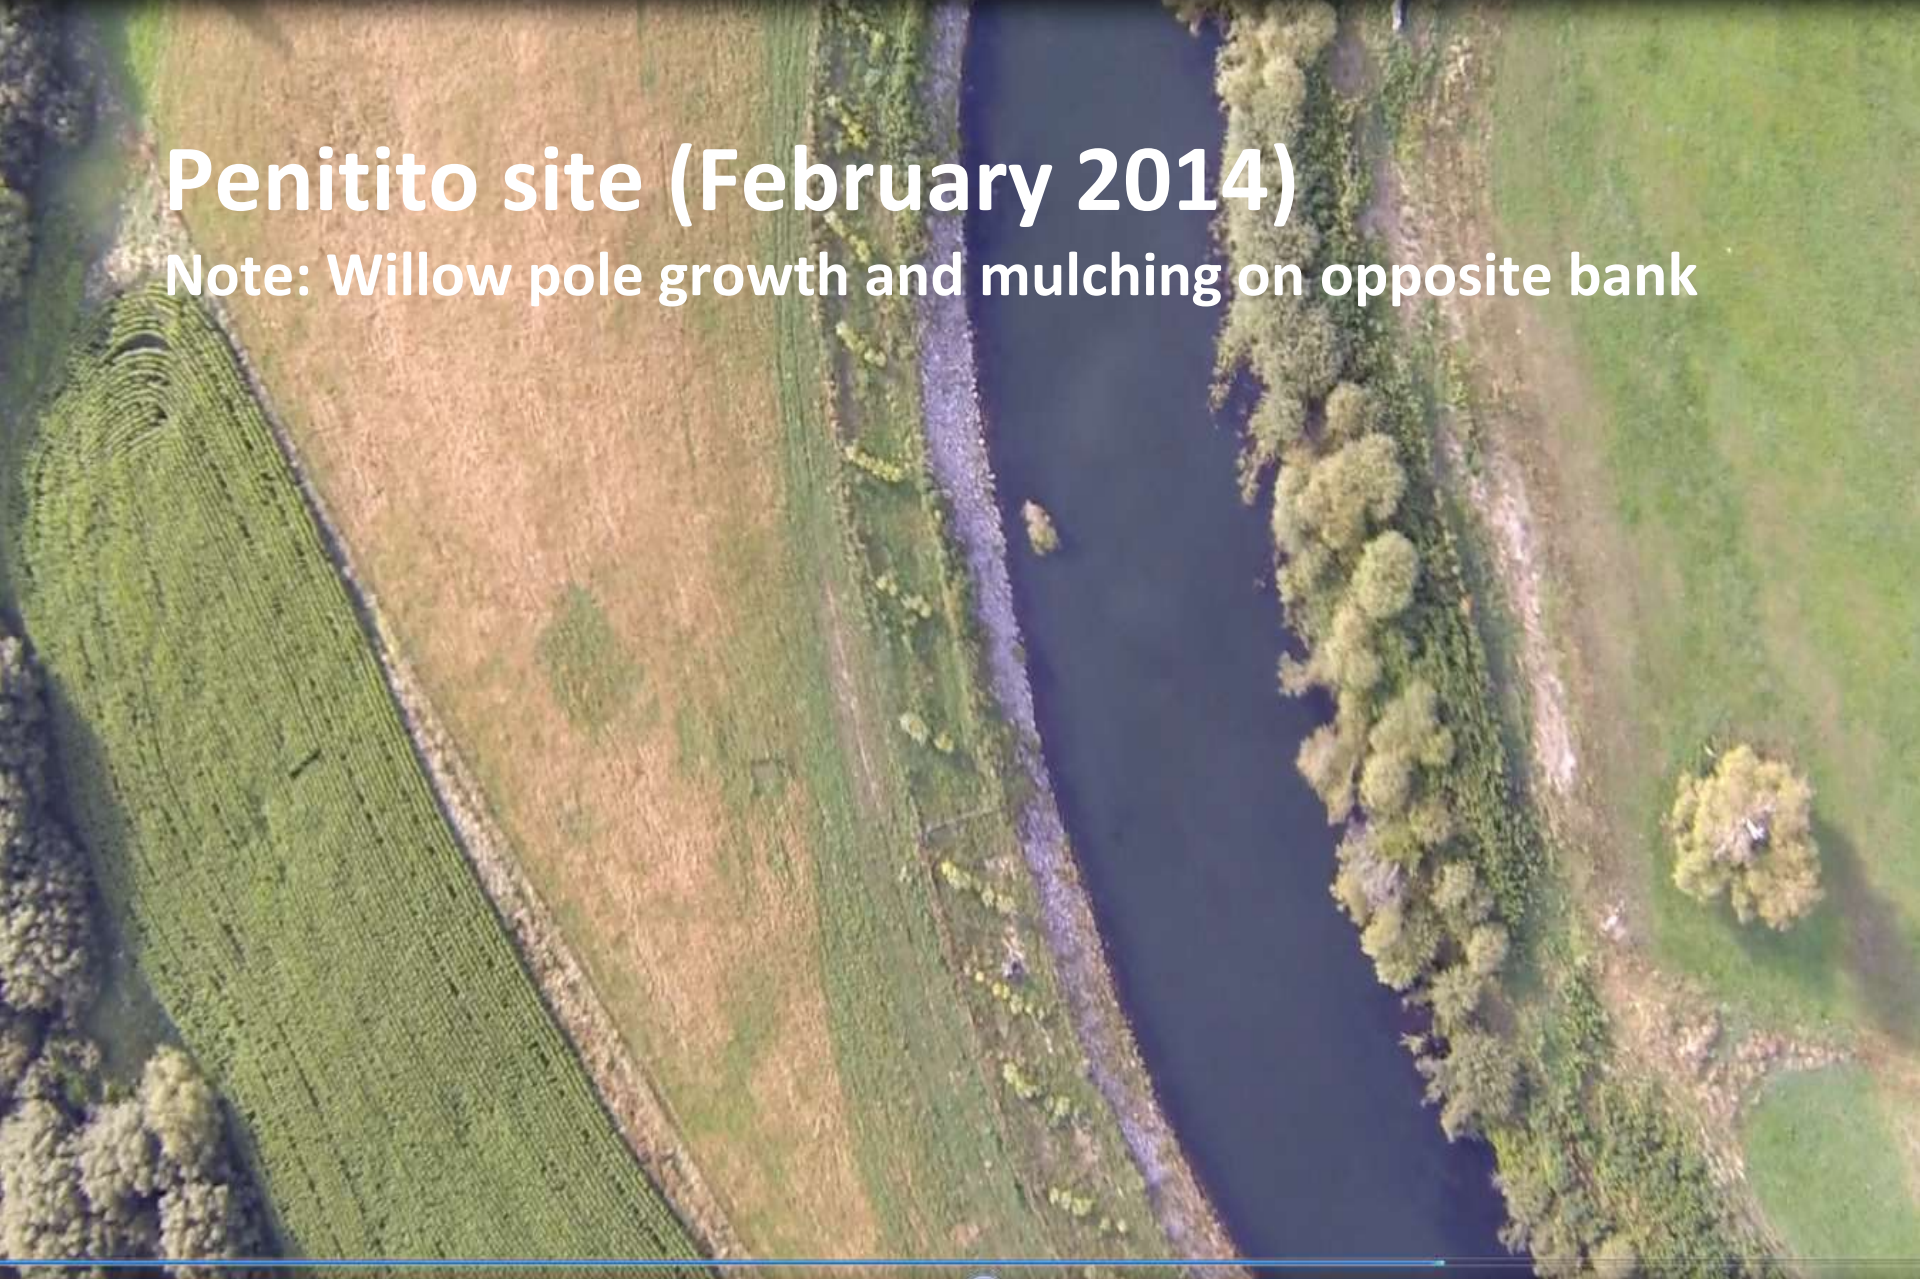
# Penitito site (February 2014)

Note: Willow pole growth and mulching on opposite bank

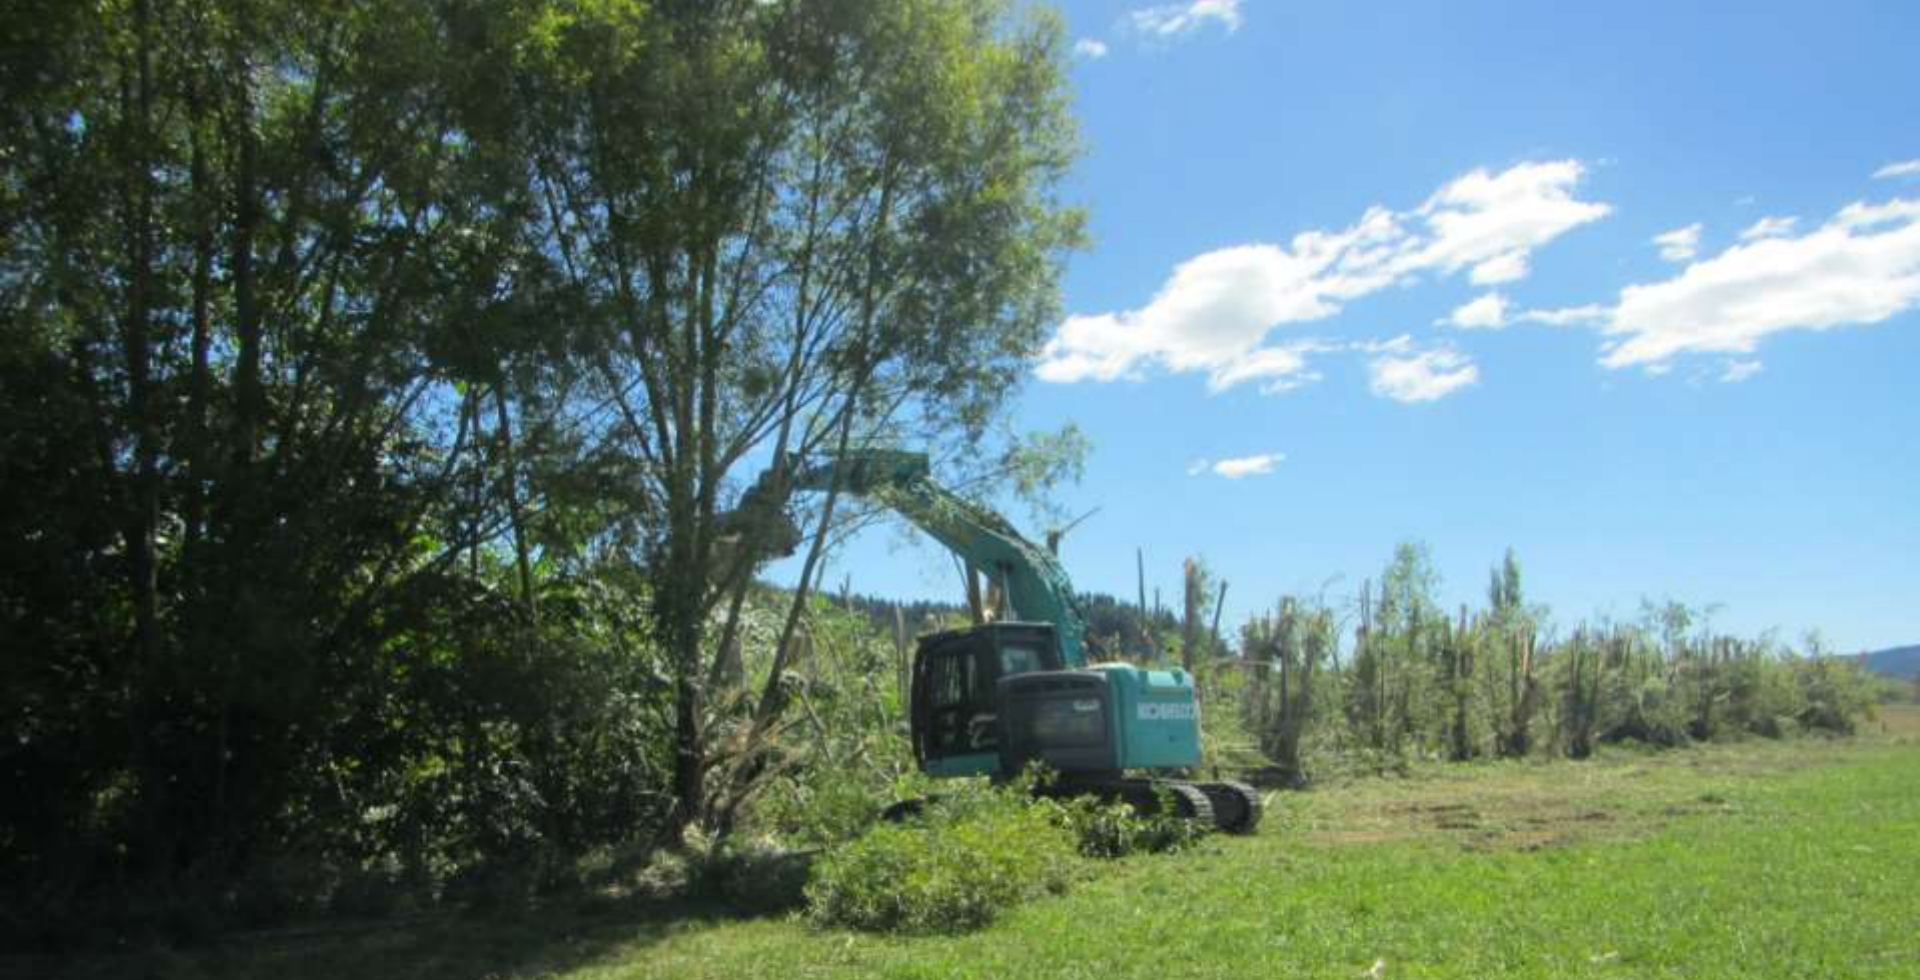
Large willows causing toppling concerns - being topped/mulched

# Mulching willows – to reduce height/weight allowing rejuvenation of trees

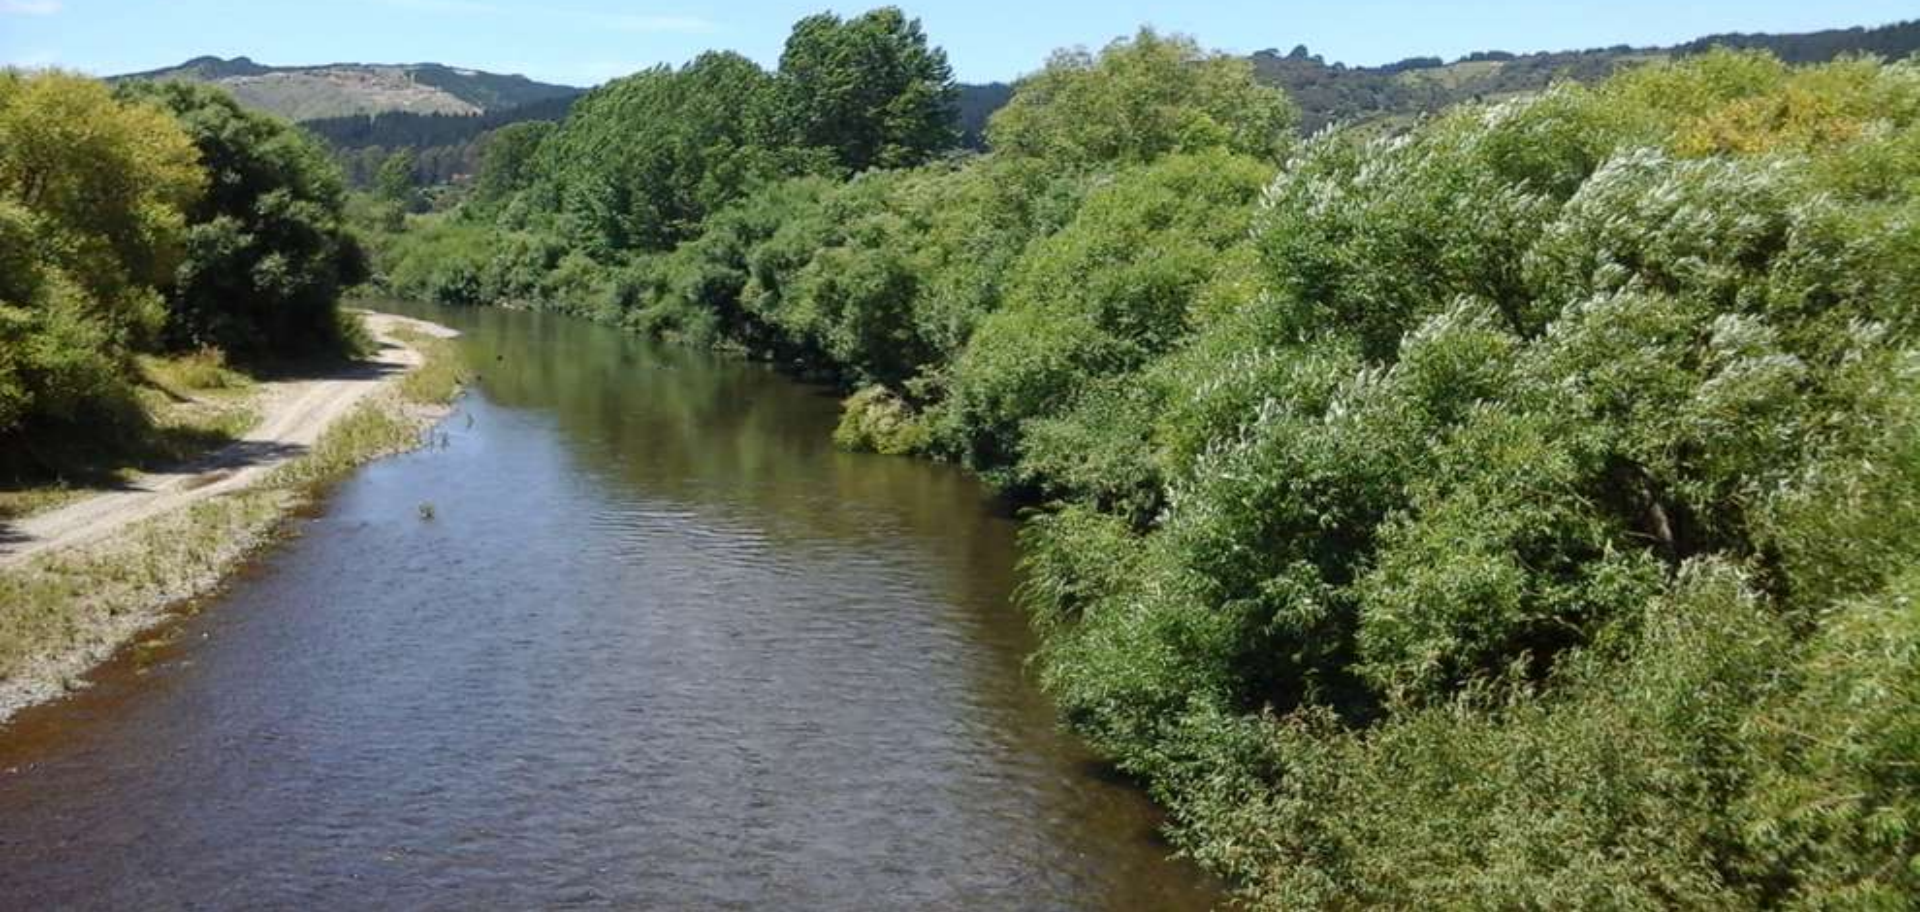
# Willows programmed for mulching / layering – upstream following slide

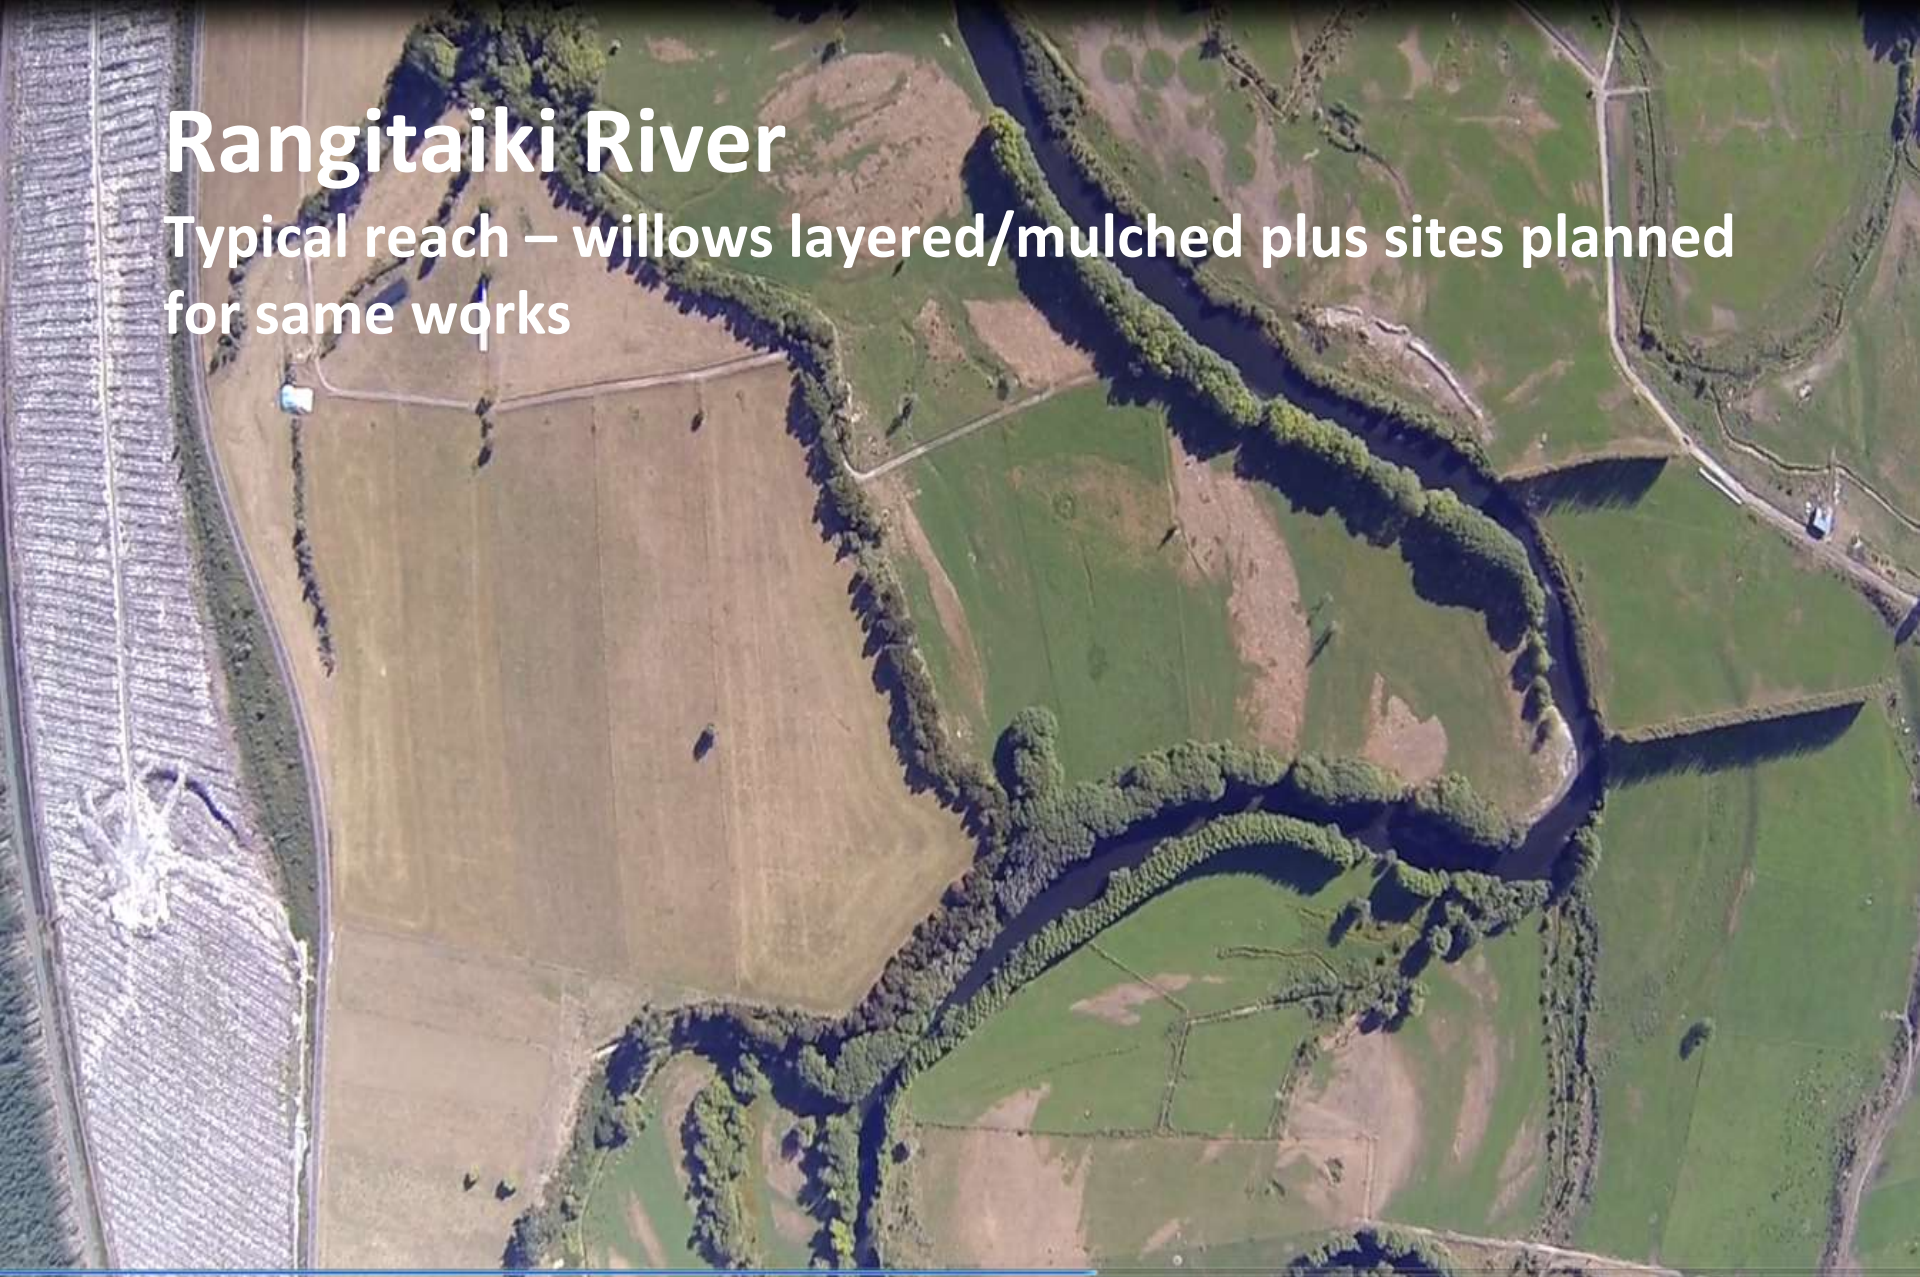
Typical reach – willows layered/mulched plus sites planned for same works

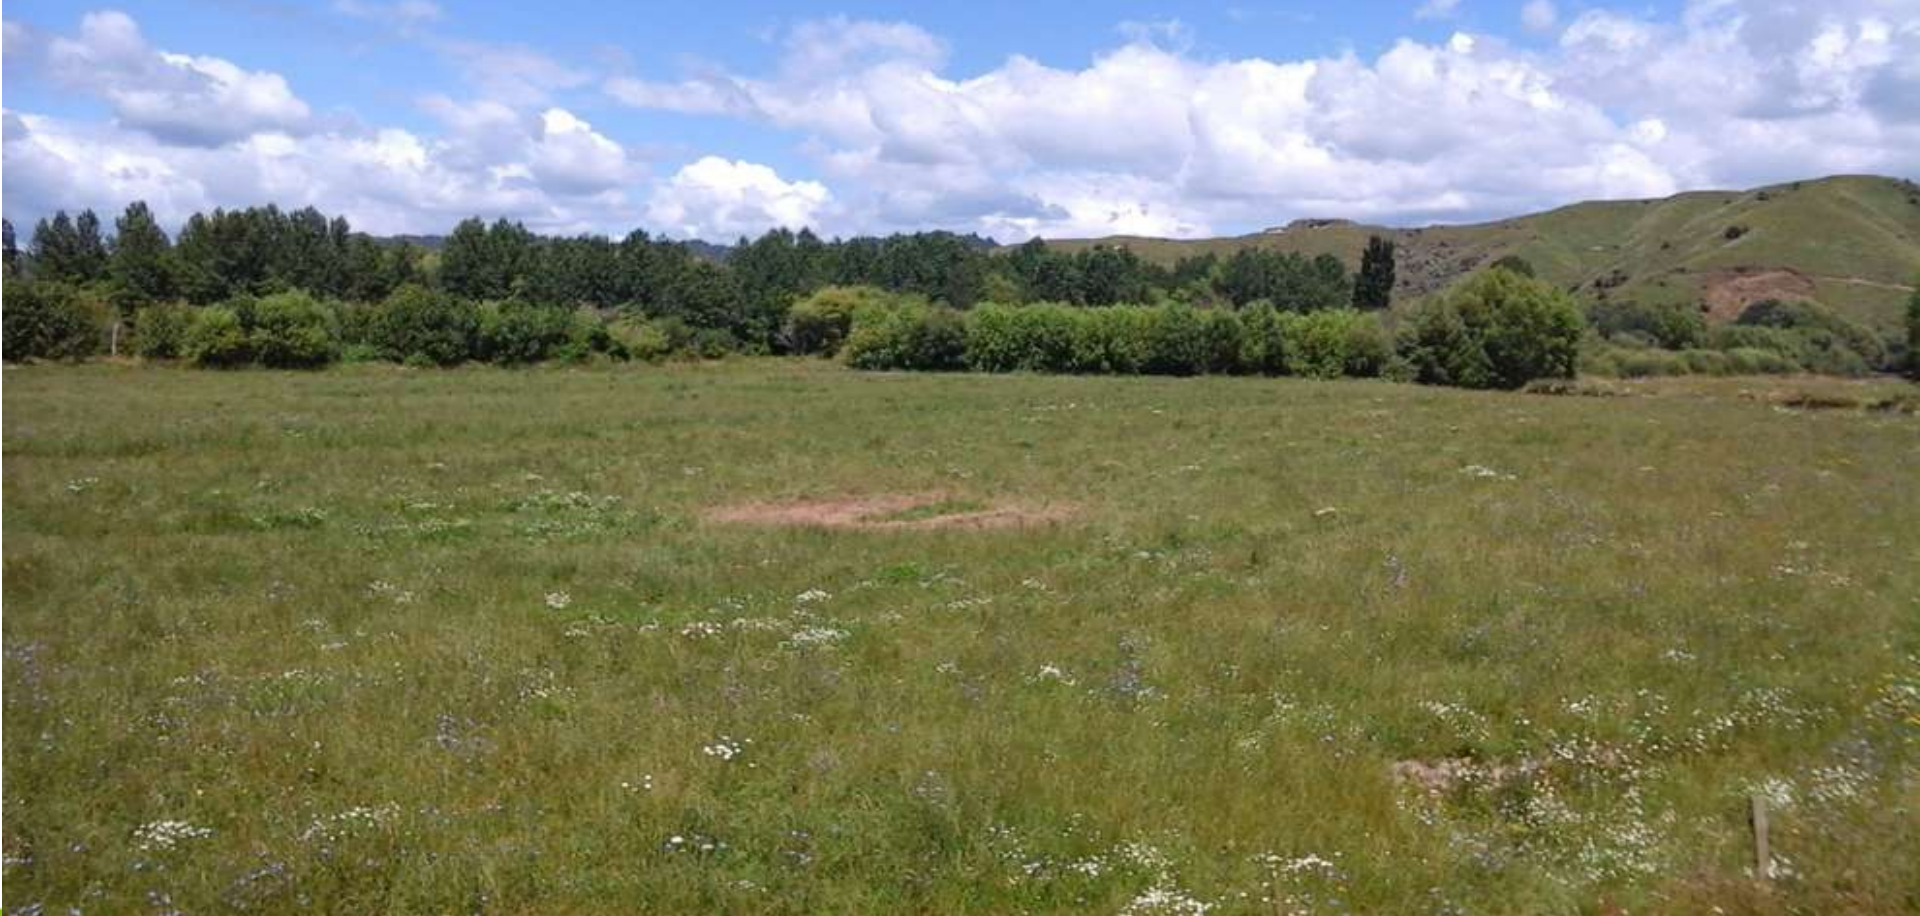
# Comparison foreground topping/ mulching 2012 - background not topped
