PFR SPTS No. 25684

## **Poplars and willows as bioengineering solutions for riverbank flood protection – learnings from Cyclone Gabrielle**

June 2024

River Managers' Special Interest Group  
Te Uru Kahika – Regional and Unitary Councils Aotearoa

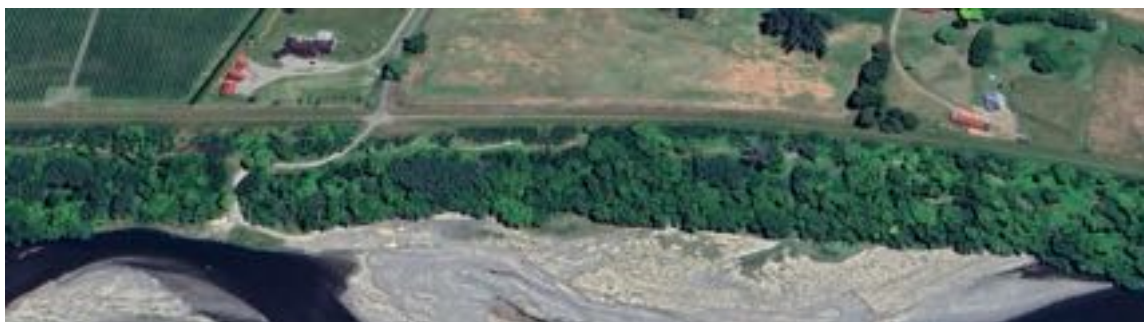
**Figure 8.** Pre-Gabrielle; Dec 2021.

An example of riverbank protection is the mid-Dartmoor site (refer Appendix 2) located on the true left bank opposite lower Ebbetts. The pre-cyclone riverbank and berm plantings consisted mainly of large to medium size tree willows, actively managed by lopping and layering. In addition to rope and rail training lines along the river edge, the berm included groynes to improve resistance to bank erosion.

The stopbank was set back 70 m from the riverbank, and most of the berm width was planted, which in normal floods would offer erosion protection to the stopbank. However, the cyclone flows significantly exceeded the floodway capacity, and the adjacent stopbank overflowed and breached. The siphoning-off of large breach flows from the main channel, combined with the directional effects of Ebbetts floodplain return flows, combined to wash out or flatten the berm planting. Fortunately, the river channel alignment held due to the combination of bank and berm erosion protection measures in place. The post-cyclone aerials showed partial regrowth of the poplars and willows flattened by floodwaters, which demonstrates the durability of the remnant erosion protection planting. The aerial photos below (Figures 8 & 9) show the pre- and post-cyclone riverbank and berm protection planting.

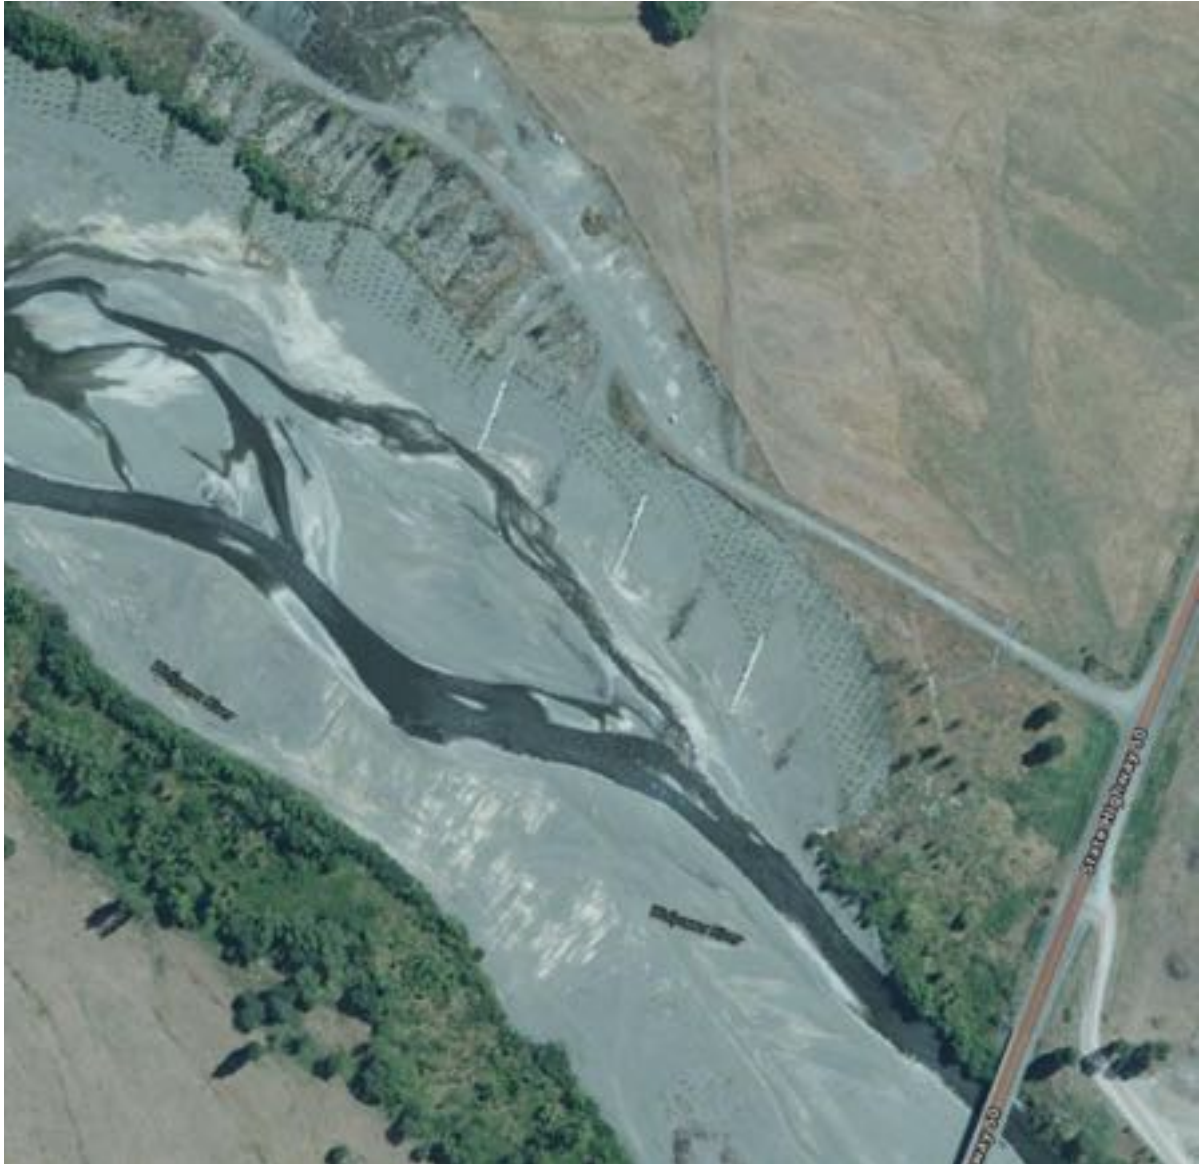
A comprehensive project was undertaken upstream of SH50, and just prior to Cyclone Gabrielle, to secure the channel alignment and prevent damage to the SH50 Bridge. Works consisted of channel realignment, erosion bay infill, Akmon groynes, rope/rail groynes & training lines, and extensive tree planting (Figure 15). Infilled gravel areas closer to the river were planted with willow poles (*Salix matsudana x alba* hybrids), and poplar poles (*Populus x euramericana* 'Veronese') were planted higher up on the banks. Cyclone Gabrielle partially undermined the Akmon and rope/rail groynes causing bank erosion and channel realignment (Figure 16). A further flood in June 2023 further damaged these works upstream of SH50, resulting in bridge abutment wash-out and road closure.

**Figure 15.** Newly completed Waipawa River training works upstream of SH50 – prior to Cyclone Gabrielle.

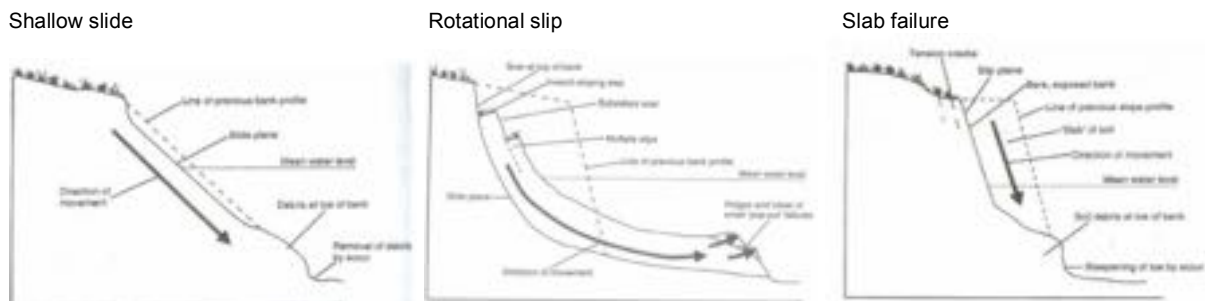
An understanding of the mechanism of bank erosion and/or instability is important to help determine the appropriate bioengineering method. Figure 19 shows several possible bank instability modes demonstrated in the Te Ārai (as well as the Ūawa-Hikurangi and Waimatā Rivers). The mechanism of bank saturation during flood (adding weight, increasing soil pore water pressures, and lubricating slip surfaces), toe erosion (especially on the outside of bends), and flood recession (removal of stabilising hydrostatic pressure) – all contribute to riverbank slope failures. These rivers have high suspended sediment loads, and deposit silts on the banks during quiet flood sequences, thus healing the slope failures and shrinking channel capacity. Riverbank toe erosion, slope failure, and channel enlargement during the next major flood repeats this natural cycle.

Figure 19. Riverbank slope failure modes.

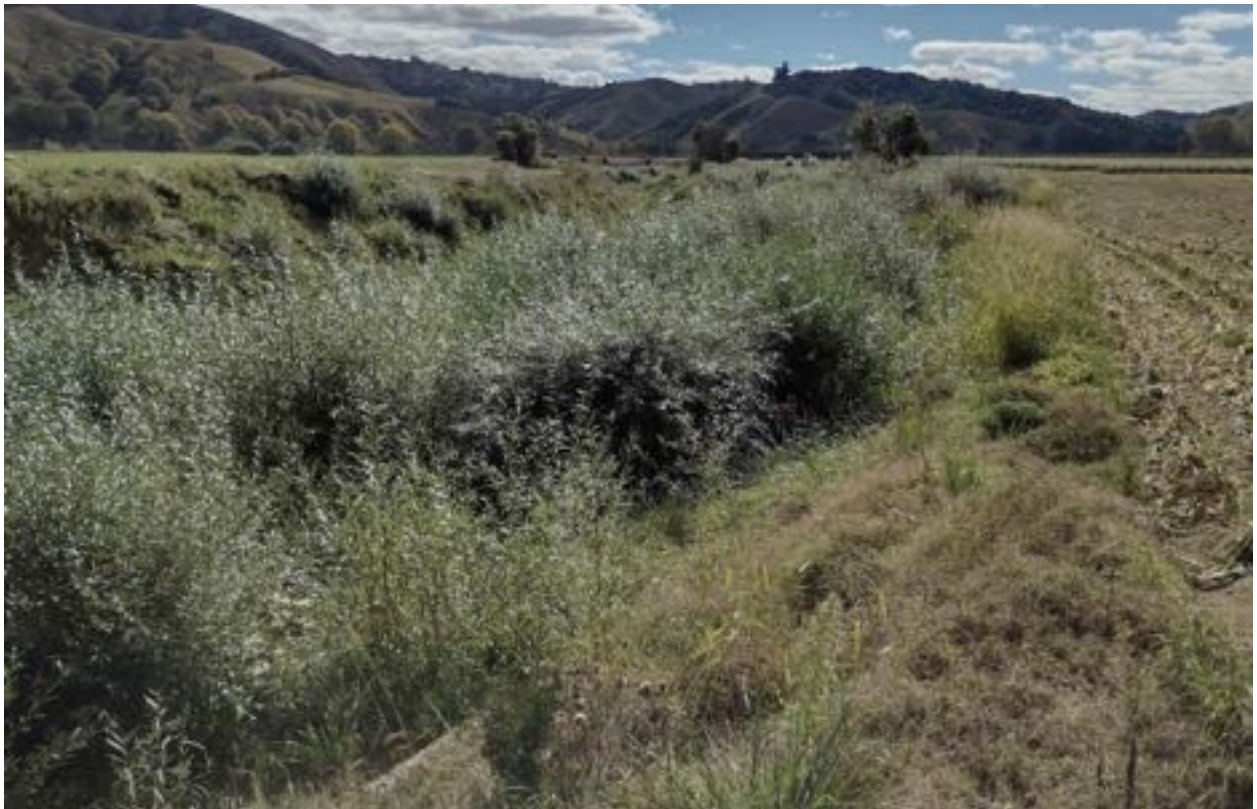
Except for a few sites, the river edges and bank were intact and protected by mature woody vegetation (Figure 21). Woody debris trapped in the channel had been removed, and the woody vegetation (largely osier willow) had been coppiced (Figure 22). Eroded outside bends had not yet been re-stabilised (Figure 23). There was no evidence of trees being flattened by floodwaters as noted on the Tūtaekurī River. This was no doubt attributable to the lower gradient and flood velocities in the Te Ārai River.

**Figure 21.** Typical bank vegetation on downstream Te Ārai River with dense osier willow on near bank.

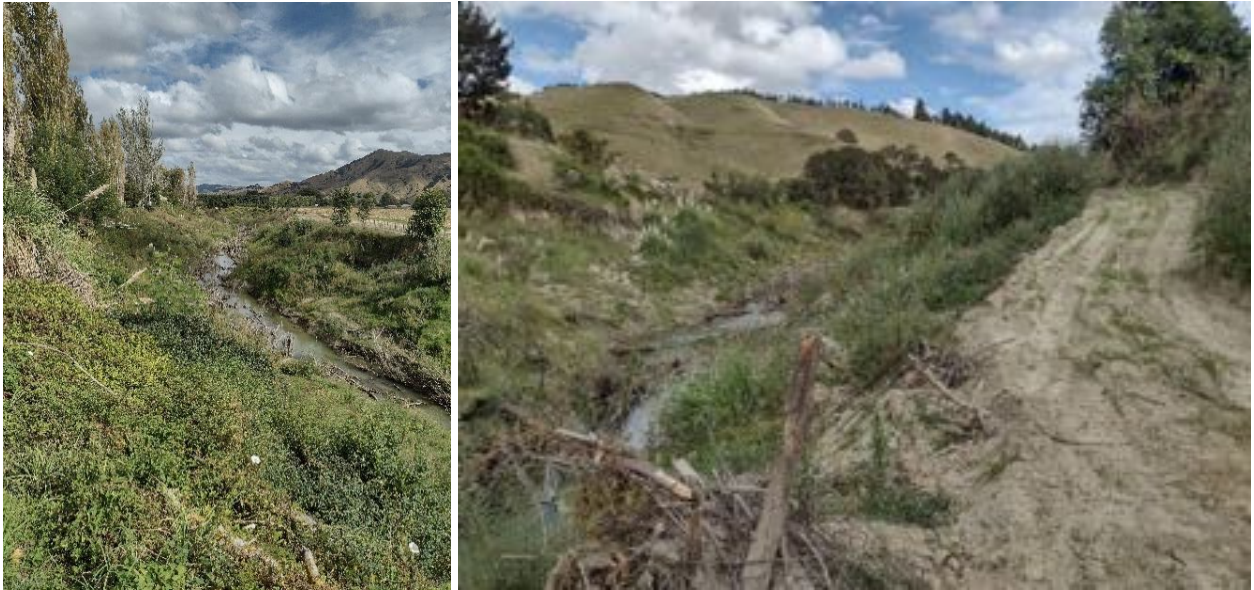
**Figure 22.** Bank edge and slope vegetation in the lower reaches of Te Ārai River, with woody debris in the channel. The access track is facilitating woody debris removal from the channel.

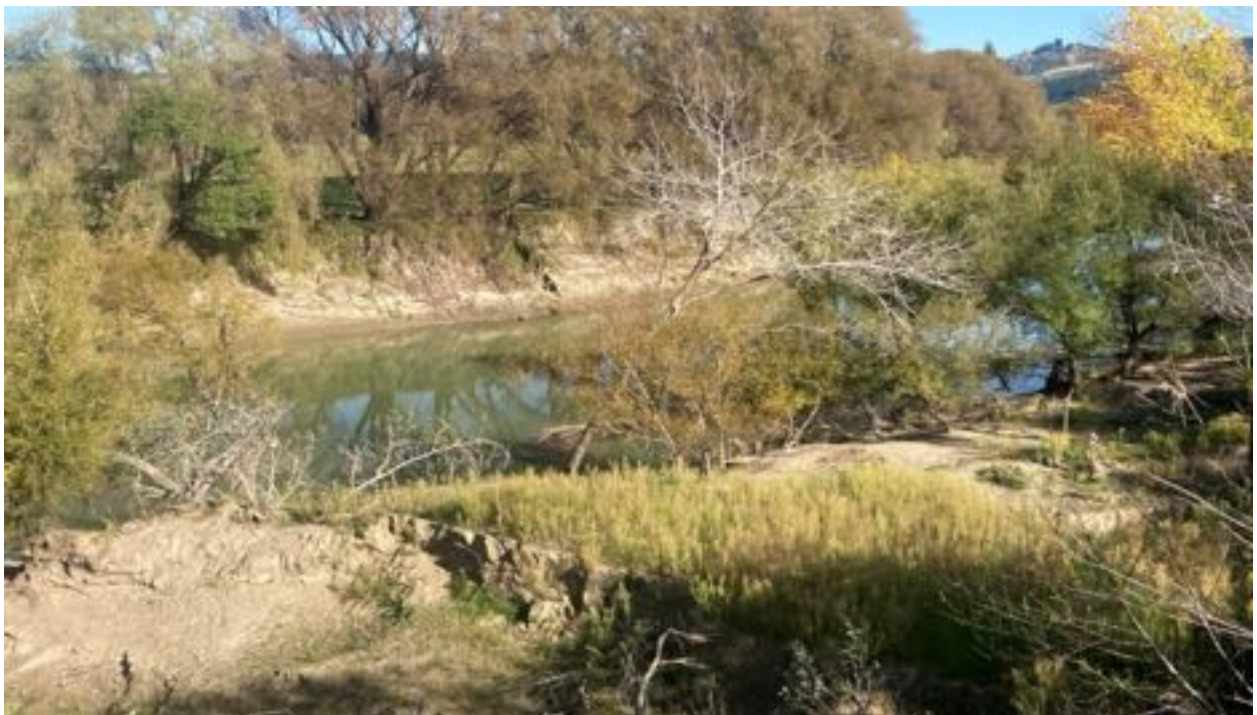
Banks on the Hikuwai River showed a high degree of stability. Where tree willows were planted at the top of the bank there was little if any slumping (Figure 24). Fibrous willow roots occupied the bank profile down to the channel. We observed large roots in the banks, partially exposed by the floodwaters, which were running laterally at different depths, and with fibrous roots extending from them (Figure 24). This was clear evidence of how willow root systems hold steep banks intact. Erosion from the top of the banks was evident where drains entered the river, and where overland flow from a low point on the paddock flowed back into the river (Figure 25). Toe erosion and slumping of the bank occurred along stretches of the river, either with no trees planted at the top of the bank, or where unsuitable trees (mānuka, poplar, tōtara) were undermined (Figure 26). At several locations, we observed that poplars planted on the top of the bank, and close to edge, were undermined and toppled by floodwaters. One example was at Hikuwai No. 1 Bridge (Figure 27).

**Figure 24.** Willows lining the top of the bank, with roots visible down the sloping bank to the channel, Hikuwai River.

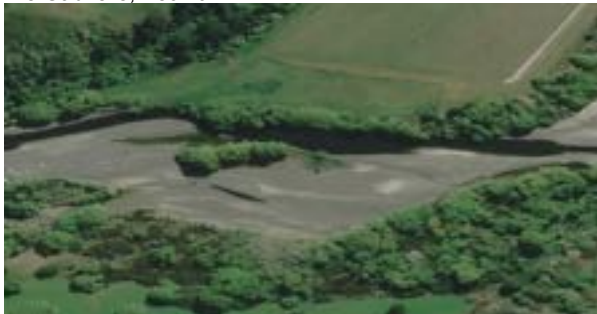
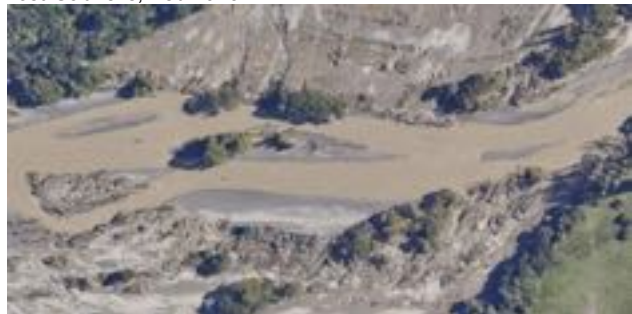
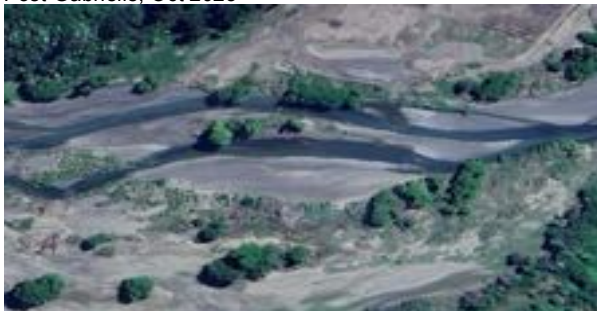
The site visit showed strong regrowth of layered or partially undermined bank and berm willows. The river channel and floodplain areas had been cleared of woody debris, which was carted away for processing, or chipped on site. The wider buffer plantings showed especially high resilience with minimal damage. There was substantial filtering and trapping of woody debris, which was especially obvious on post-Gabrielle aerial photos at the downstream end of the vineyard.

**Figure A1.** Aerial photos – upstream of Mangaone confluence.

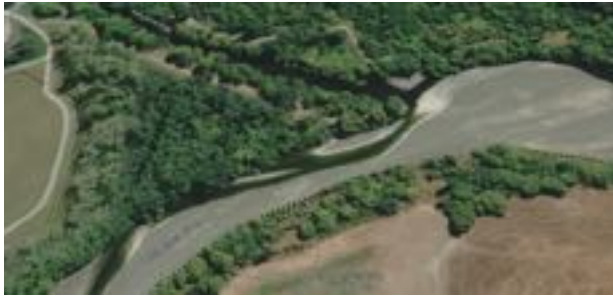
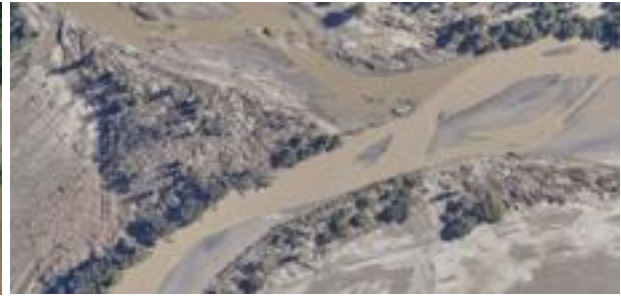
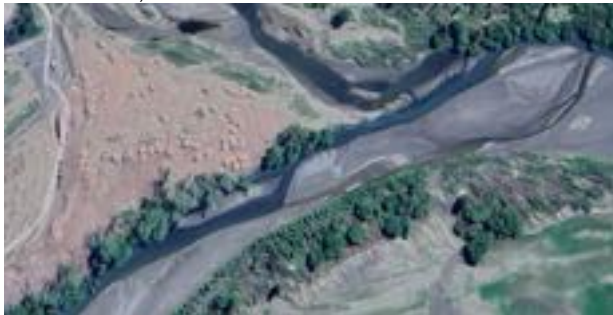
**Figure A2.** Aerial photos Tūtaekurī & Mangaone Rivers confluence site.

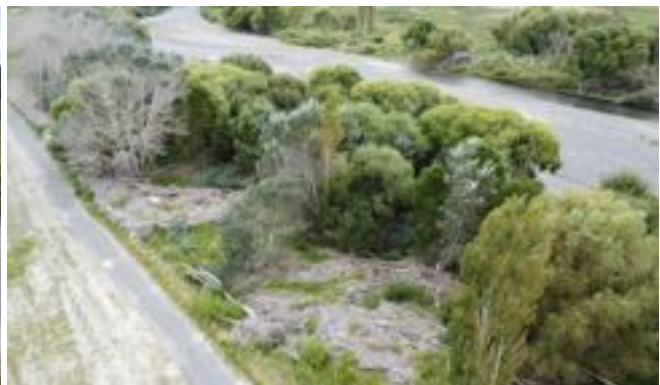
Buffer zone with trapped woody debris.

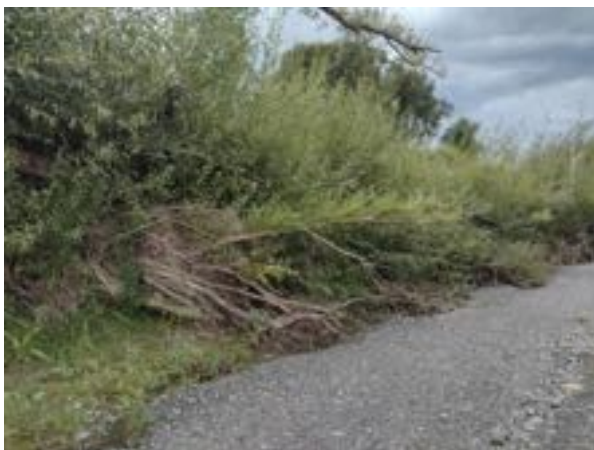
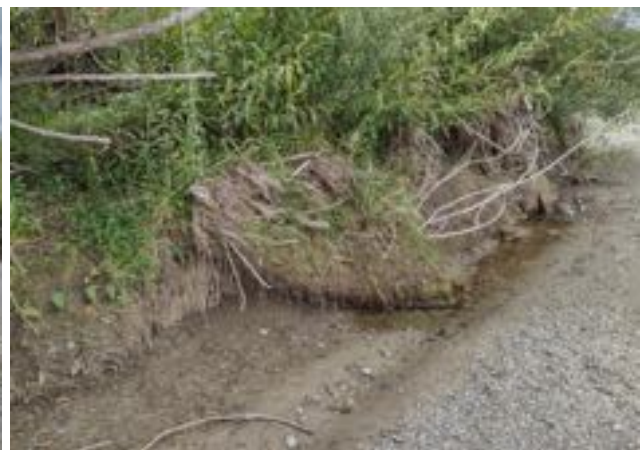
**Figure A4.** Flood layered willows & willow root mat healing bank erosion.

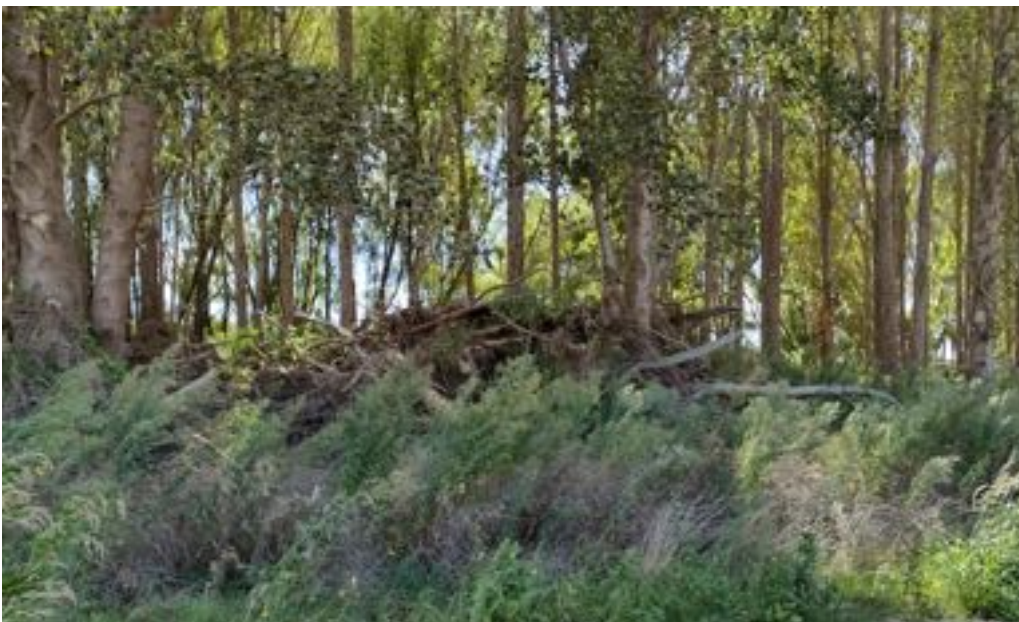
**Figure A9.** Woody debris capture in buffer zones.

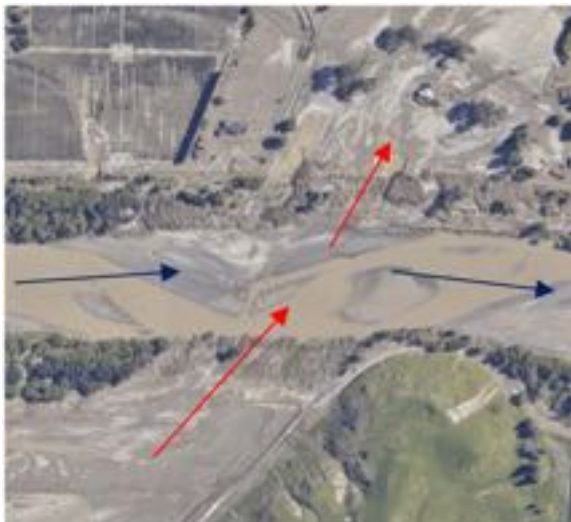
**Figure A12.** Directional flow of floodwater from Ebbetts across the channel to lower Dartmoor.

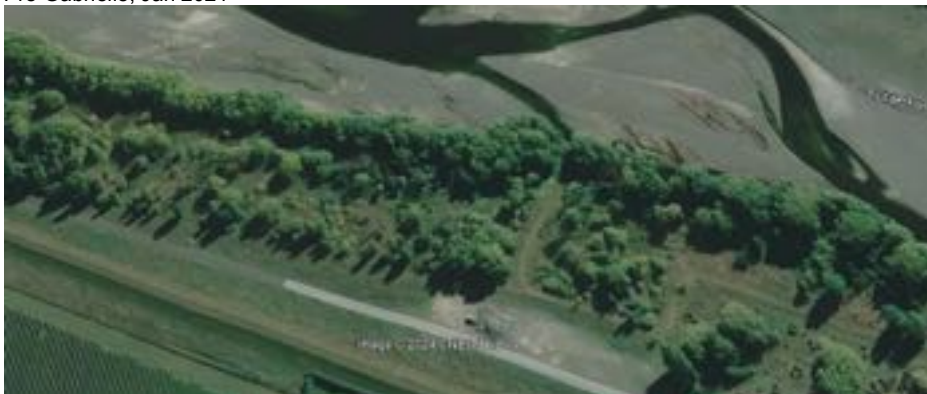
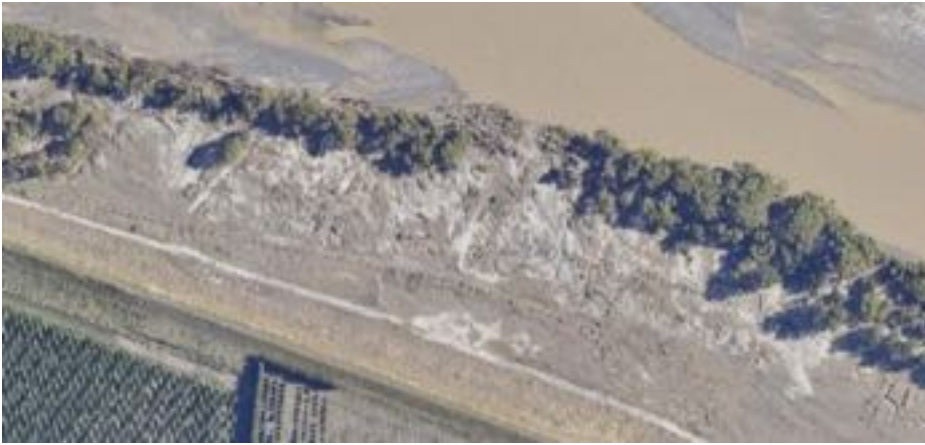
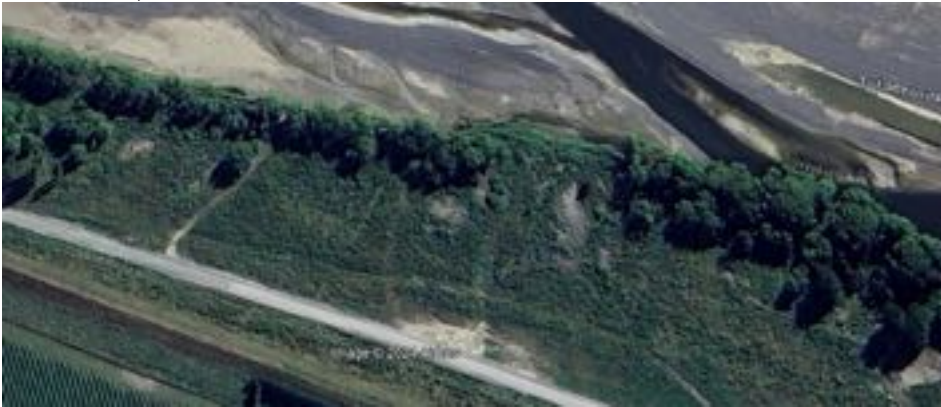
**Figure A14.** Aerial views of the Moteo site pre- and post-Gabriel.

Of particular note was the effectiveness of the buffer zone, adjacent to the major Moteo stopbank breach, in preventing the berm scour hole from connecting with the river channel. Such a connection would have increased berm and stopbank flood damage and resulting damage to floodplain property.

Overall, the buffer plantings upstream and downstream of the site were in very good condition and showed exceptional resilience to the flood event.

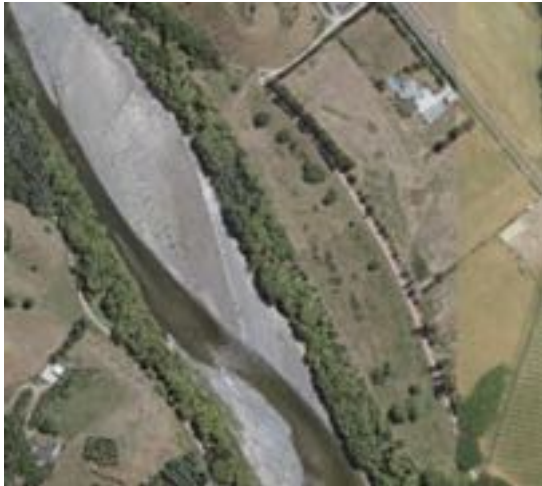
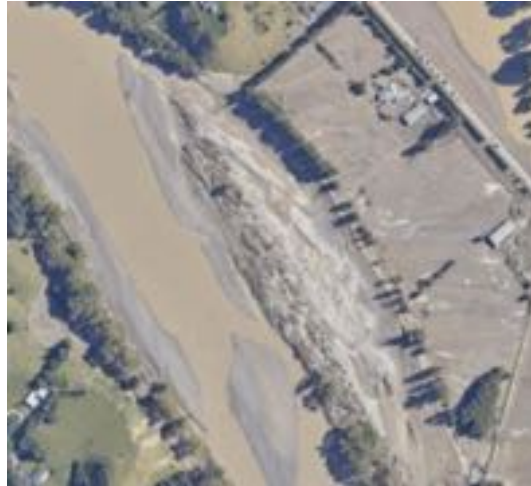
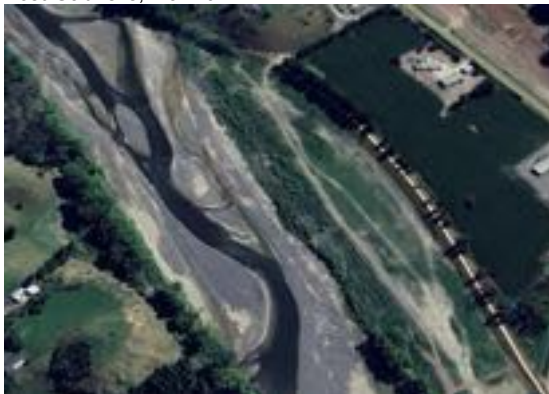
**Figure A16.** Aerial views of the Puketapu site pre- and post-Gabriel.

Post cyclone, the flood layered bank and berm vegetation showed strong regrowth. The upstream end of the site was strengthened with rope and rail groynes, willow trenching, and pole planting. Willow pole planting was also carried out to widen and infill open areas of the buffer. This work was establishing well.

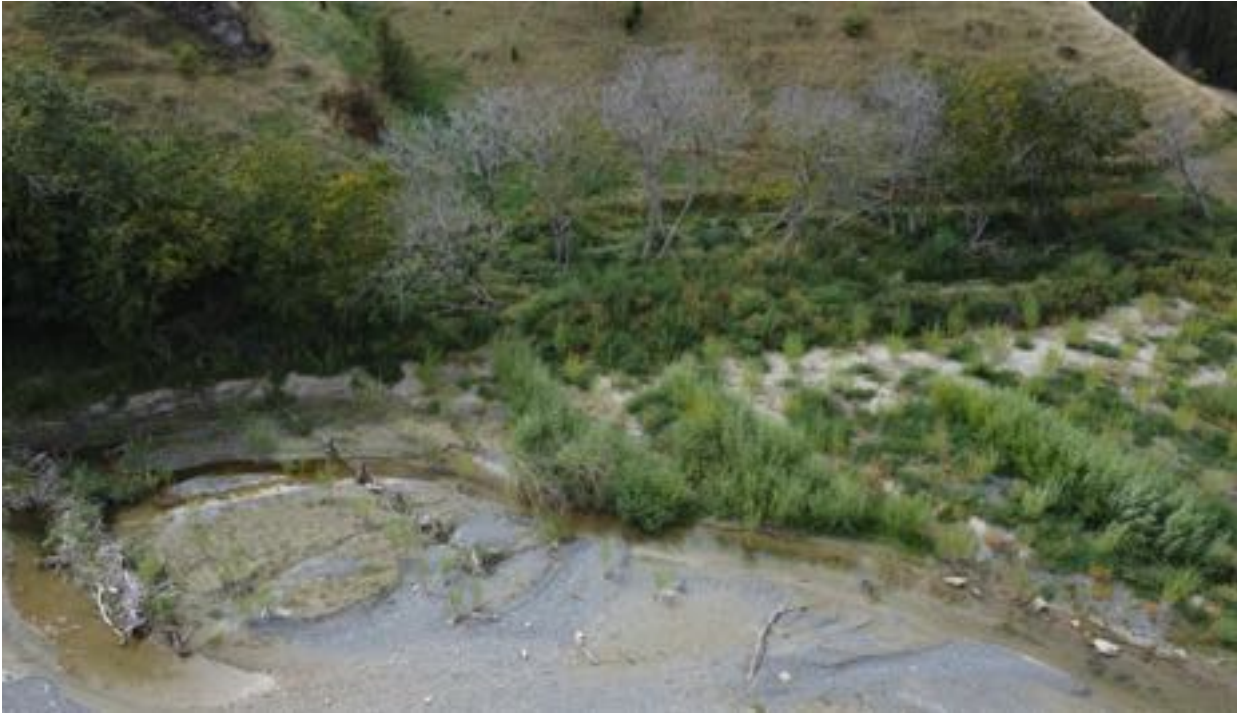
**Figure A17.** Rope & rail groynes, willow trenching, and pole planting.

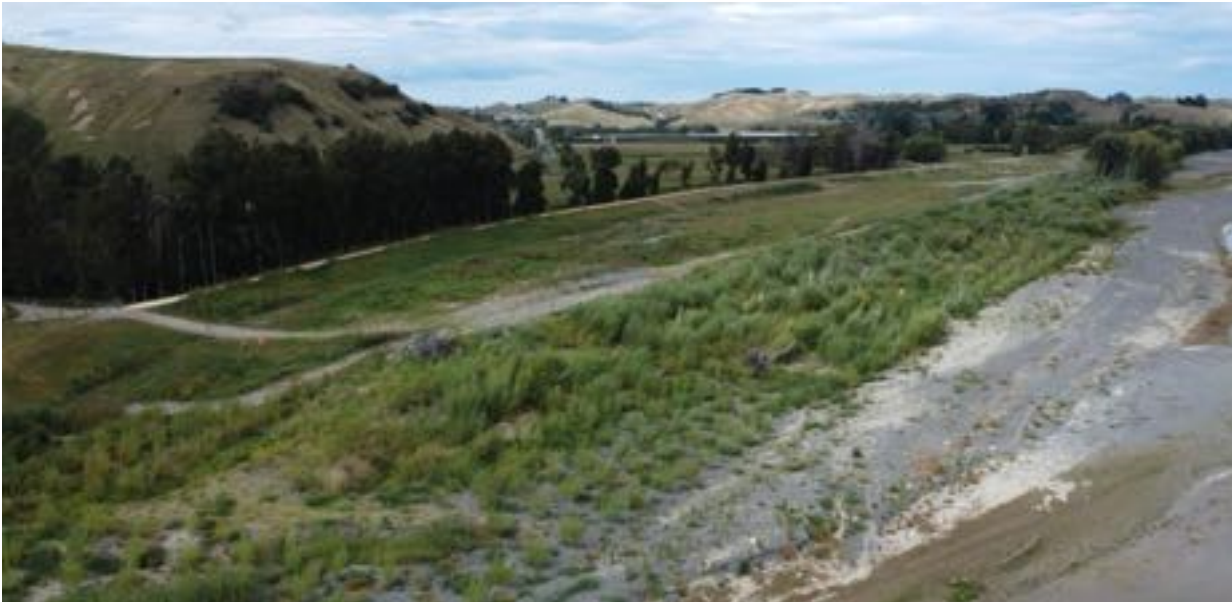
**Figure A18.** Flood layered willow regrowth & pole planting.

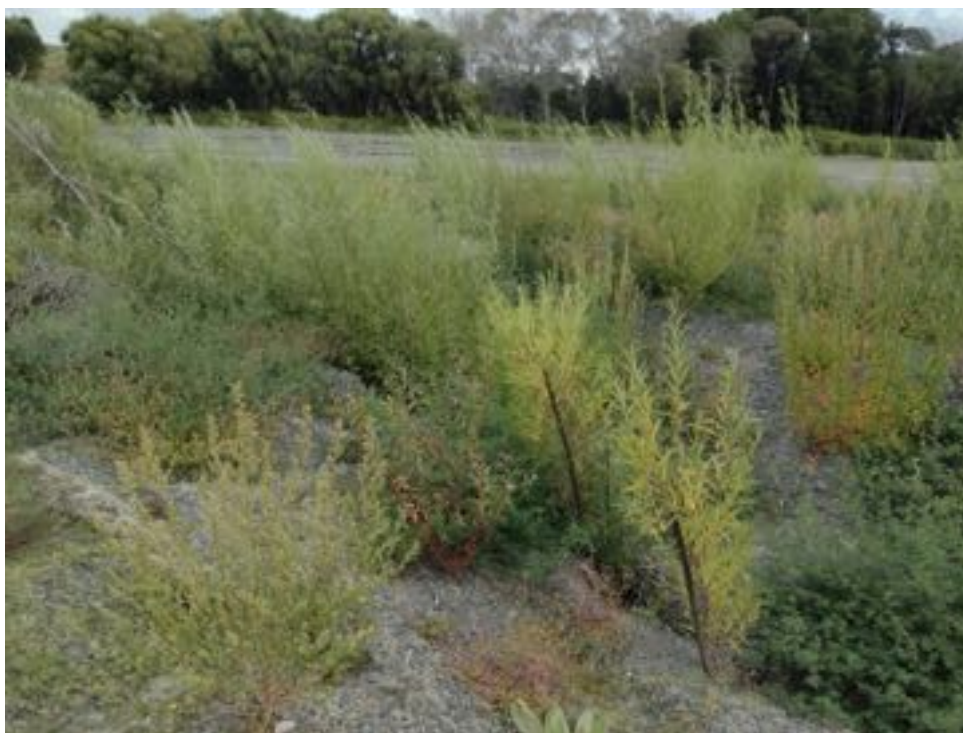
**Figure A19.** Newly planted willow poles.

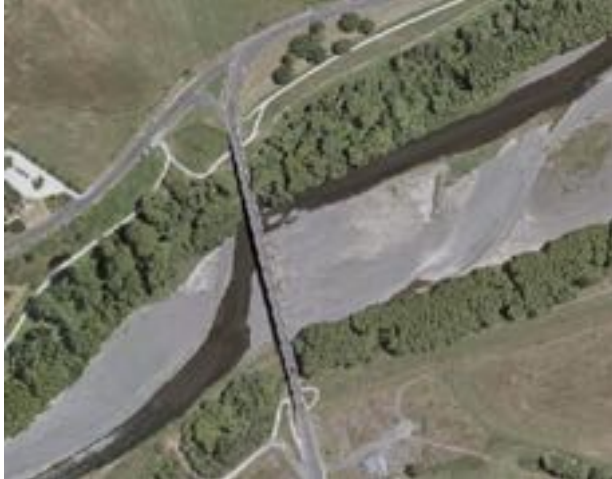
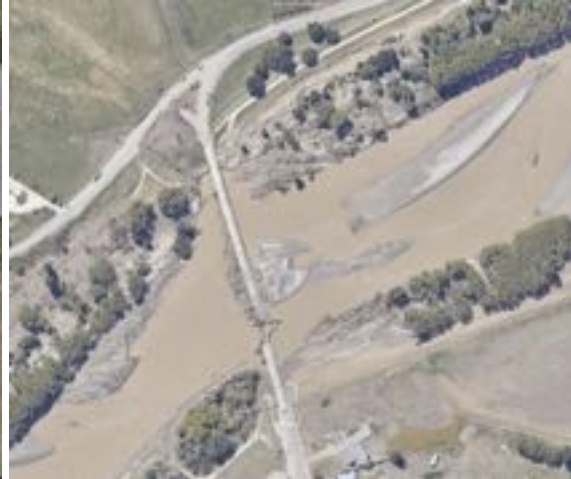
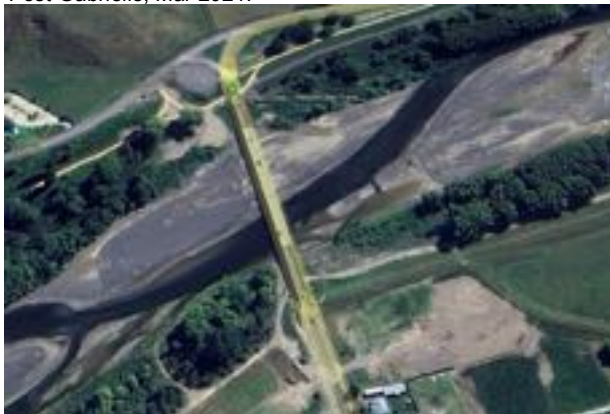
**Figure A20.** Aerial views of the Redclyffe Bridge.

There was substantial bank and berm erosion upstream at both ends of the bridge. Berm erosion also occurred adjacent to the newly upgraded Taradale stopbank. Fortunately these erosion sites didn't grow and cause bridge abutment washout or stopbank breach.

Overall the buffer plantings upstream and downstream of the site were in very good condition, and showed exceptional resilience to the flood event.

Post-cyclone repairs undertaken included debris removal from the bridge and channel, interim bridge repairs, scour hole filling on the banks and berms, and willow pole planting. Substantial further work will be needed to secure this vulnerable site.

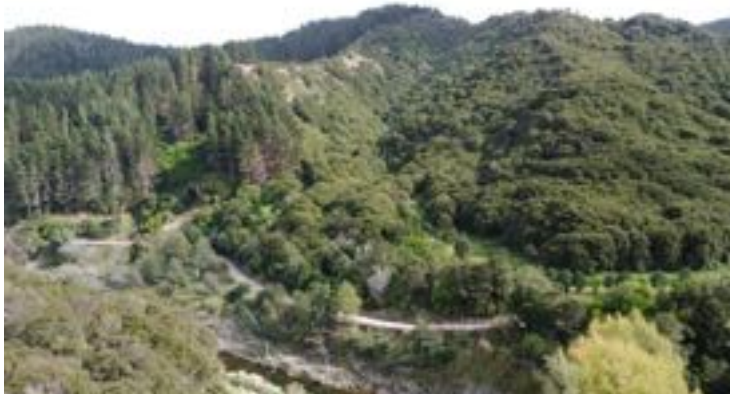
**Figure A26.** Hill slope vegetation contrast – forestry and native regeneration – Waimatā River.

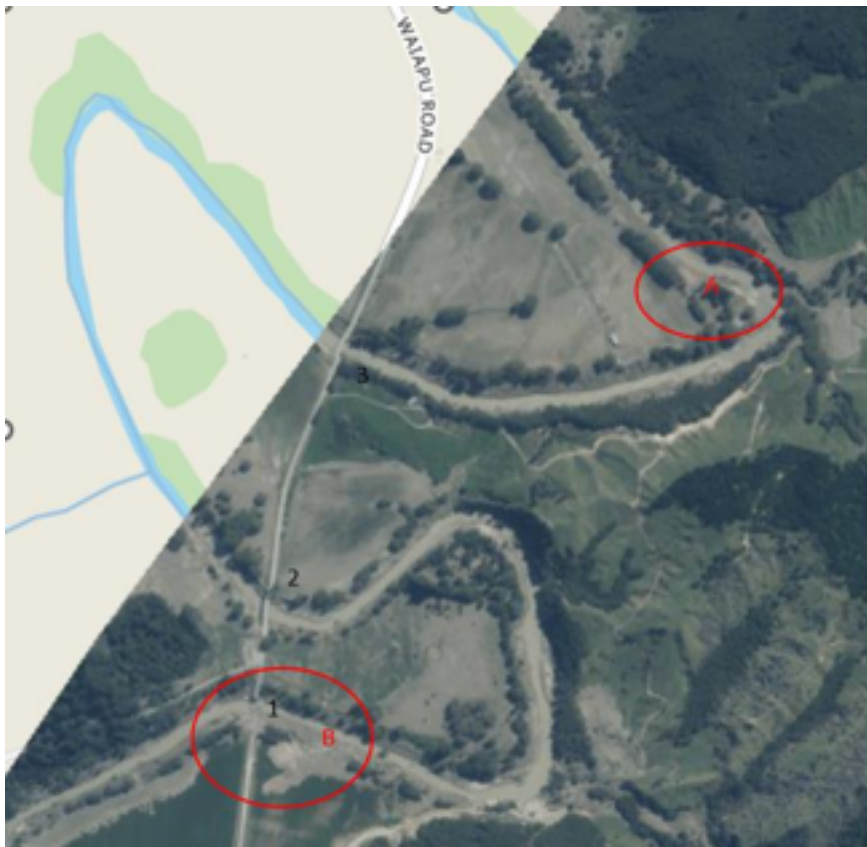
Within Tairāwhiti there were a number of instances where woody debris capture on river berms and floodplain areas reduced downstream movement of flood debris. This was a fortuitous outcome of berm tree location and alignment in relation to in-river and overland flow patterns. In the case of the Hikuwai River there were two sites, upstream of Hikuwai Bridges No. 3 & No. 1, where significant volumes of debris accumulated (see Figures A28 & A29).

**Figure A28.** Hikuwai River – woody debris capture sites.

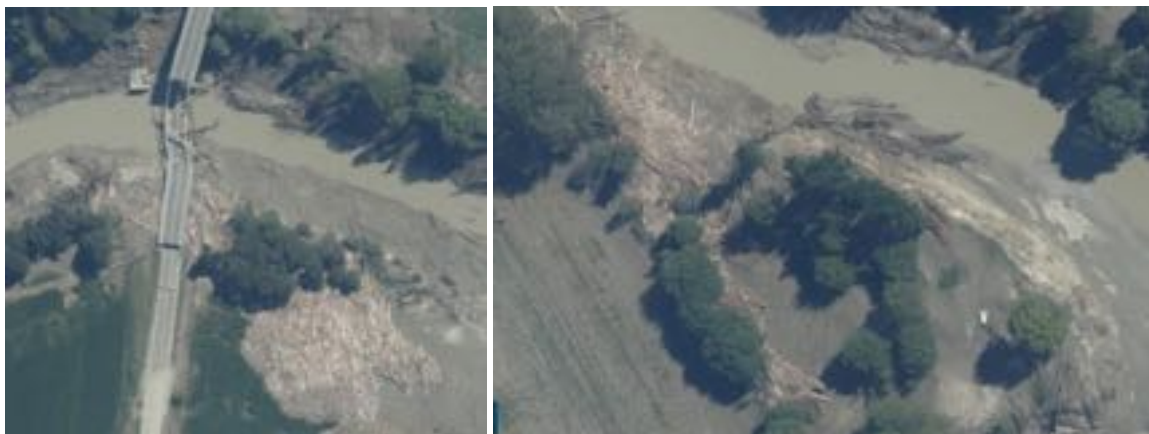
**Figure A29.** Hikuwai River – woody debris capture – Sites A & B.

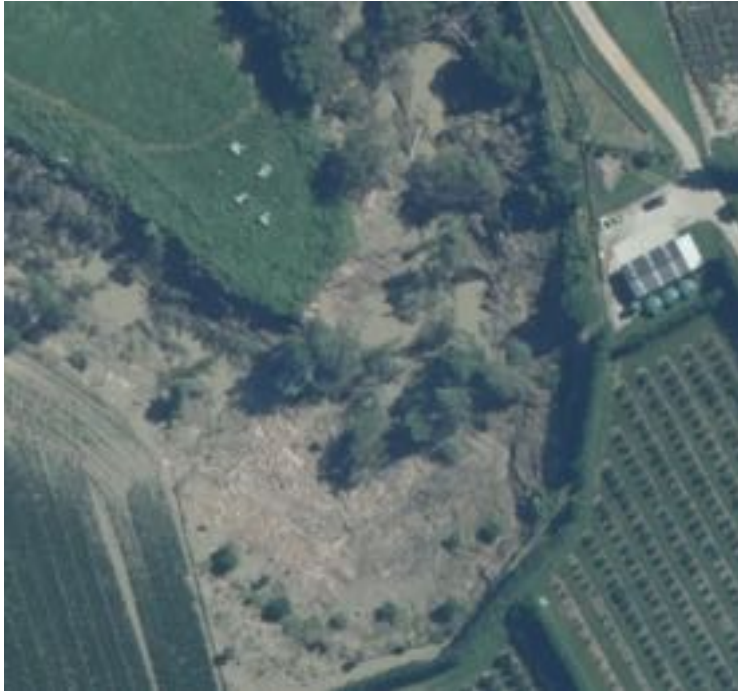
The lower reaches of the Te Ārai channel were badly congested with large trees (mainly willow) before Cyclone Gabrielle. This tree growth roughened the channel, reducing flow velocity and channel flood capacity, and increasing floodplain overflows. The in-channel trees may have reduced bank slumping and erosion and will have reduced downstream movement of up-catchment sourced woody debris (Figure A30). In rivers such as the Te Ārai there may be a compromise to be found between flood capacity, bank stability, and debris capture, by managing in-channel tree type, location, and size.

**Figure A30.** Te Ārai River – woody debris capture in lower reaches.

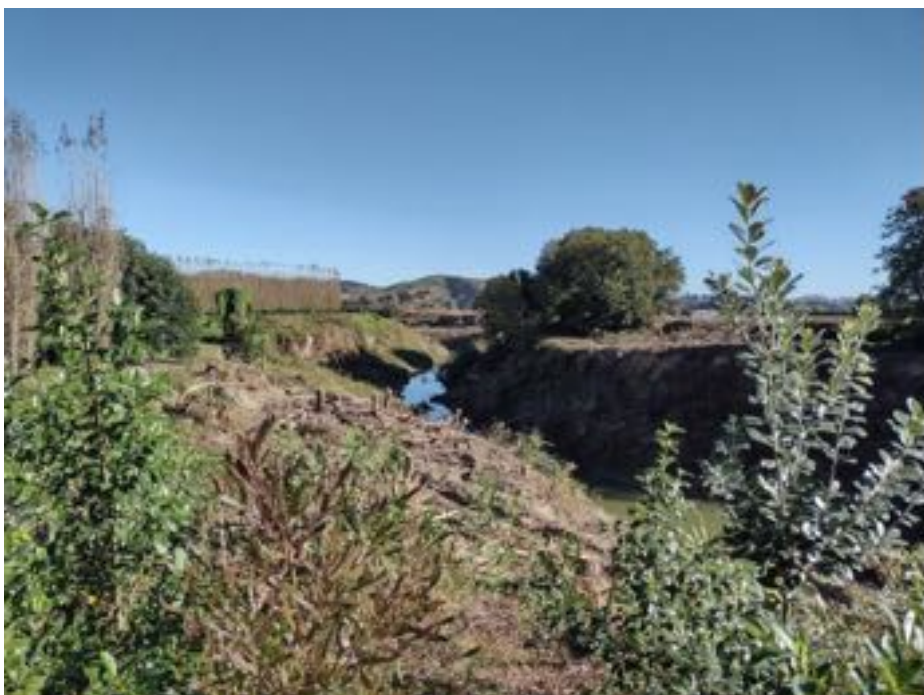
**Figure A31.** Te Ārai River – results of extensive channel debris clearance & tree removal works post Cyclone.

The Hikuwai and Te Ārai River examples suggest that strategic siting of tree rows, at locations such as at berm or floodplain overflow areas, on sharp bends, and upstream of bridges, could help debris capture and reduce downstream debris related damage. This type of approach would need to be implemented along with ongoing localised or extensive channel tree maintenance and debris removal works programmes (Figure A31).

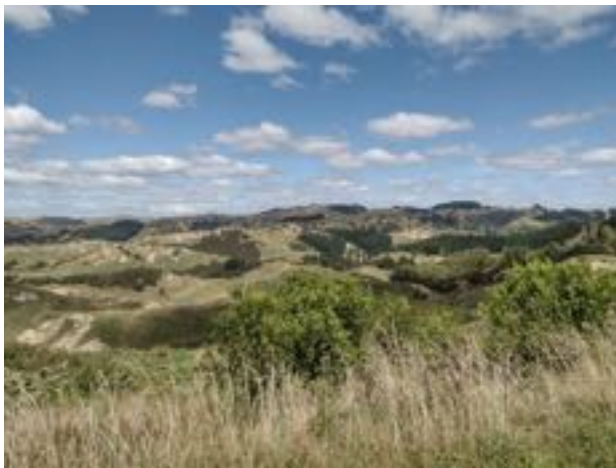
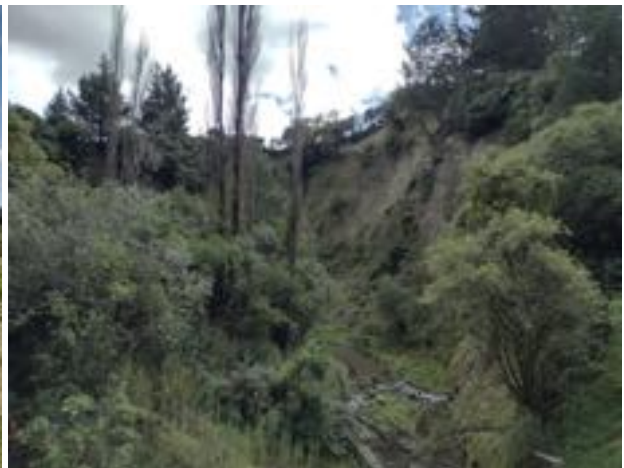
In the case of the Tūtaekurī River catchment, the main woody debris source appeared to be the tributary Mangaone River. This catchment includes plantation forestry but is mainly pastoral hill country with a high erosion potential (Figure A32 left). The waterways are often entrenched within gorges or very steep sided narrow valleys, and heavily vegetated with a range of trees and shrubs (Figure A32 right). This waterway vegetation is vulnerable to wash out and downstream movement during flood events.

**Figure A32.** Pastoral hill country, Mangaone catchment.

Entrenched Mangaone tributary stream channel.

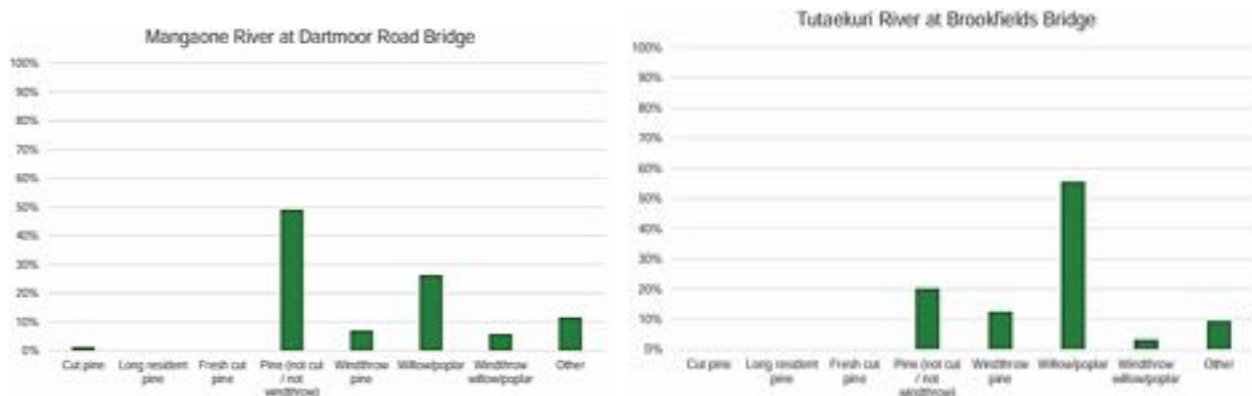
The Cyclone Gabrielle Woody Debris Species Composition Assessment report gives some insight into the categories of tree material making up the woody debris, and the extent to which tree selection and management practices could reduce debris problems in future. For example, Figure A33 shows the woody debris composition at Dartmoor Road Bridge (Mangaone River) and Brookfields Bridge (Tūtaekurī River), respectively. Most of the material at the Dartmoor Road Bridge is pine, whereas at the Brookfields Bridge site it is willow/poplar. This seems reasonable given the Tūtaekurī River reach downstream of Dartmoor is managed for flood protection purposes, and the bank and berm vegetation is mainly willow and poplar.

**Figure A33.** Woody debris composition at a) Dartmoor Bridge and b) Brooklands Bridge.

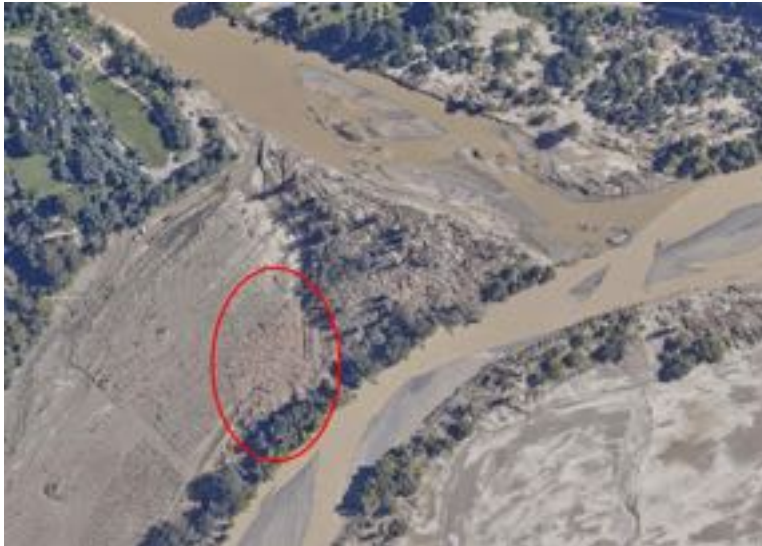
One example was the site on the Tūtaekurī River upstream of the Mangaone confluence. Figure A34 shows a large pocket of woody debris which has moved onto and over the floodplain to be captured landside of berm buffer vegetation. Figure A35 shows woody debris capture on both landside and riverside of buffer vegetation.

**Figure A34.** Floodplain woody debris capture— Tūtaekurī & Mangaone River confluence.

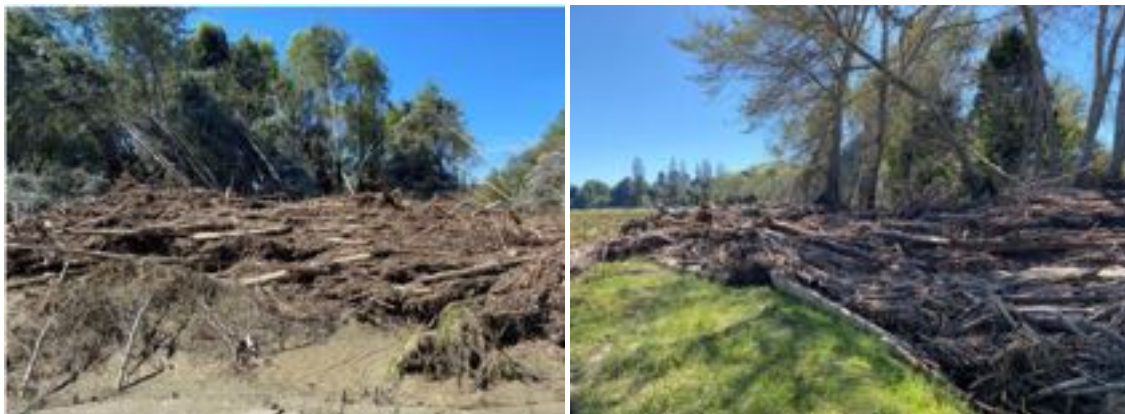
**Figure A35.** Woody debris capture by berm buffer zones – riverside & landside.

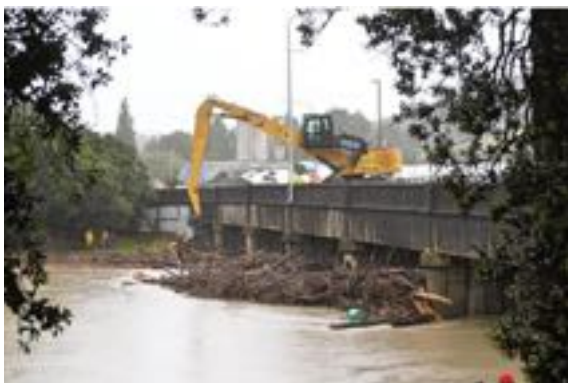
One issue that has become apparent since Cyclone Gabrielle is that bridges, and their waterway capacity, are critical elements of flood protection systems. Bridges, depending on their design and upstream woody debris input, can act as flood bottlenecks and are incredibly effective debris traps (Figures A36 & A37). This of course can stress bridges to the point of collapse – but equally important, reduce river flood capacity with resulting stopbank overflow, breach, and related flood damage. New bridges should be designed with generous waterway/flood capacity provision, allowing for climate change and future flood protection system upgrade. Bridge waterway designs could include a debris supply assessment – and ensure that debris capture is minimised (i.e. appropriate spans, pier spacings and design, and underside levels). Existing bridges could be retrofitted with debris deflectors or lifters (Figure A38), and measures for debris removal during flood should be considered.

**Figure A37.** Woody debris removal during flood.

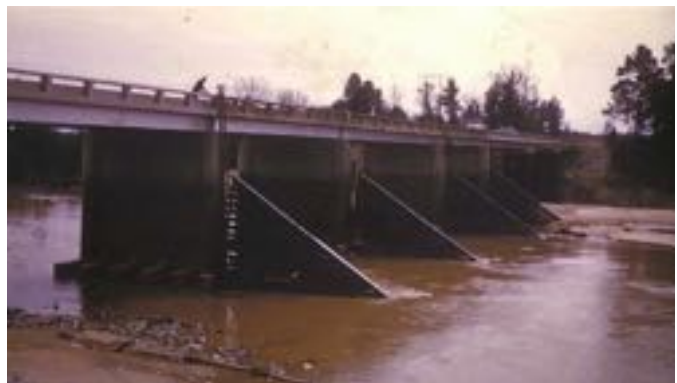
**Figure A38.** Bridge debris fins.
